Forensic Analysis of the NSTX-U PF1A-Upper Coil Failure

Rev. 0

November 18, 2016

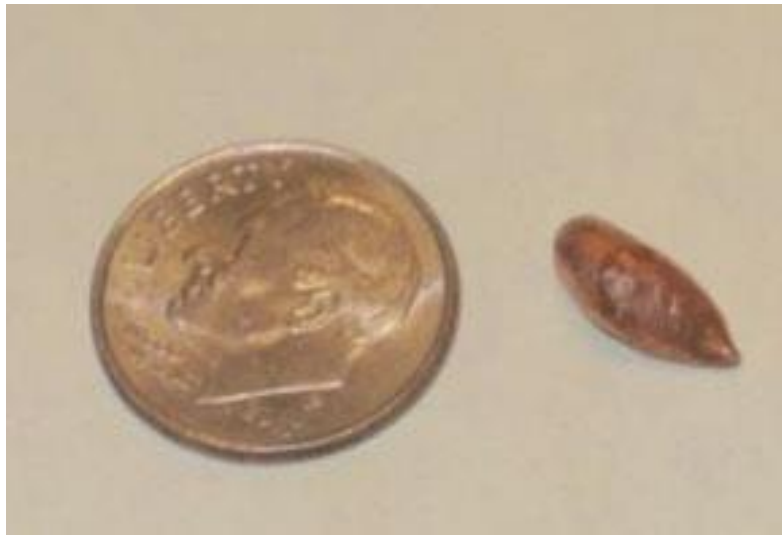
Between June 30 and July 5, attempts were made to clear the blocked cooling path by various means including reversing flow. Coolant water recovered from PF1A-U was observed to be cloudy and evidenced particulate matter and a 'charred' odor. A biological assay was performed on a sample of coolant liquid and evidenced levels of biological activity in initial samples [9]. Coolant water from other coils was also sampled, tested, and was unremarkable. The coolant path of PF1A-U was flushed with de-ionized water mixed with Dawn and subsequently Alconox. The blockage was reconfirmed to be within the body of the coil and not in the supply/return hoses. Each time the blockage appeared to have been cleared, the coil re-clogged. Any resulting flow was far less than normal flow rates. On July 5, 2016, during 600 psi hydrostatic pressure testing of PF1A-U, water was observed coming from the bottom of NSTX-U. A copper/carbon slug was recovered from water used to flush the coil cooling path (Figure 4) along with other debris (Figure 5). Chemical analysis of the slug showed that its component elements correspond with the composition of the conductor/epoxy/glass matrix, but not the brazes (which would have shown evidence of silver and other elements). The conclusion at that time was that while a leak may exist at a braze, the slug was formed elsewhere.

Figure 4 – Copper/carbon slug found in flushed PF1A-U coolant compared to the size of a dime

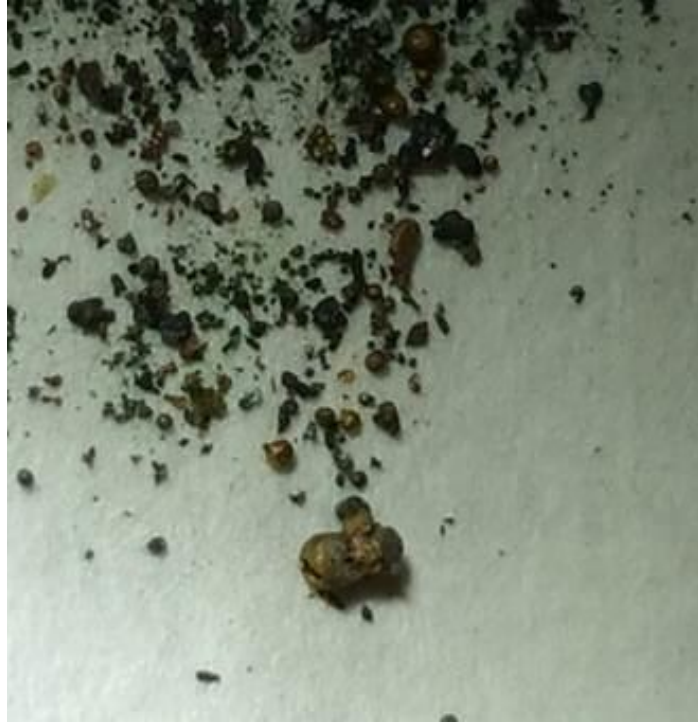
Figure 5 – Debris found in the flushed PF1A-U coolant

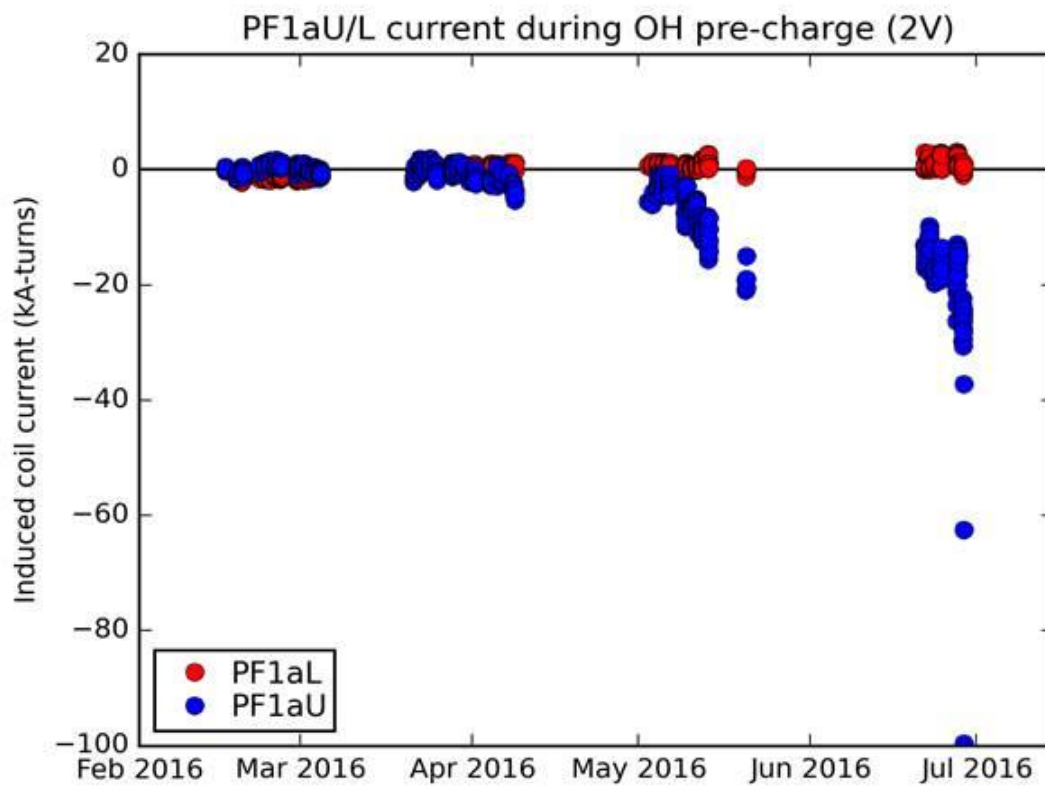
From July 20 through July 22, 2016, limited operations resume including inductively energizing PF1A-U for the purpose of performing a diagnostic on the coil. Review of archived data shows a gradual deterioration of PF1A-U's resistance and inductance (Figure 6) going back several months. All data pointed to an internal electrical failure of the coil including a breached cooling path. Effective July 22, 2016, PF1A-U operations were suspended.

Figure 6 – Gradual change in the inductance of PF1A-U over several months

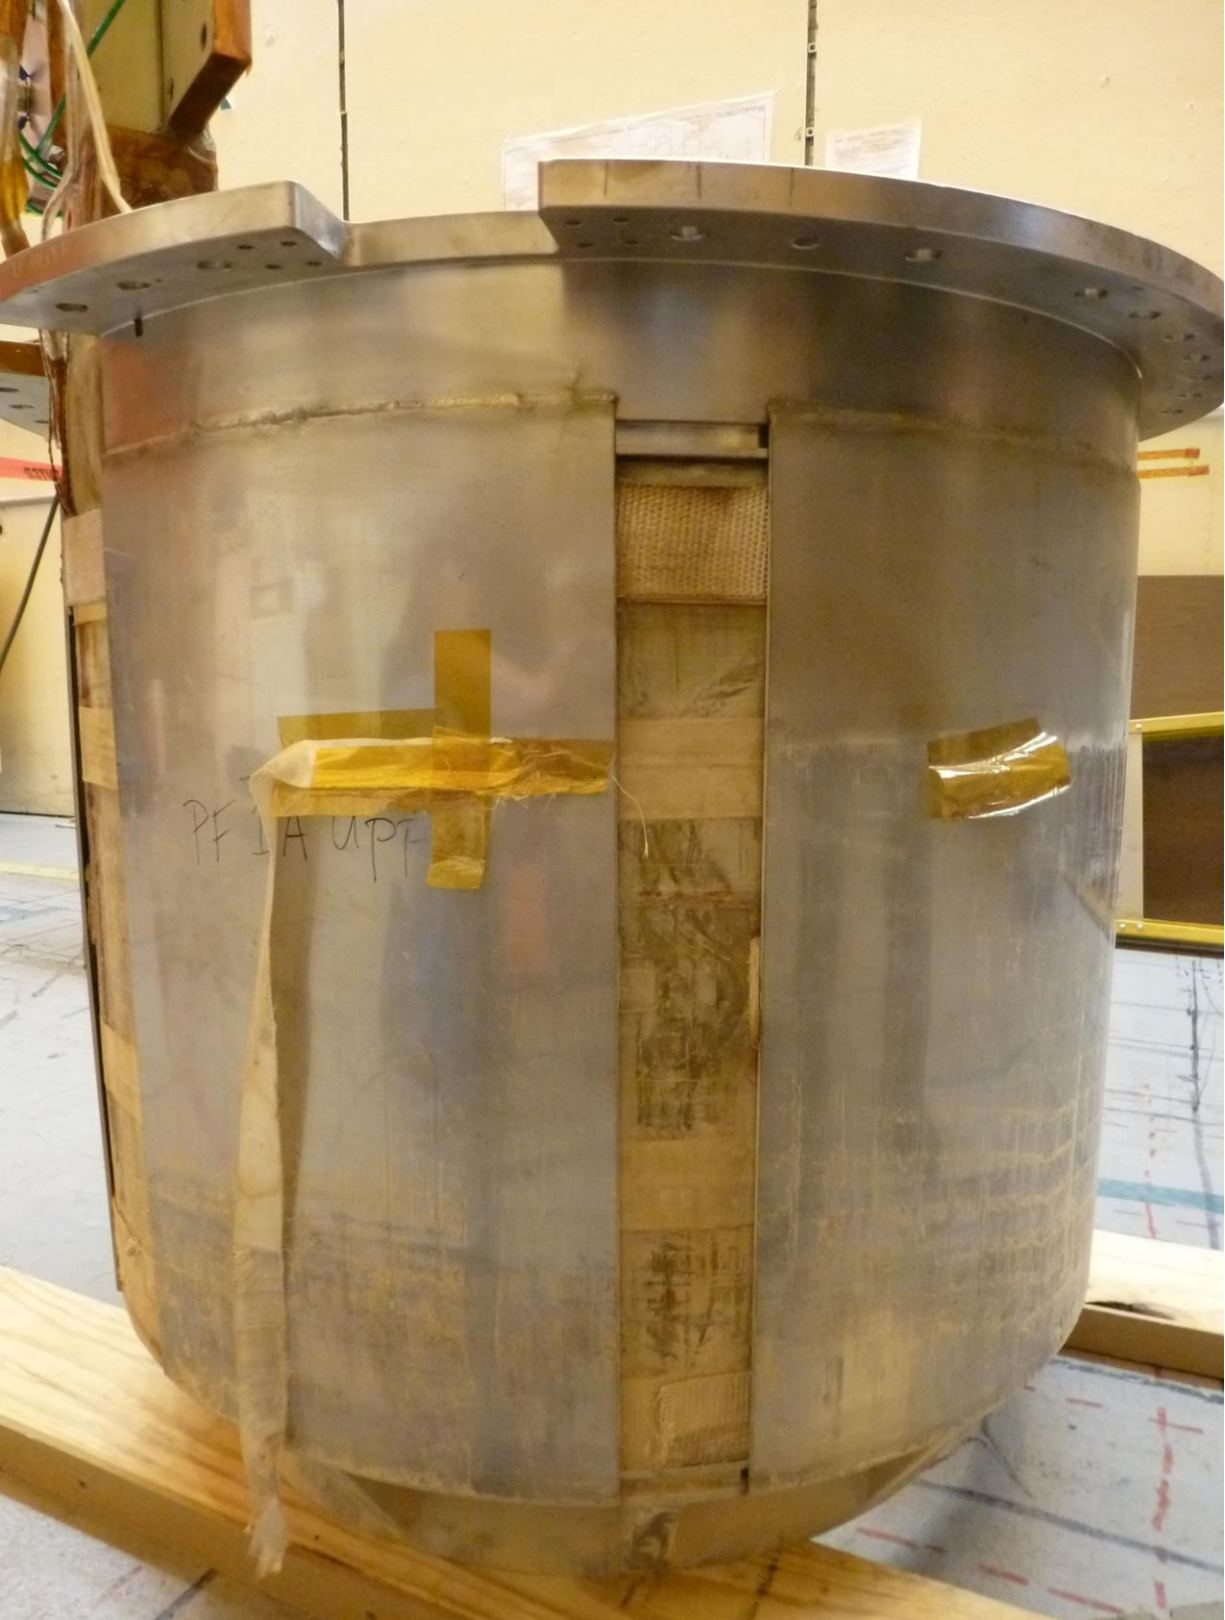
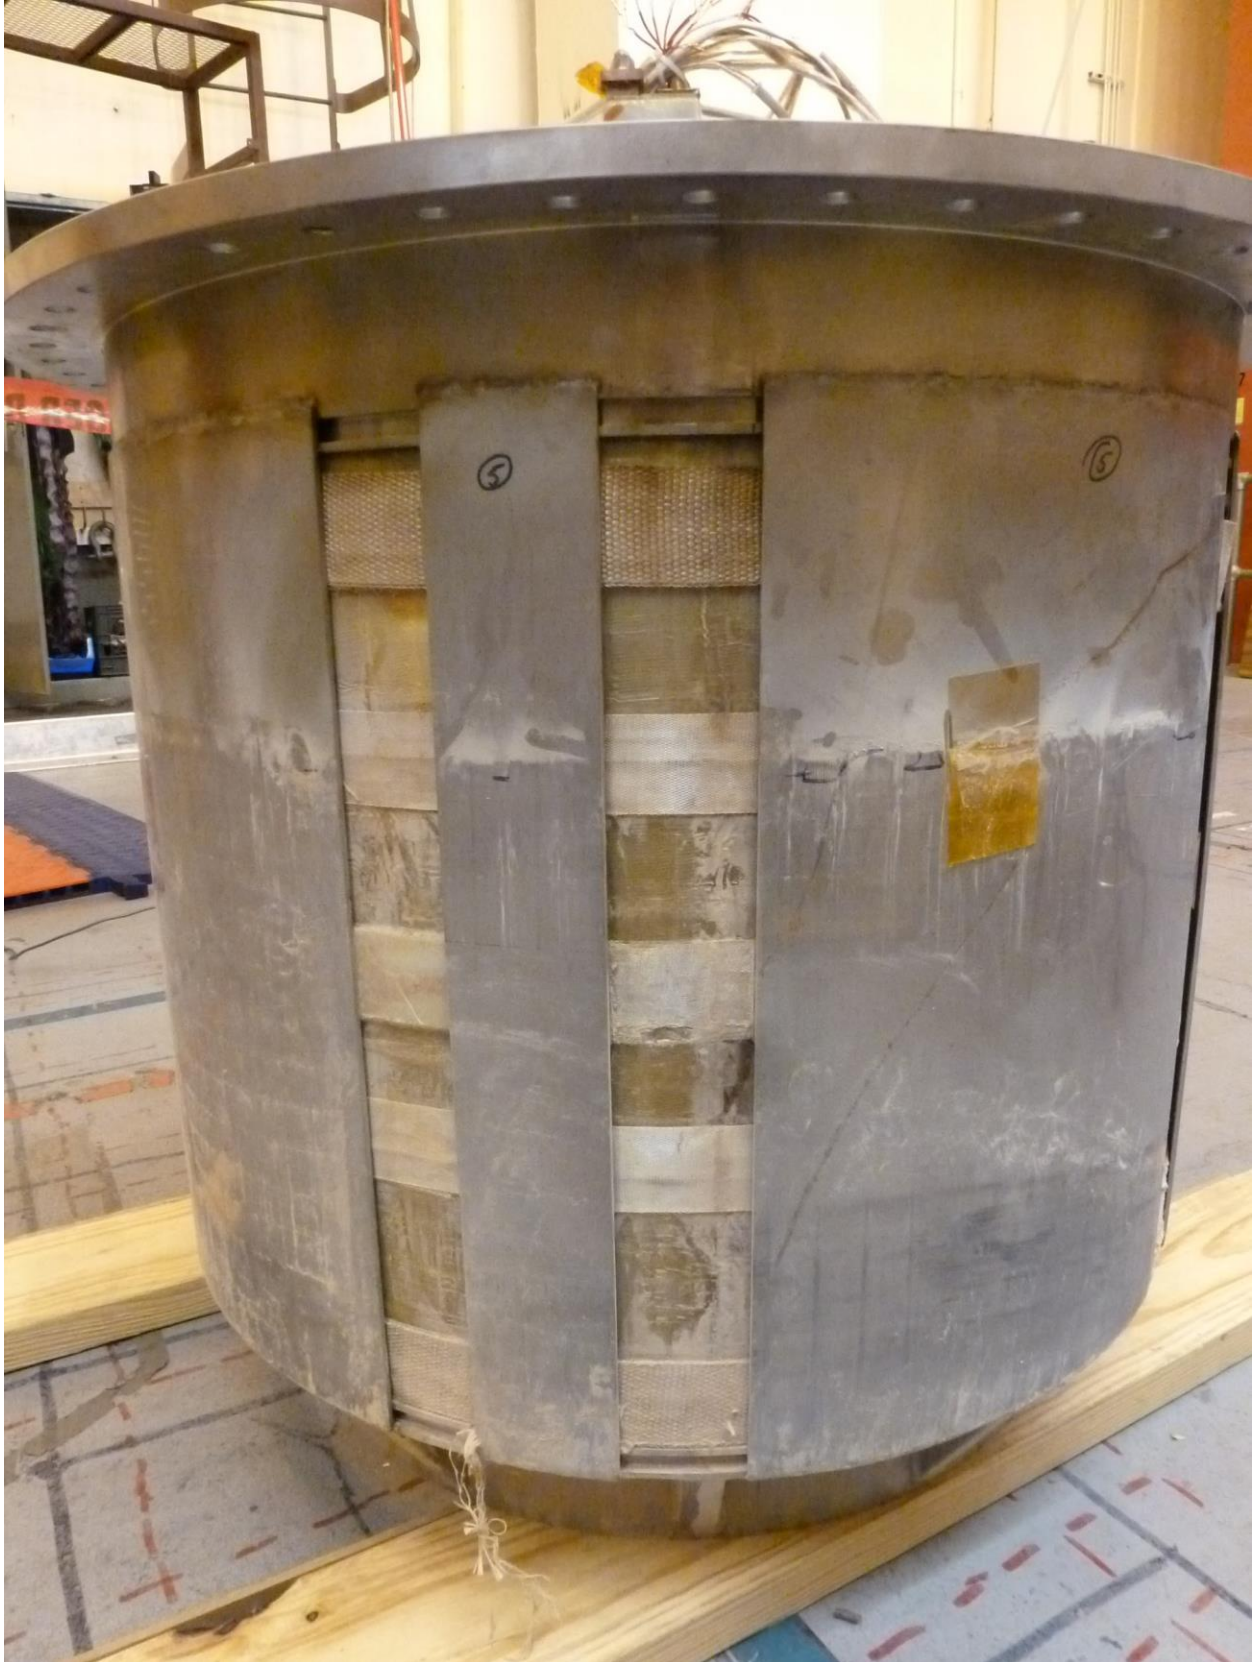
The PF1A-U was visually examined and extensively photographed (Figures 11 thru 13) in the South High Bay. It was noted that portions of the observable surfaces evidenced a powdered deposit indicative of dried sediment. An external visual inspection of the coil conductor leads was unremarkable (Figures 14 and 15). A majority of the electromagnet was not visible due to the shields that cover the perimeter of the coil. These shields are welded to the upper and lower flanges of the mandrel. Nevertheless, areas of surface delamination and discoloration were observable in the gaps between the shields. Prior to removal of the shields, the lead-to-lead electrical coil resistance was measured with a Megger 10A DLRO micro-ohmmeter to be 5.942 milliohms on August 24, 2016. High-pot electrical tests at voltages ranging from 500 to 5,000 volts were performed and the data recorded for comparative purposes (Table 1). The shields were then removed with a die-grinder, thereby exposing the overall circumferential surface of the coil pack (Figures 16 thru 19). Blue tape was placed over sharp mandrel edges left by the grinder process as a safety precaution. High-pot electrical tests at voltages ranging from 500 to 5,000 volts were repeated on the shield-less coil on August 26, 2016 and compared to the previous tests. The comparison of the electrical tests was unremarkable (Table 1).

Figure 12 – PF1A-U Exterior

Figure 13 – PF1A-U Exterior

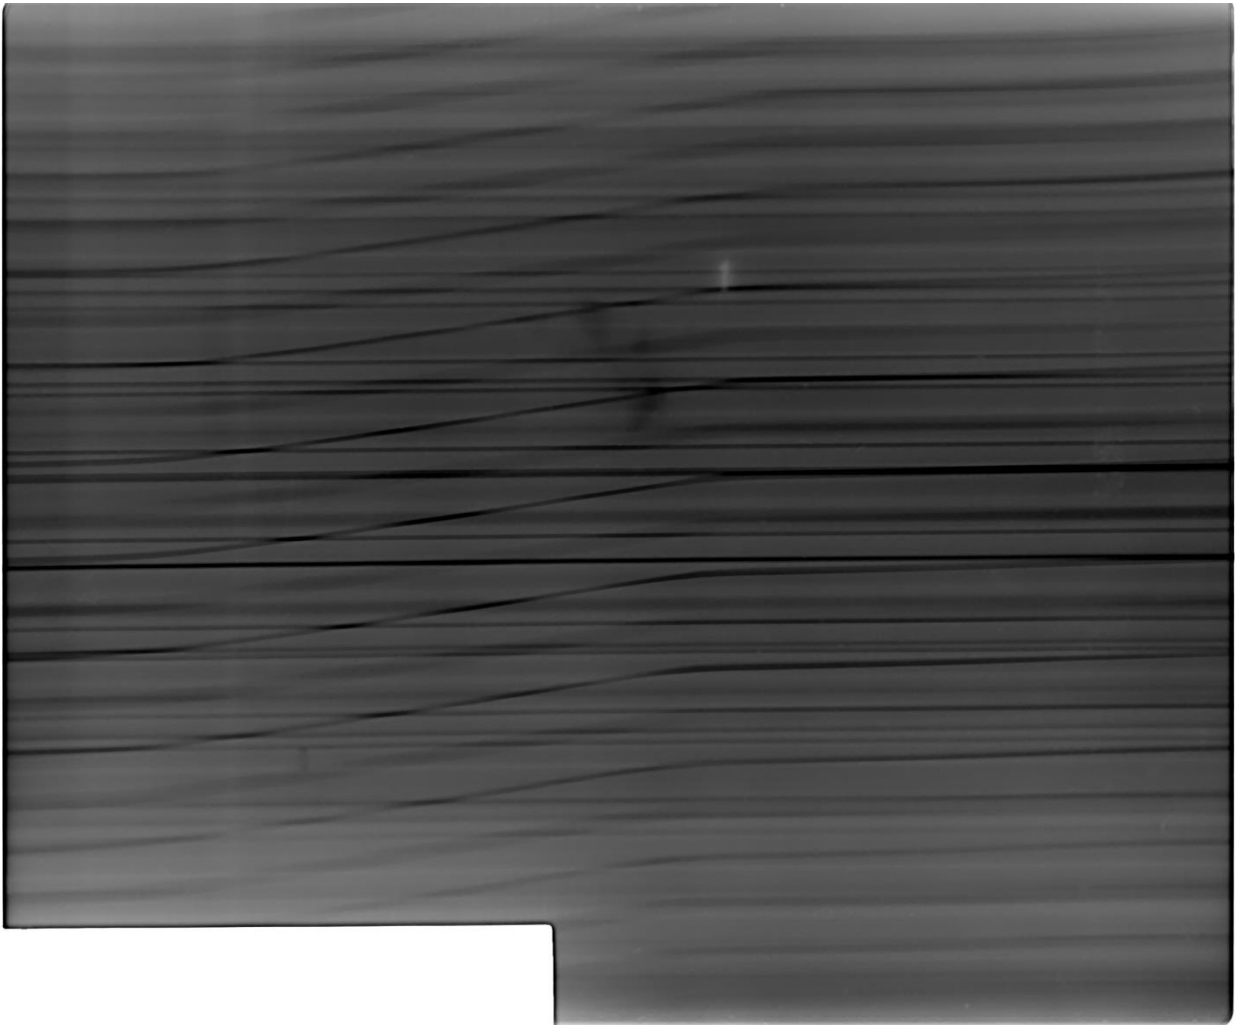
Figure 30 – Radiographic image of area “1_B”

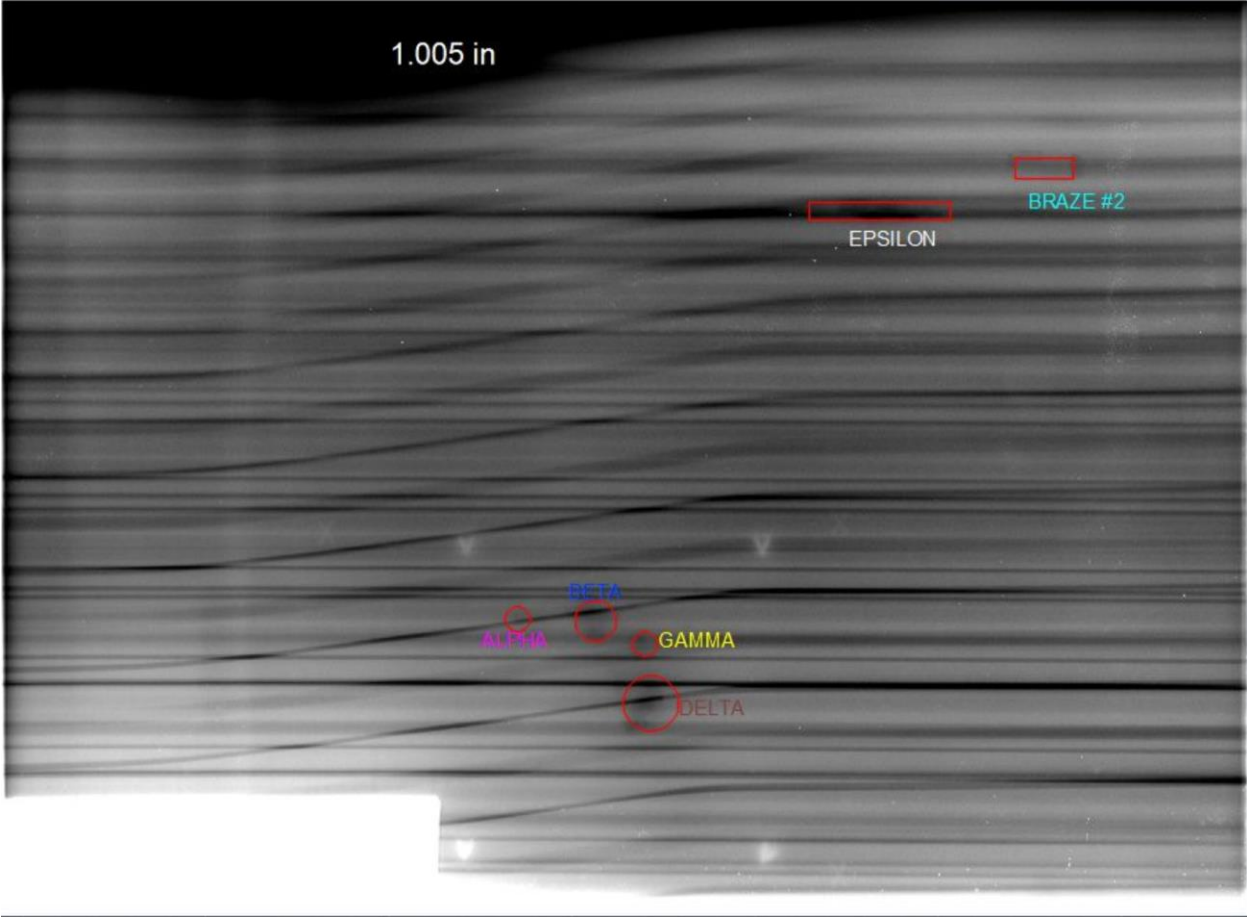
and rectangles were drawn over the observed density variations to optically determine an approximate center point reference for each area (Figure 33). A triangulation analysis was performed to determine proximate radial positions of the observed anomalies (Figures 34 thru 37). The analysis indicated that the regions alpha through gamma were proximal to conductor rows eight (8) and nine (9), and between conductor layers two (2) and three (3). The analysis also indicated that braze joint number two (2) was radially proximal to layer two (2). This geometric approximation corresponded to the ETI MPO [6] documentation for braze joint number two (2), validating the radial positional interpolation of regions alpha through epsilon.

Figure 33 – Approximate references for anomalies identified in region 0_1A

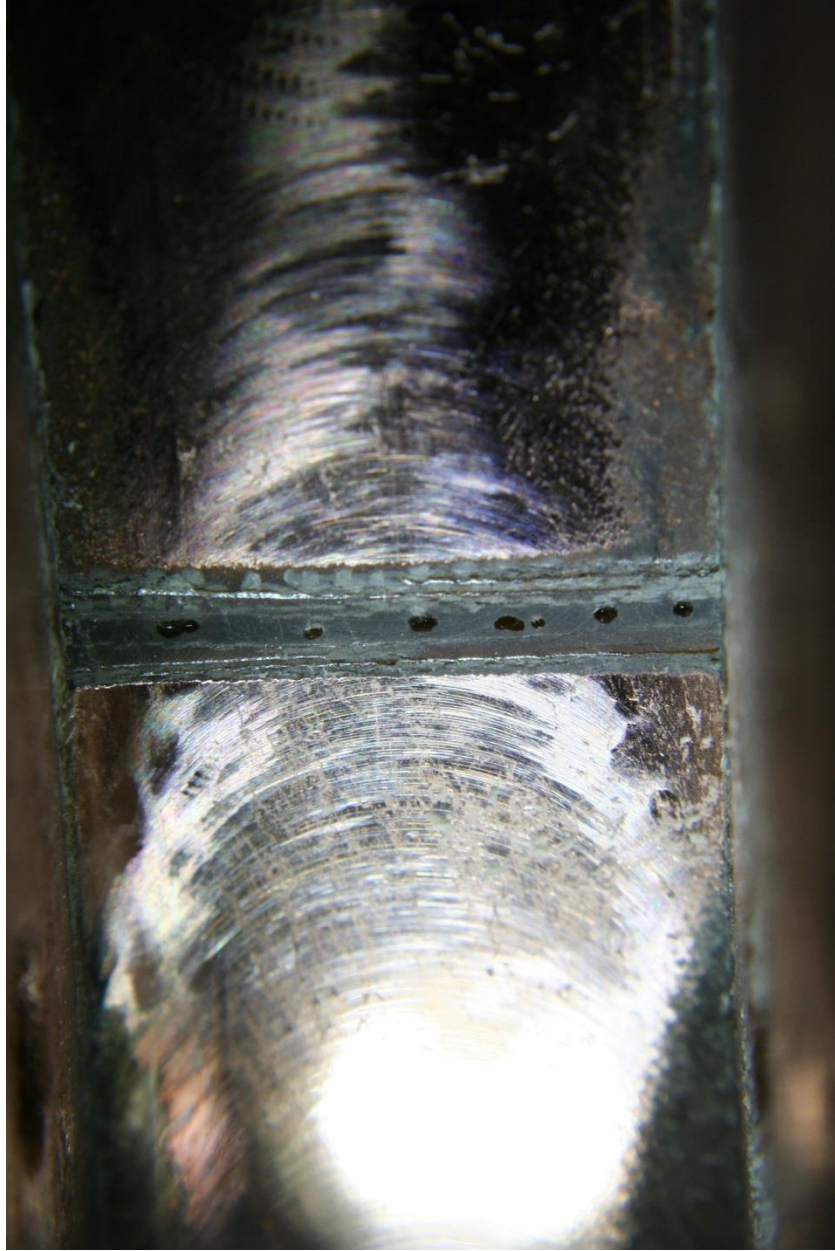
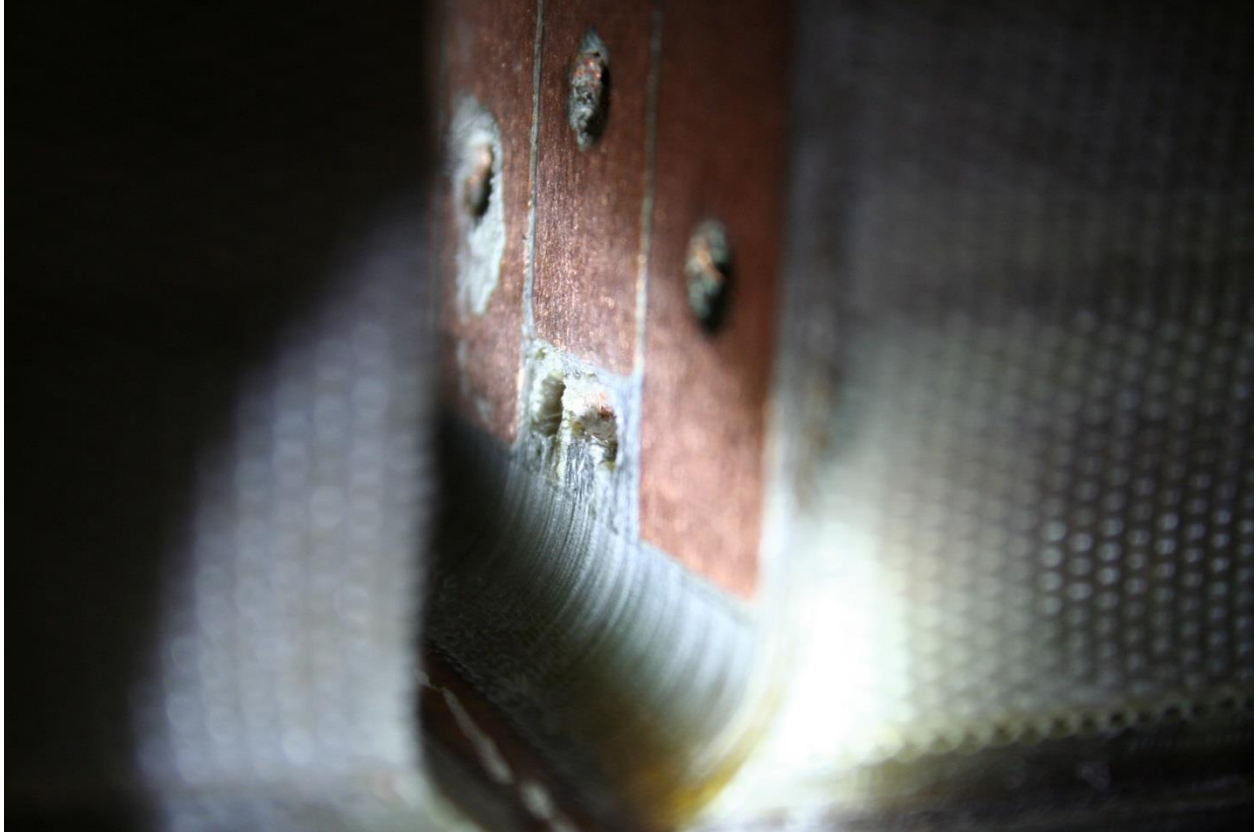
Figure 45 – Cutting Plane A void

Figure 46 – Cutting Plane A void

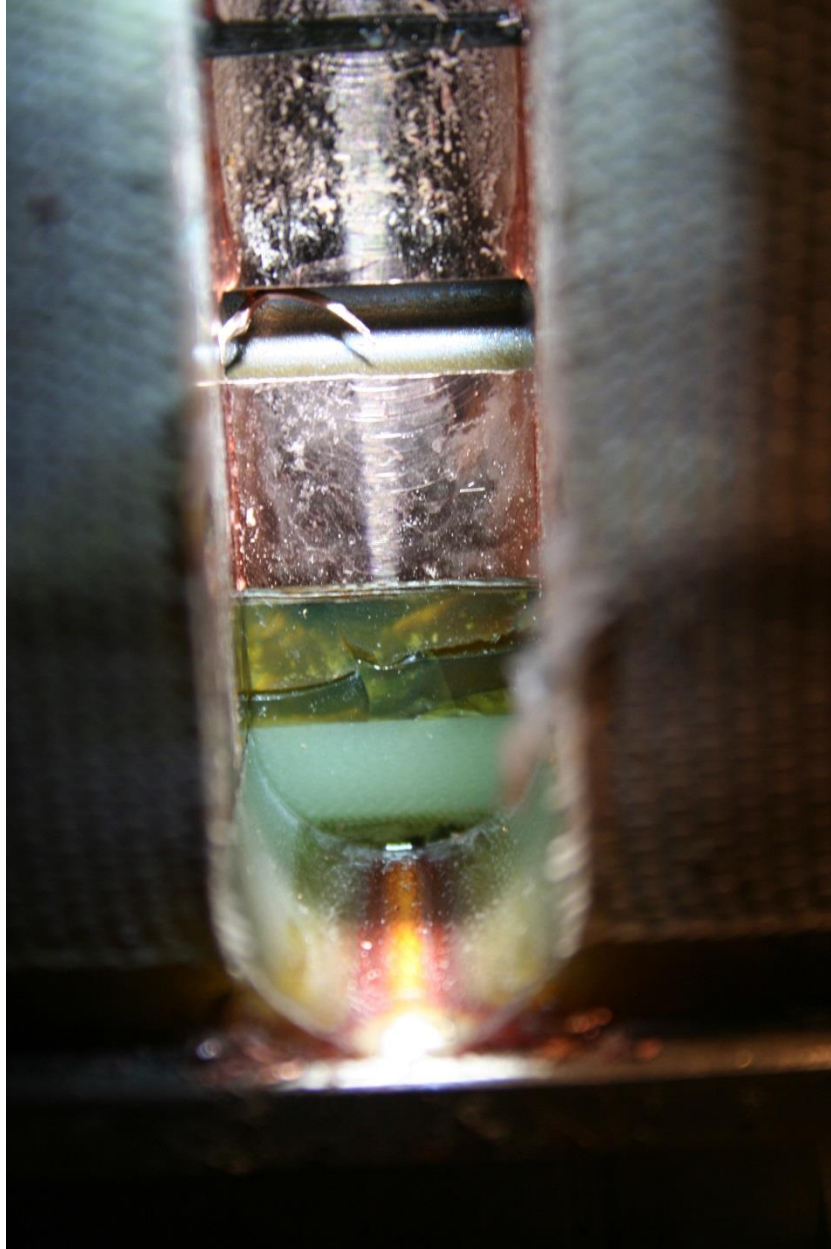
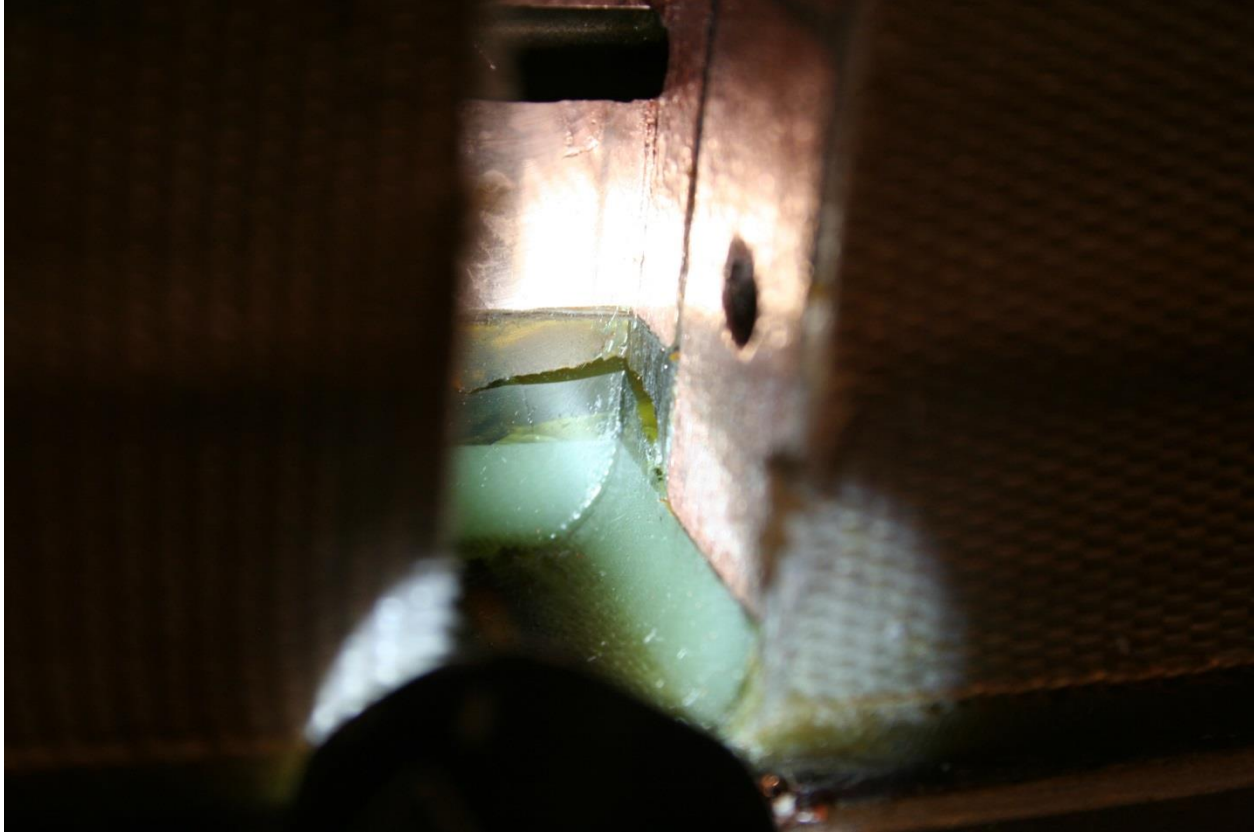
Figure 52 – Cutting Plane B resin rich area and crack

Figure 53 – Cutting Plane B resin rich area and crack

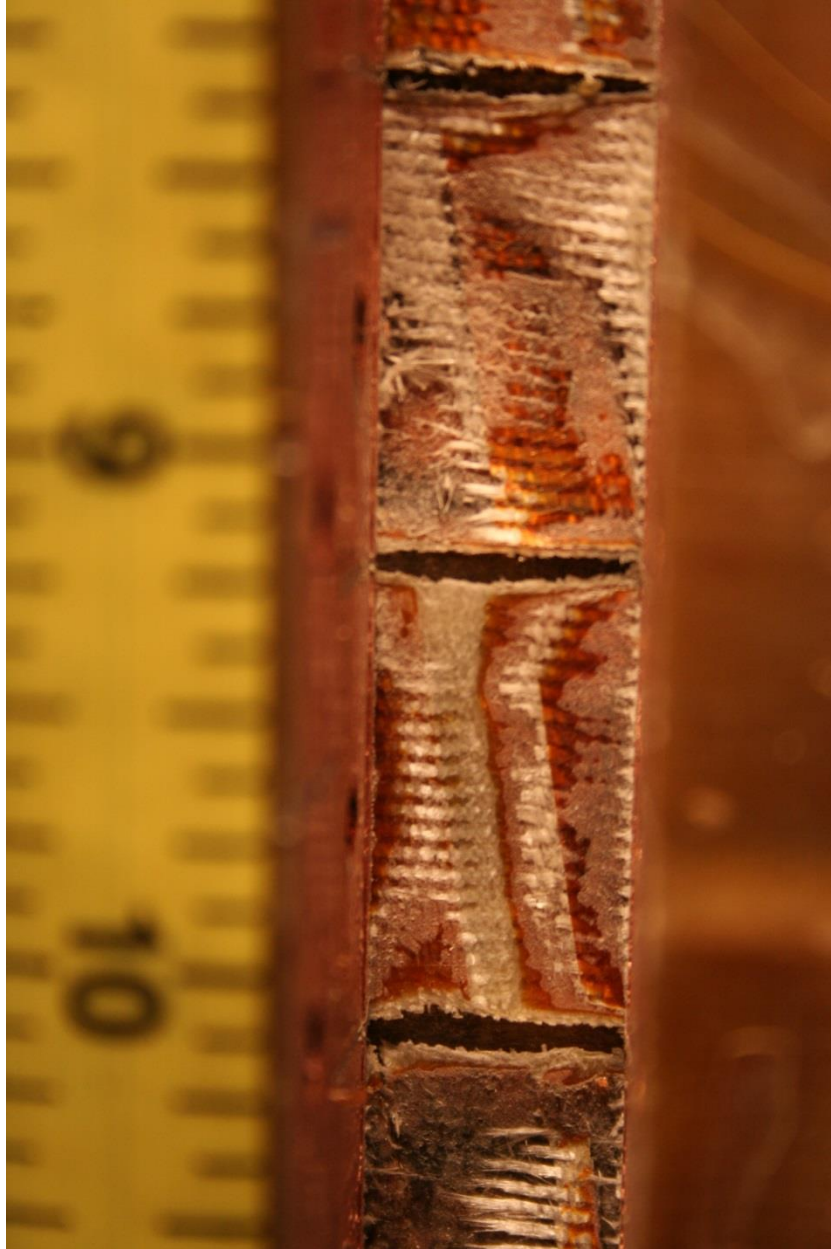
Figure 54 – Cutting Plane B delaminated region

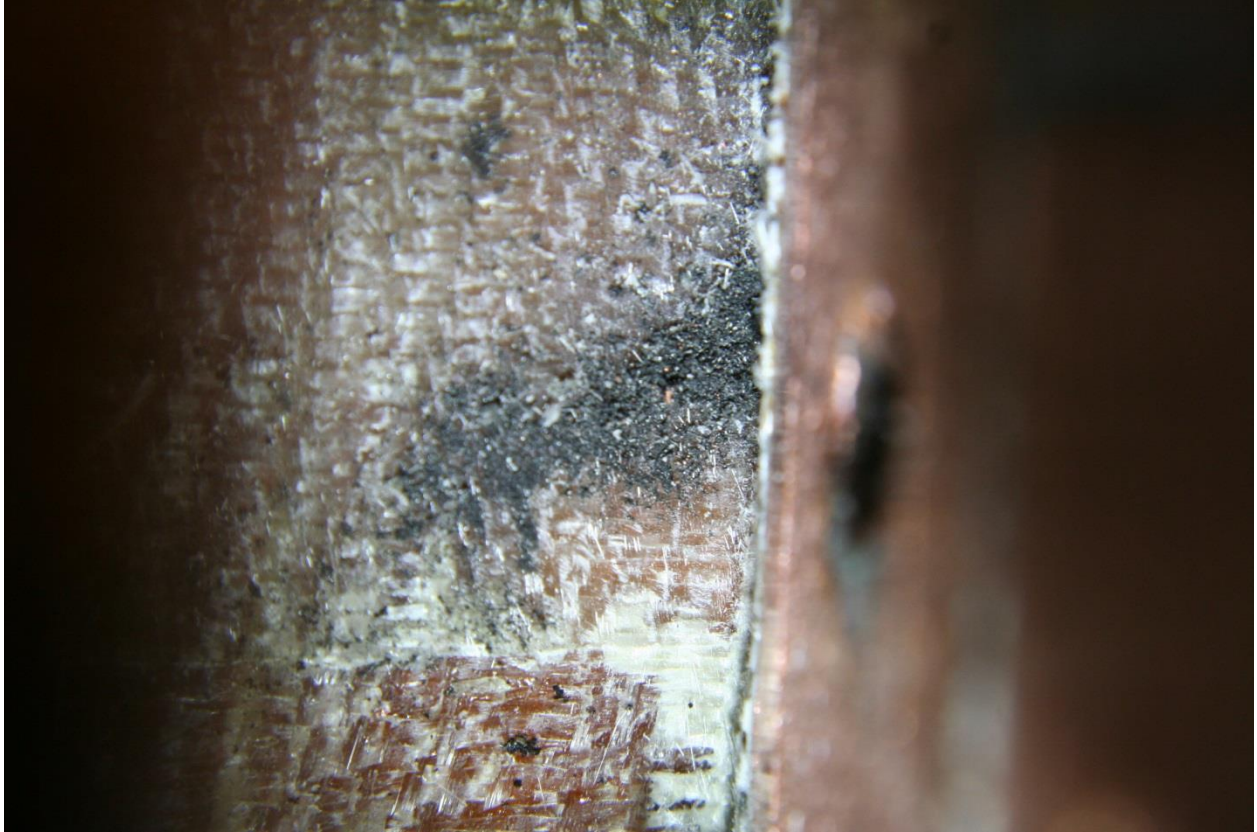
. Figure 59 – Cutting Plane B debris

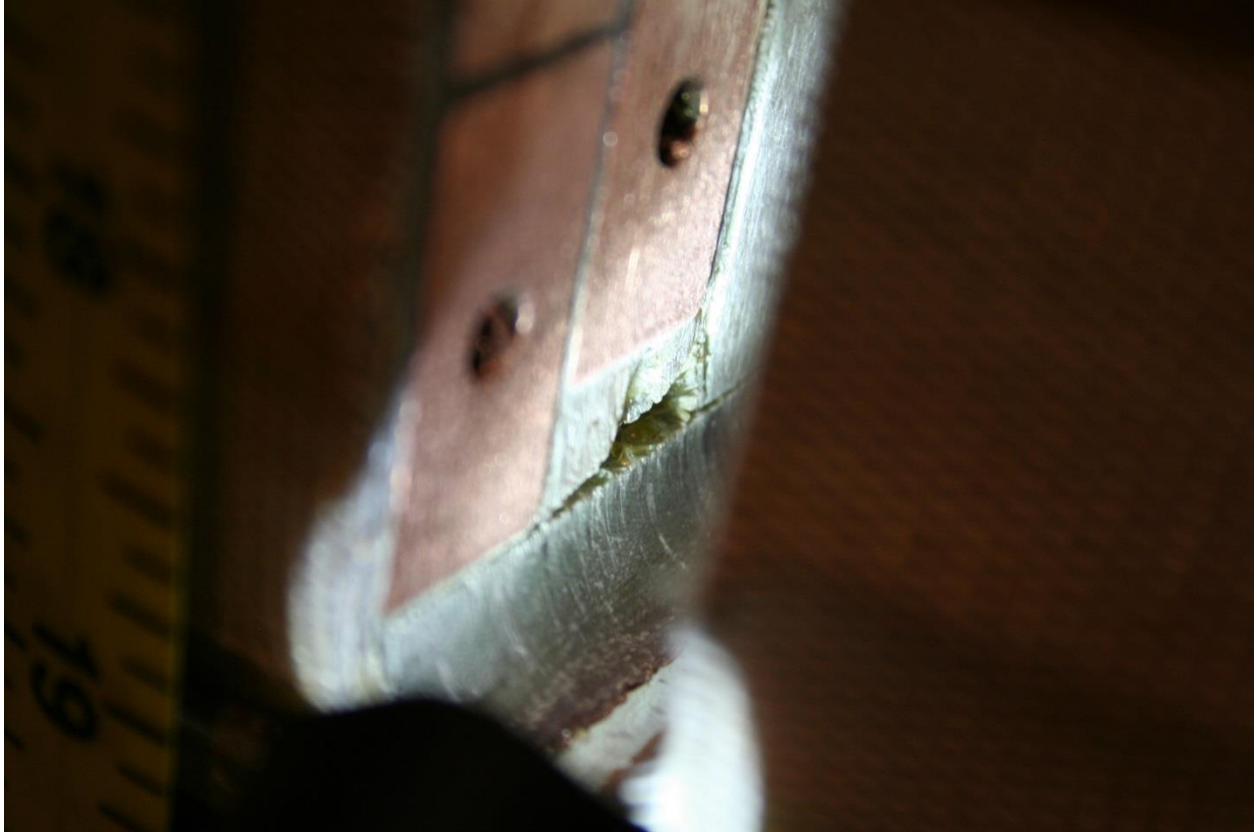
Cutting Plane A	Probable lack of adhesion of insulation layer to primed conductor	Figure 48
Cutting Plane A	Exterior ground-wrap to mandrel depth: approximately conductor row 1, conductor row 7, conductor row 16	Figures 49-51
Cutting Plane B	Resin rich area with crack/void in insulation space	Figures 52-53
Cutting Plane B	Delaminated and un-wetted insulation layer between conductor layers 2 and 3	Figure 54
Cutting Plane B	Unwetted insulation glass fibers between conductor layers 2 and 3	Figure 55
Cutting Plane B	Samples collected from delaminated insulation layer between conductors layers 2 and 3	Figures 56-58
Cutting Plane B	Debris observed suspended on surface of conductor layer 2 (from behind removed sample at 5")	Figure 59
Cutting Plane B	Discolored area proximal to rows 14-16 on the surface of layer 2	Figure 60
Cutting Plane B	Delamination gap and depth measurements	Figures 61-63
Cutting Plane B	Insulation void/crack at bottom of conductor layer 3	Figure 64

Figure 64 – Cutting Plane B void

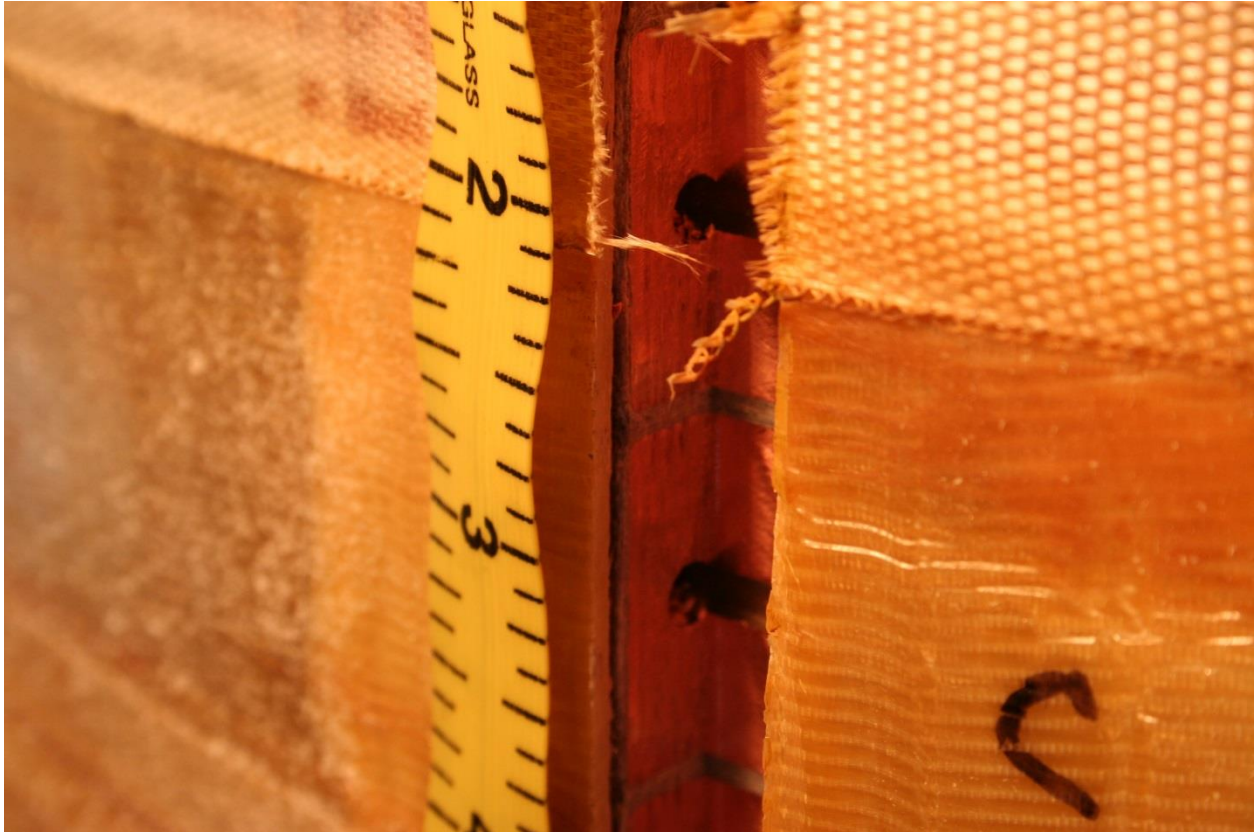
Figure 69 – Cutting Plane C ground wrap delamination

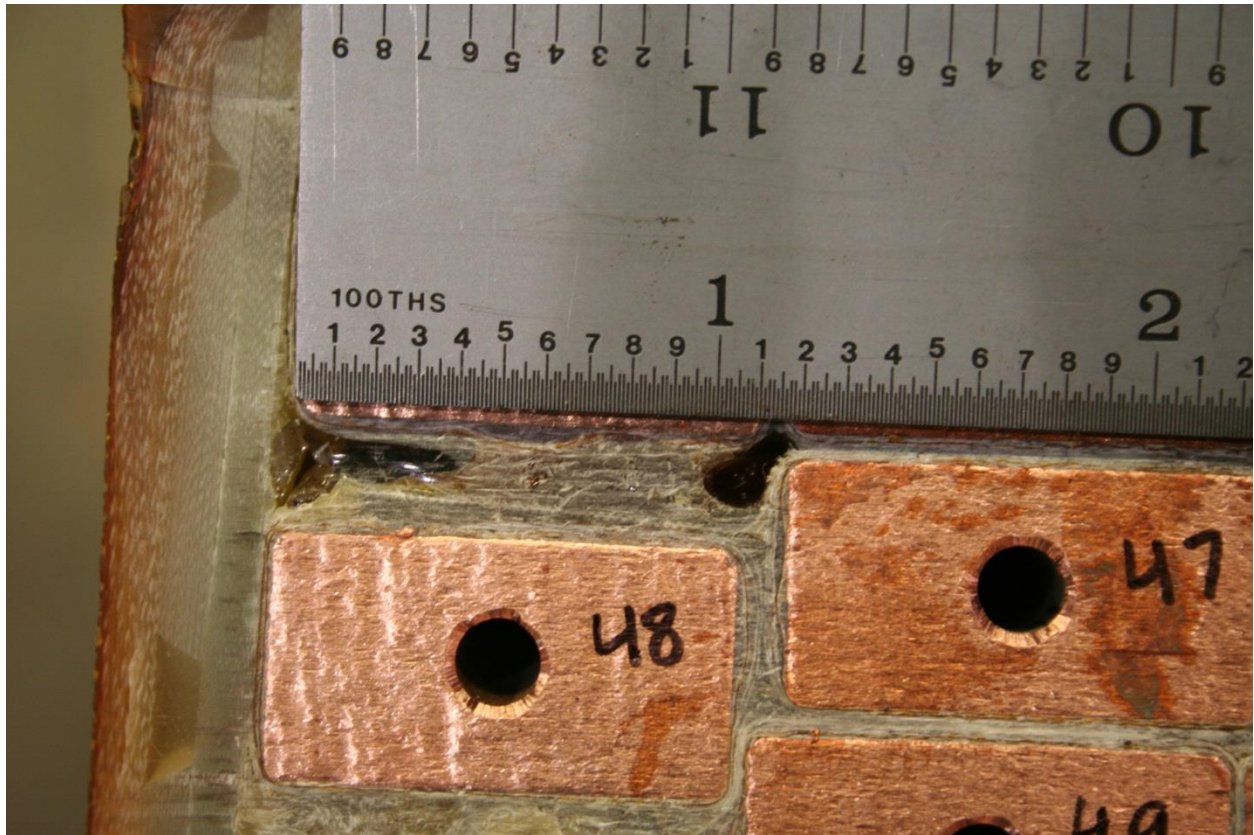
Exterior visual examination of cutting planes A and C, left and right, evidenced similar insulation anomalies observed during the milling process (Figures 84 thru 87). Cutting plane B, left and right, evidenced a separation between conductor layers two (2) and three (3) from approximately conductor row three (3) to conductor row sixteen (16) (Figures 88 and 89). Observed conductor spacing, insulation characteristics, and conductor keystoneing were noted and photographed (Figures 90 thru 93). Examination of the insulation wrap sequence evidenced that each conductor was wrapped with a half-lap co-wound glass/Kapton layer with the glass portion laid-up against the conductor surface (Figure 94). A glass-only half-lap layer was observed to be wound over the co-wound glass/Kapton layer (Figure 95). Each layer-to-layer region evidenced an additional flat-laid glass layer (Figure 96).

Figure 84 – Coil pack section plane C void

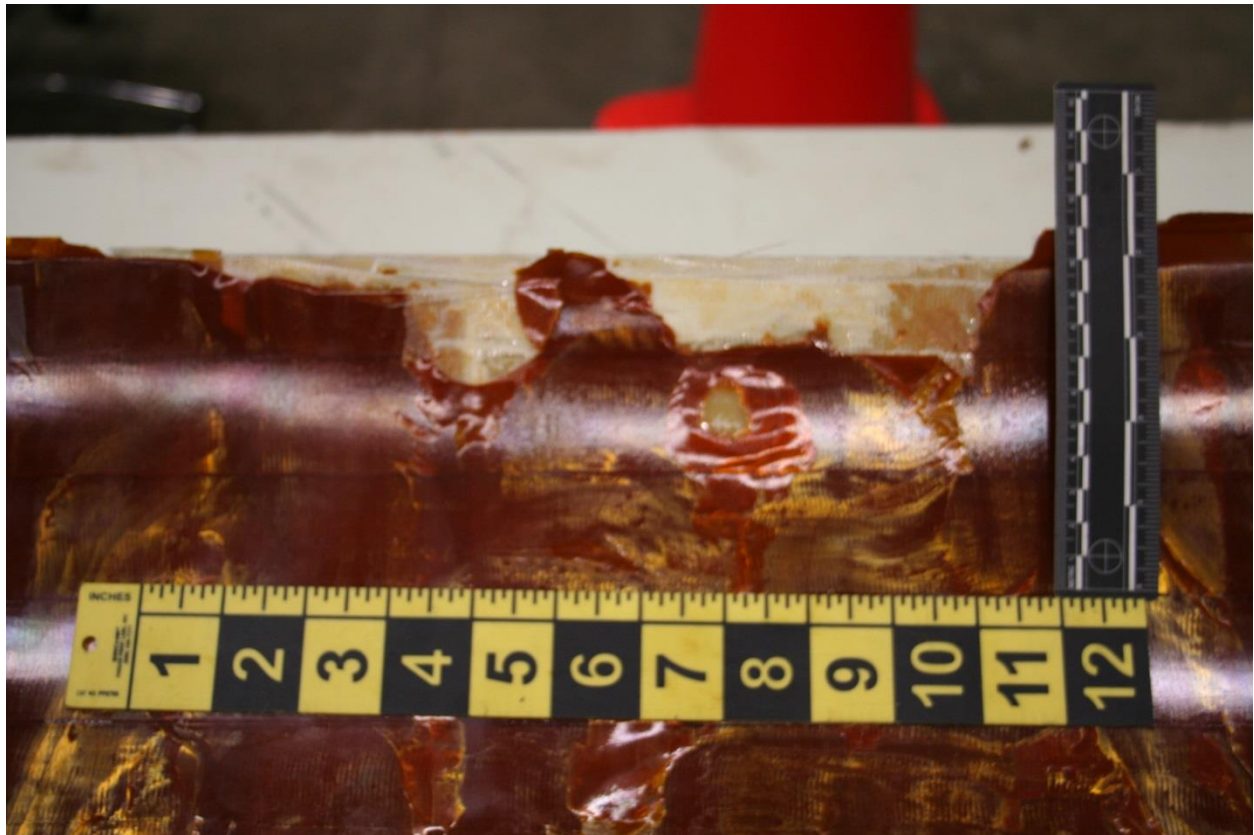
Figure 86 – Coil pack section plane B dry glass

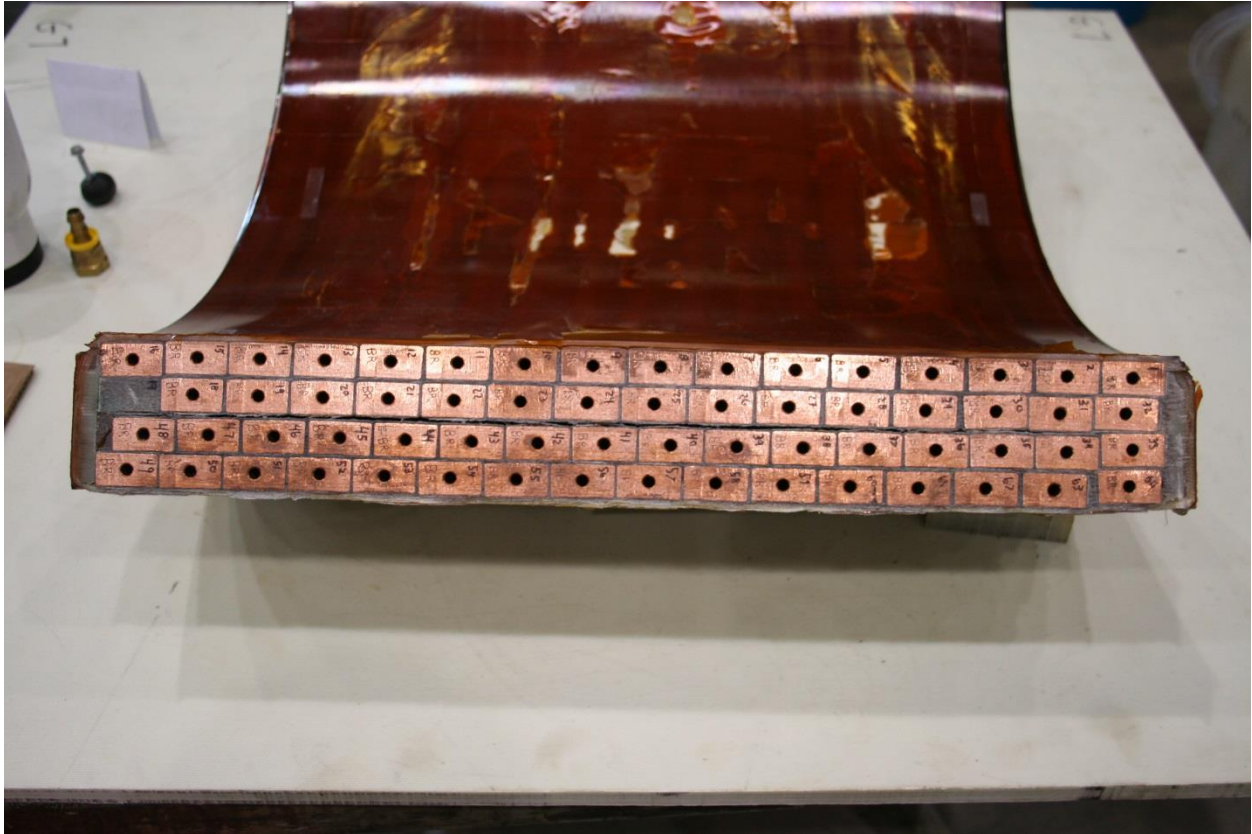
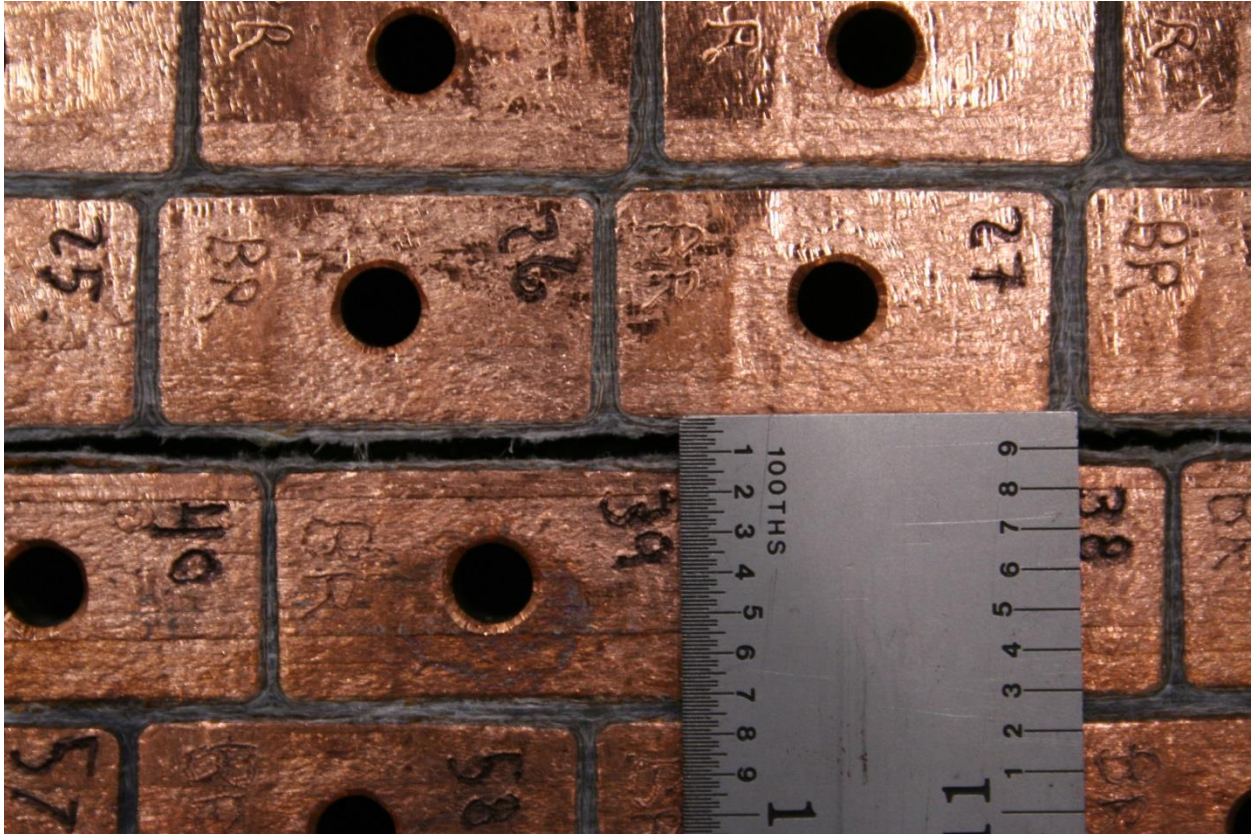
5. Over-Pressurization: empirical evidence indicated the insulation proximal to layer 2-3 experienced a pressurization event causing layer separation. Other insulation delaminations were observed with pressurization as a probable cause. Numerous delaminations were also found on the outside surface of the ground layer of the coil.

Figure 88 – Coil pack section plane B separation

Figure 89 – Coil pack section plane B separation
