Forensic Analysis of the NSTX-U PF1A-Upper Coil Failure

Rev. 0

November 18, 2016

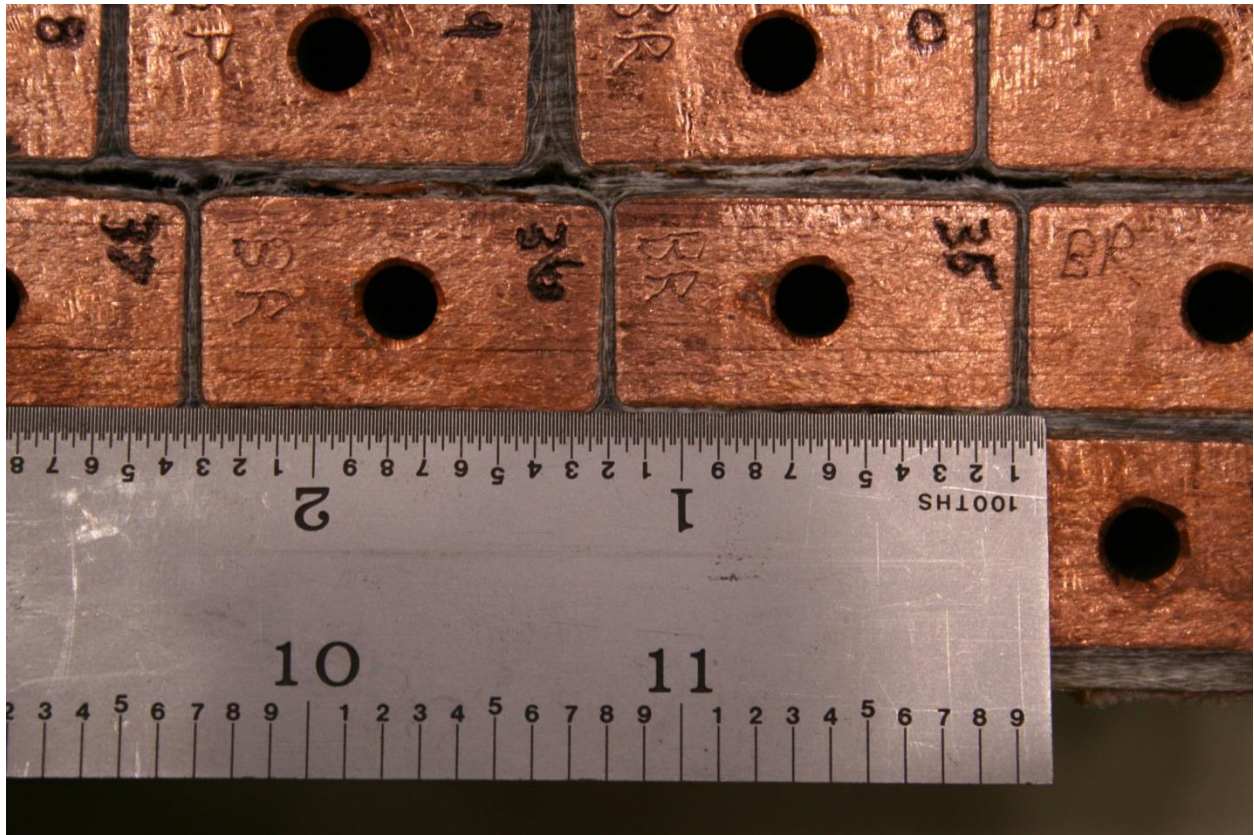
Figure 90 – Coil pack section plane B keystoneing

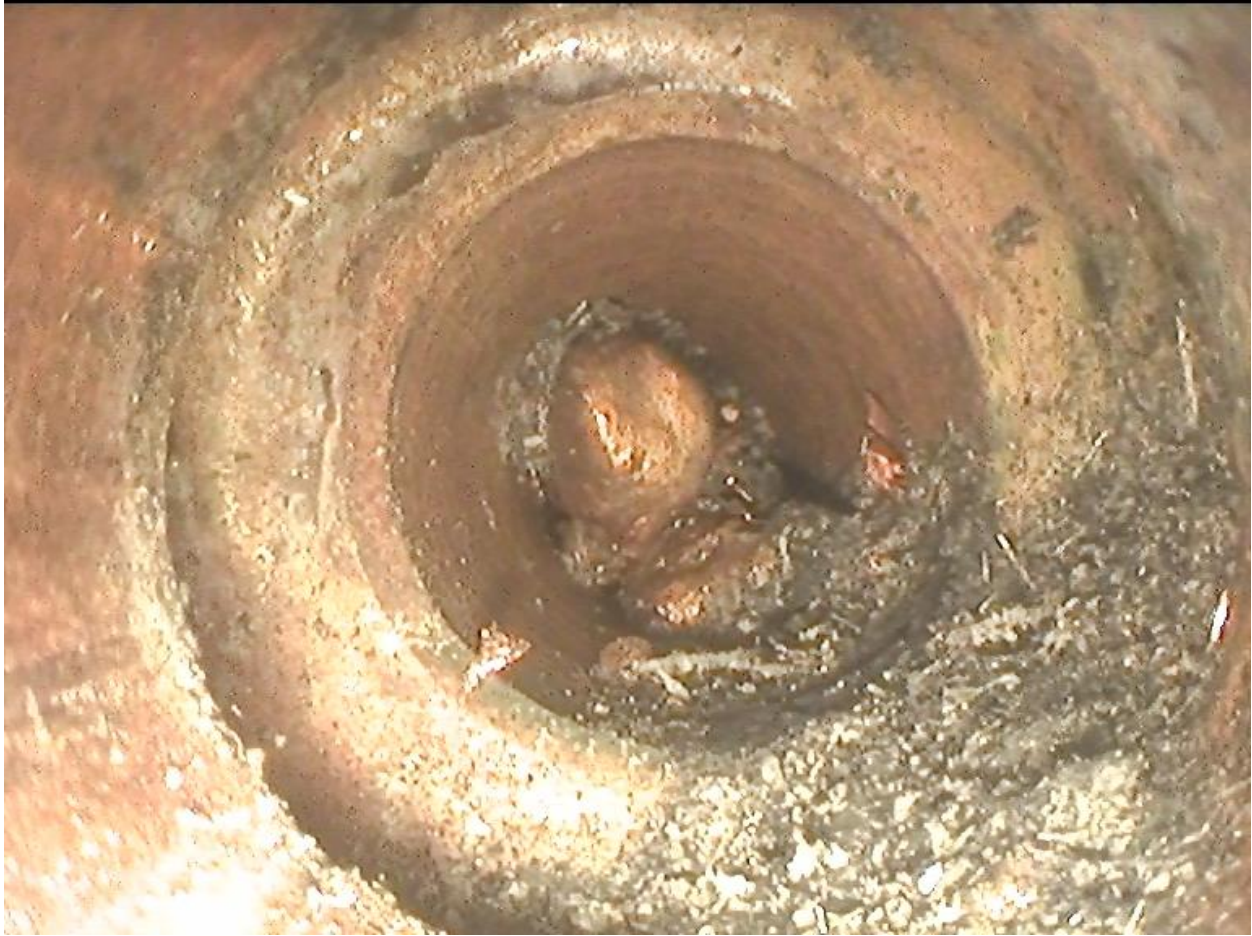
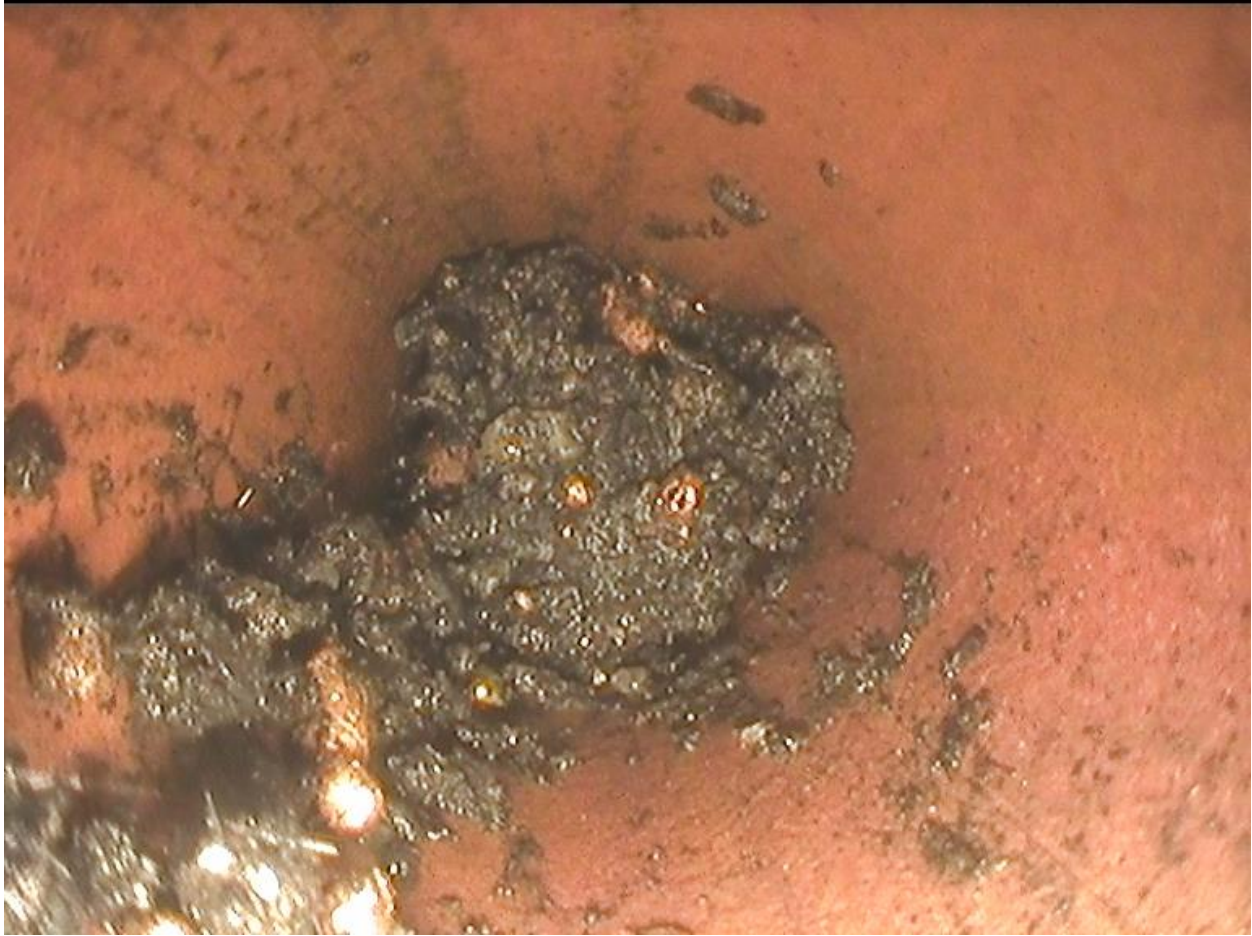
<u>Item</u>	<u>Location</u>	<u>Observations</u>	<u>Photographs</u>
Braze Joint #1	C-A, conductor layer 1, row 15	Blockage Observed	Figures 97-99
Braze Joint #2	A-B, conductor layer 2, row 3	Void Observed	Figures 100-102
Braze Joint #3	A-B, conductor layer 3, row 13	Blockage Observed	Figures 103-105
Braze Joint #4	C-A, conductor layer 4, row 6	Misalignment Observed	Figures 106-107
Anomaly "Delta"	A-B, conductor layer 3, row 9	Void in sidewall of cooling path	Figures 108-112
Conductor 24	A-B, conductor layer 2, row 9	Discoloration along surface of cooling path	Figure 113

3. Improper VPI: empirical evidence indicated numerous areas of insufficient wetting and voids in the insulation layer(s).
4. Blockage(s): empirical evidence indicated two (2) blockages proximal to braze joints. The blockage material did not originate at the blockage location. It is probable that the blockage material migrated from the electrically active void space. This was confirmed, in part, due to the ability to remove the blockages in the cooling channels by prodding with a thin tool. Once free of the obstructions, the braze joint areas where they were lodged did not show any indication that the blockage material originated there. All removed blockage material was bagged and cataloged for future analysis, if deemed necessary.

Figure 97 – Braze Joint #1 with blockage – view from plane A

Figure 98 – Braze Joint #1 with blockage – view from plane C

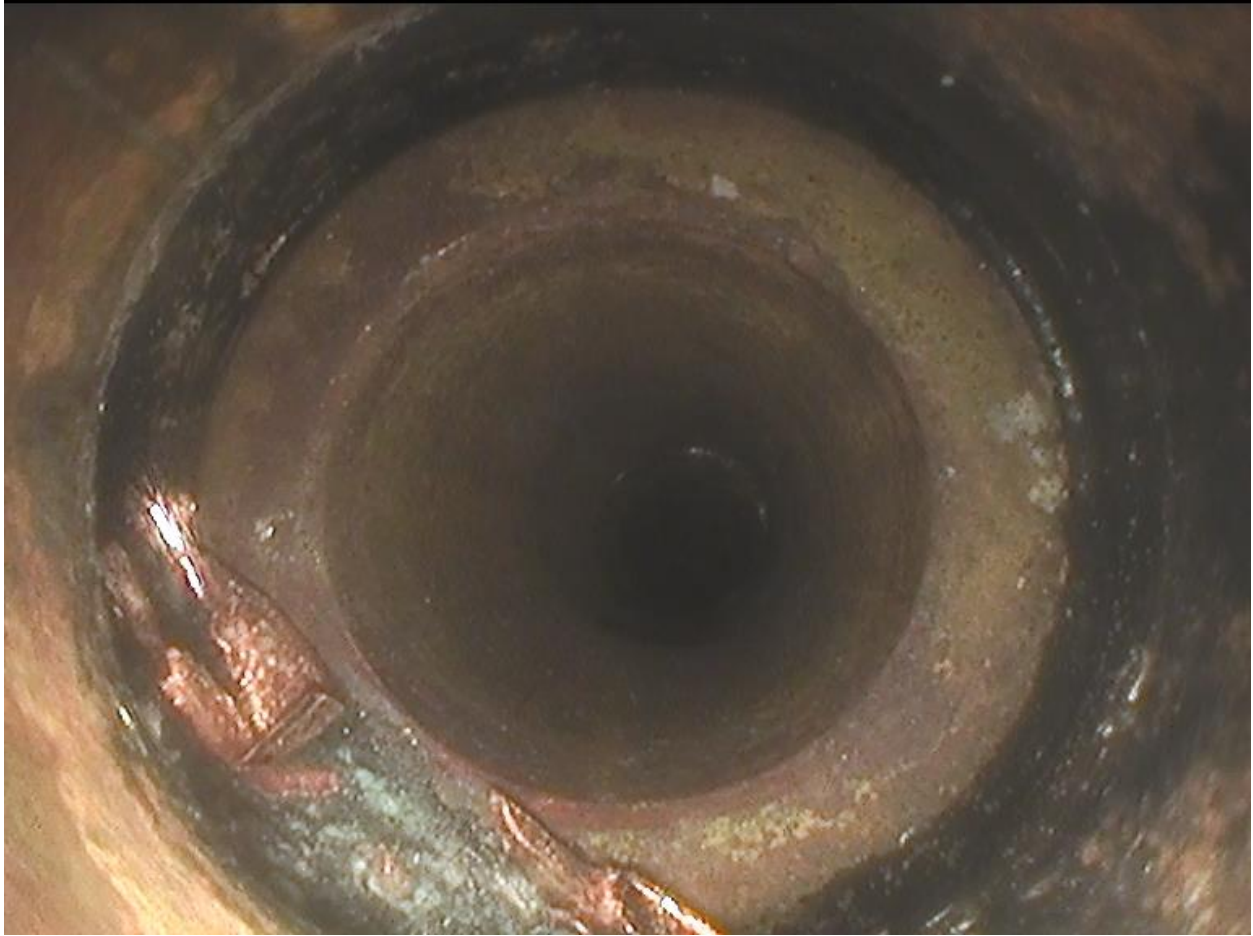
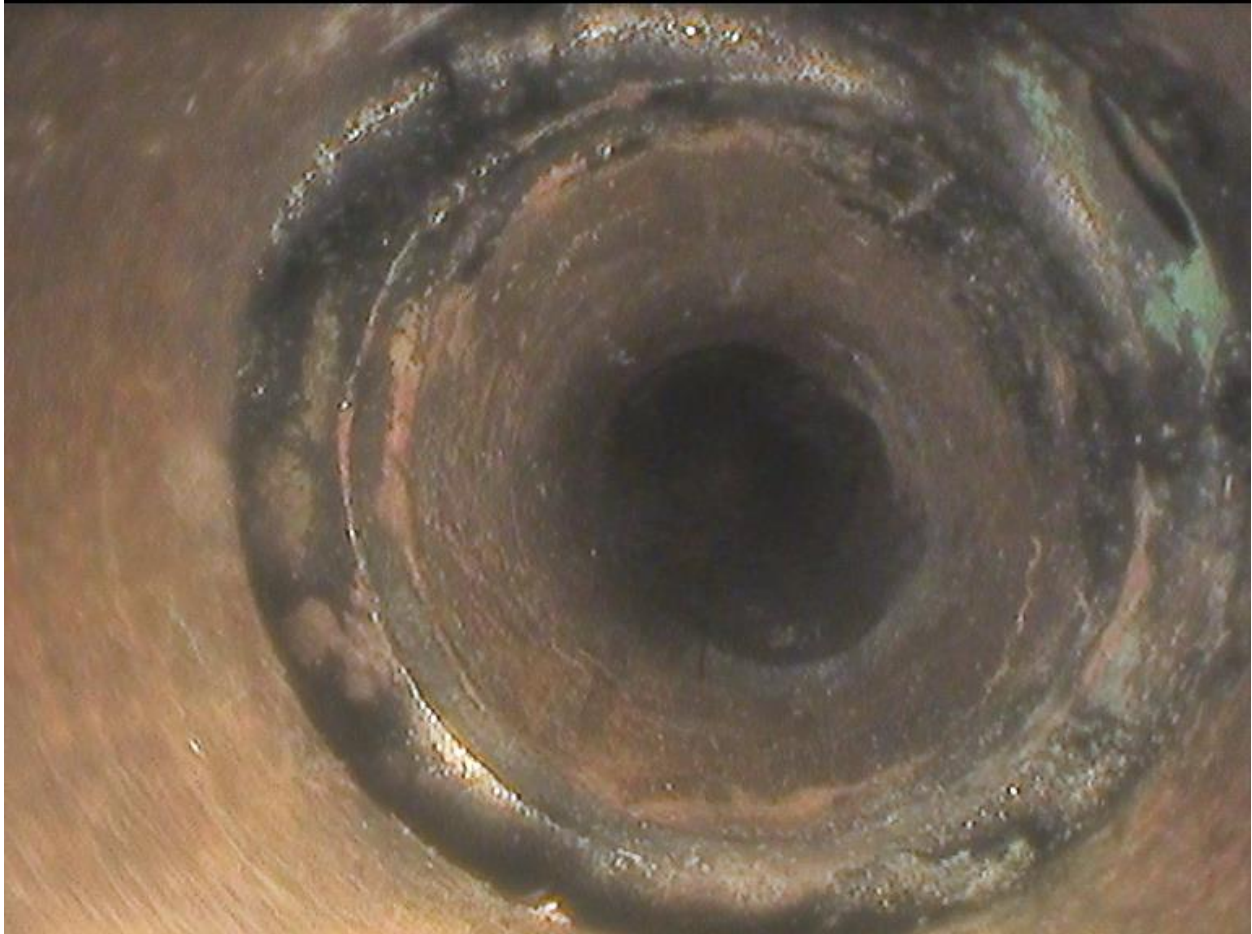
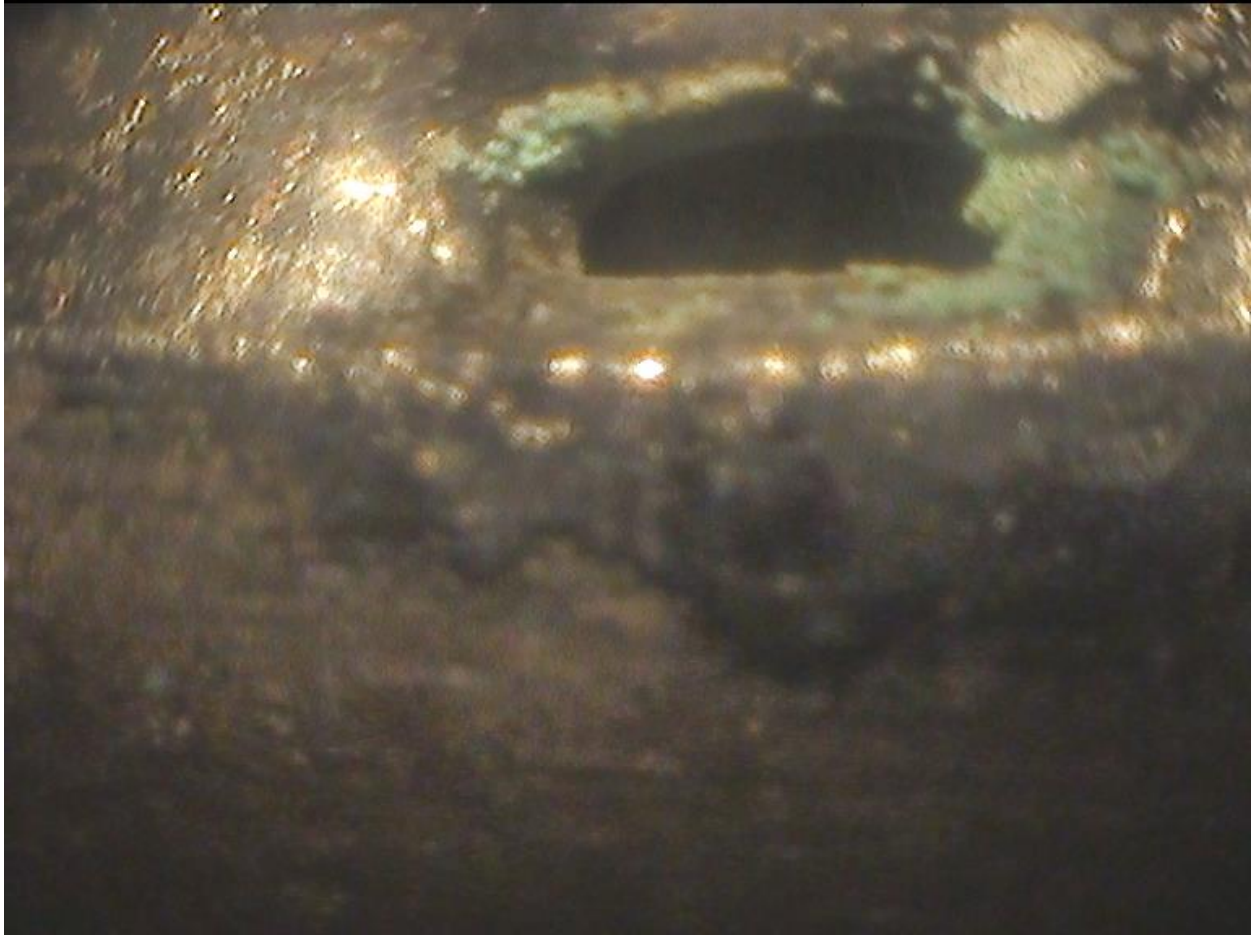
2. Braze Joint Leak: empirical evidence reduced the probability of this theory. All four (4) braze joints passed vacuum tests (15 psi) and hydrostatic leak checks at 400 psi and room temperature. Braze Joint #2 and Braze Joint #3 (in Section A-B) also passed helium leak checks at room temperature.

Figure 100 – Braze Joint #2 – view from plane B

Figure 101 – Braze Joint #2 void – view from plane B

Figure 102 – Braze Joint #2 void – side view

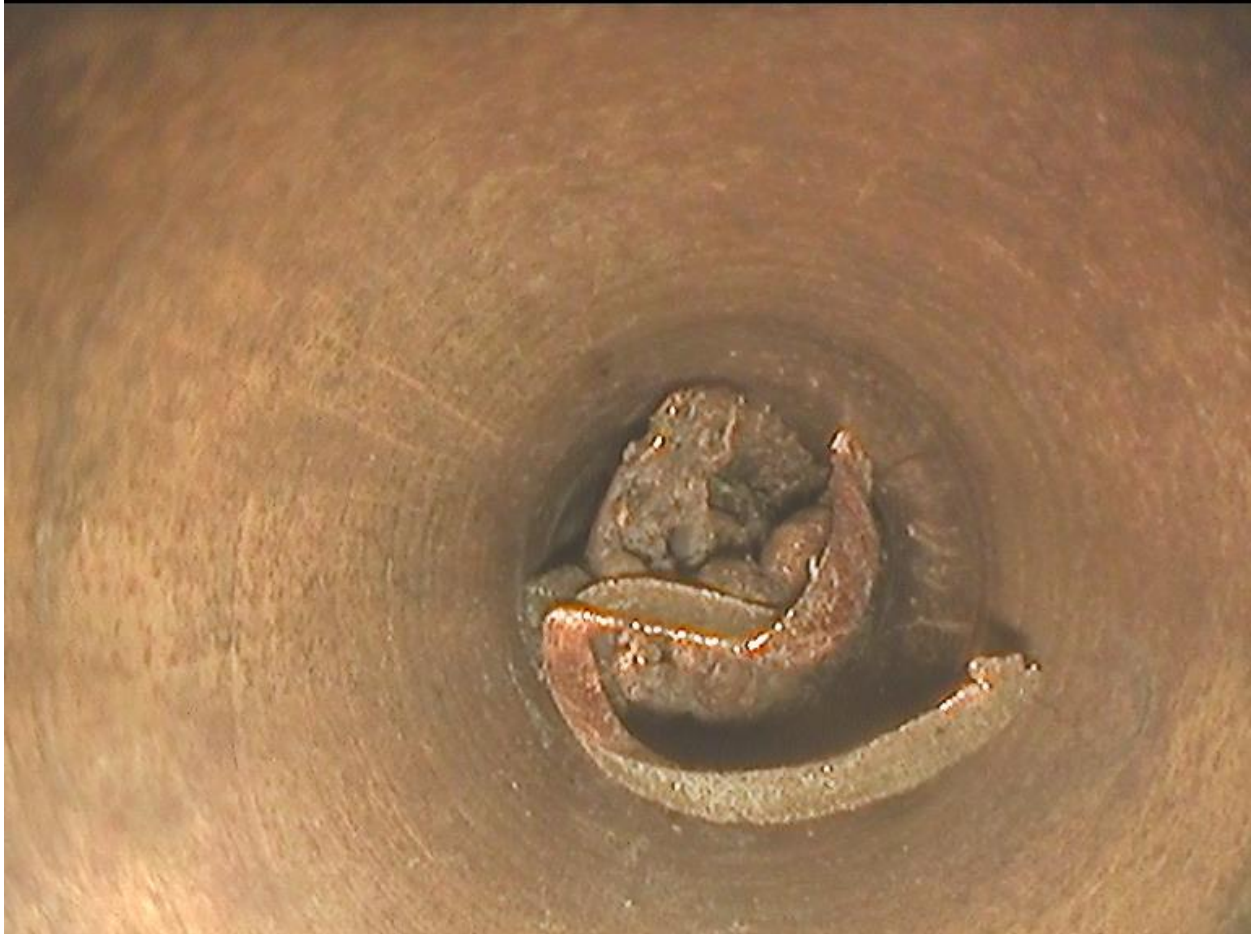
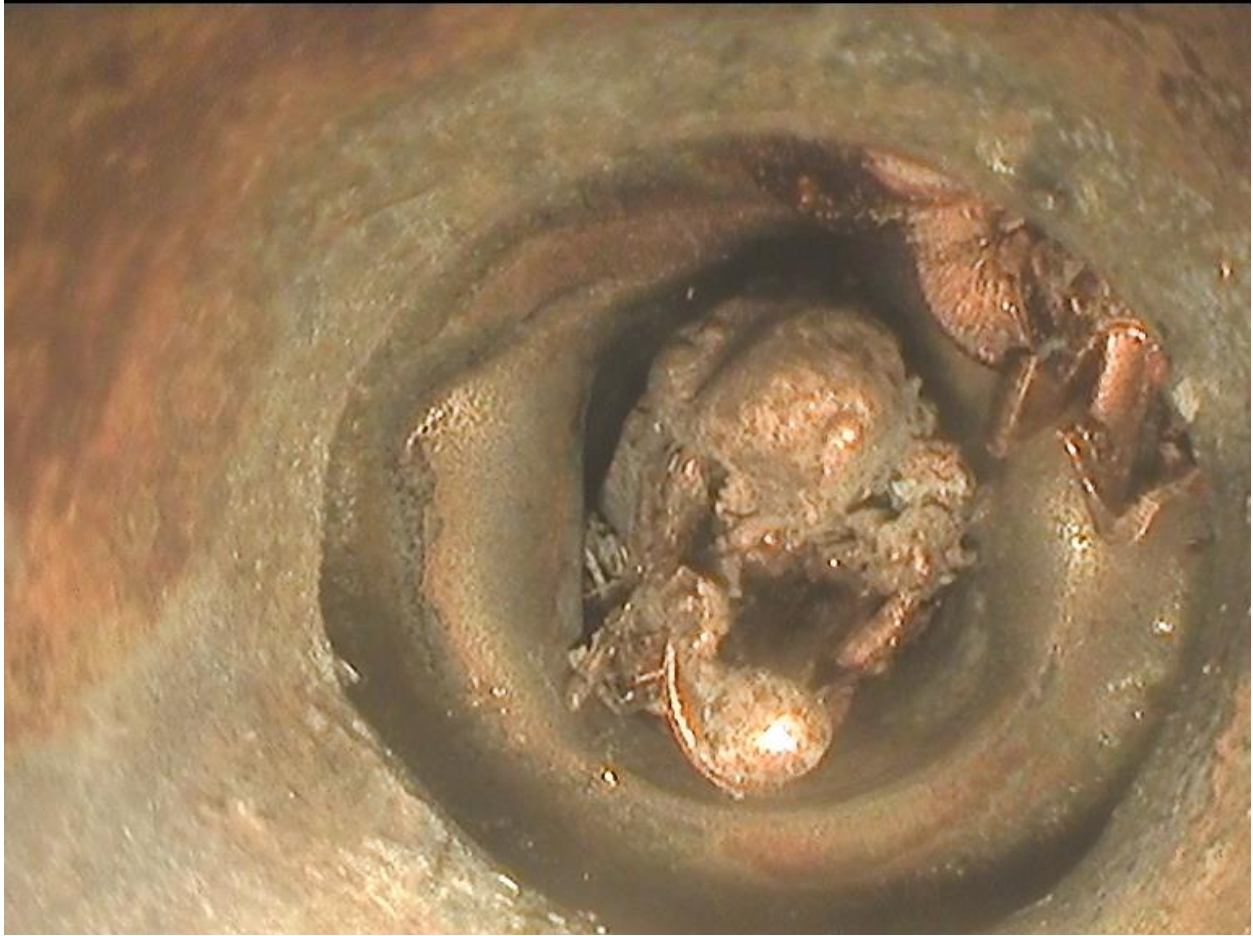
Figure 103 – Braze Joint #3 blockage – view from plane B

Figure 104 – Braze Joint #3 blockage – view from plane A

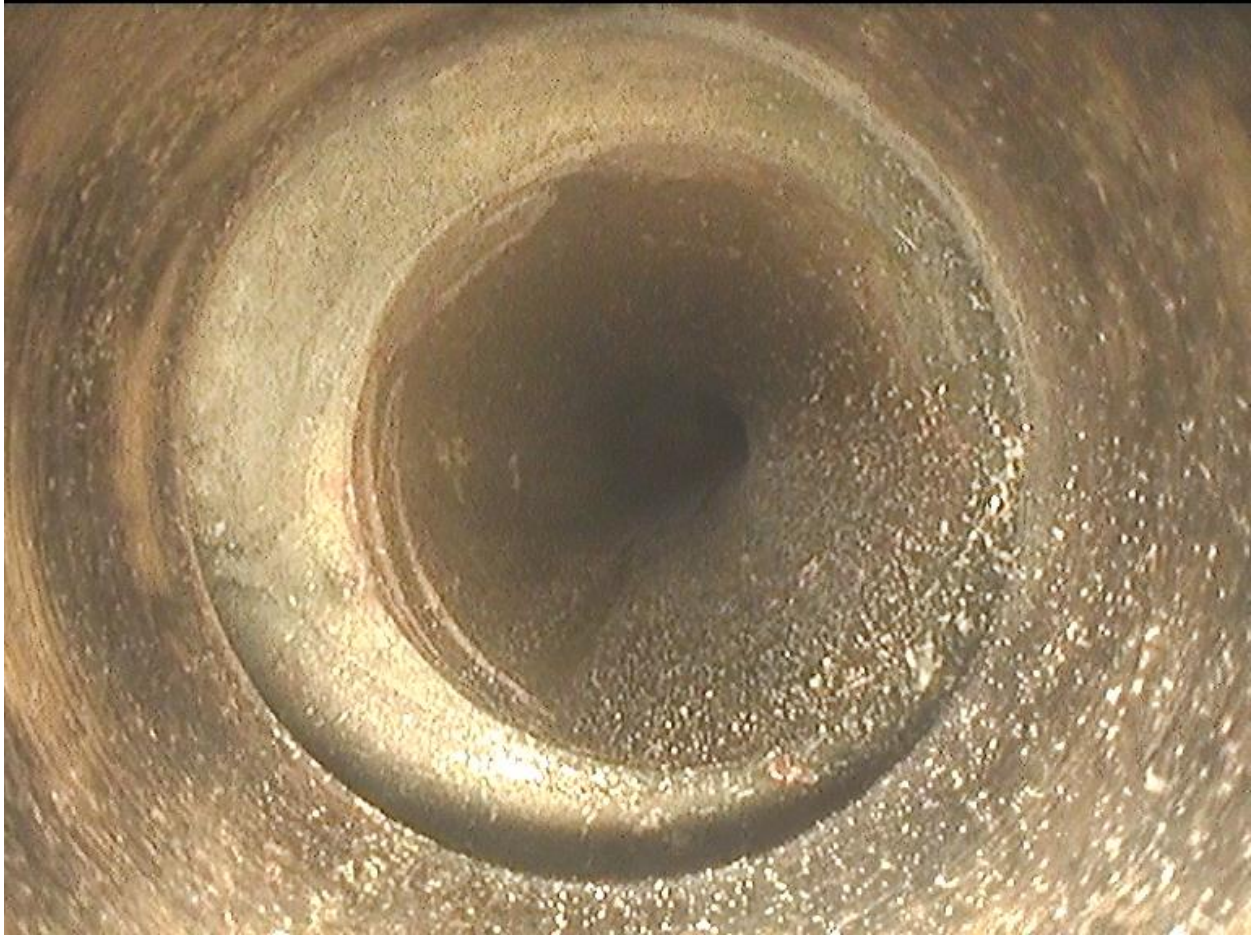
Figure 107 – Braze Joint #4 misalignment – view from plane B

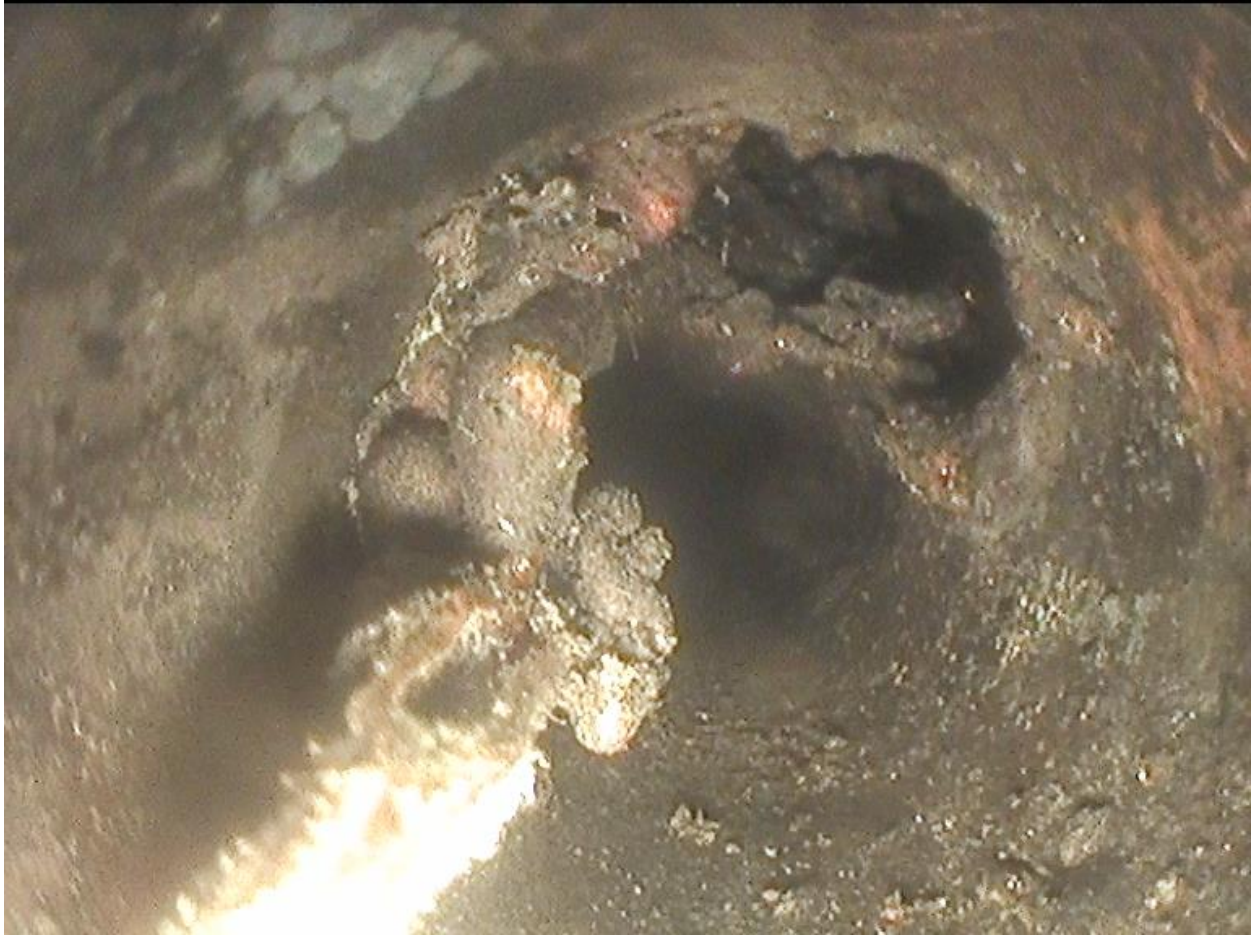
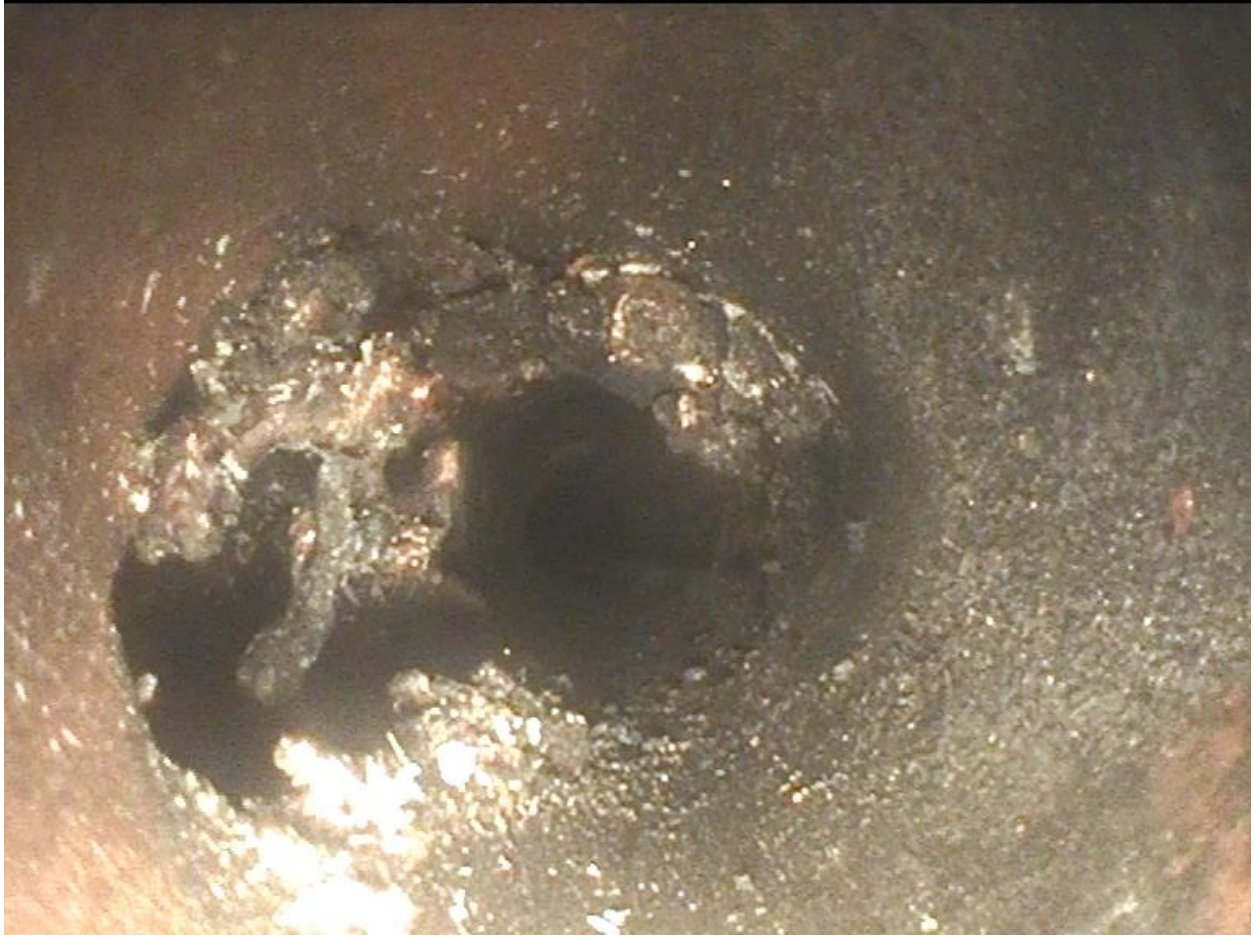
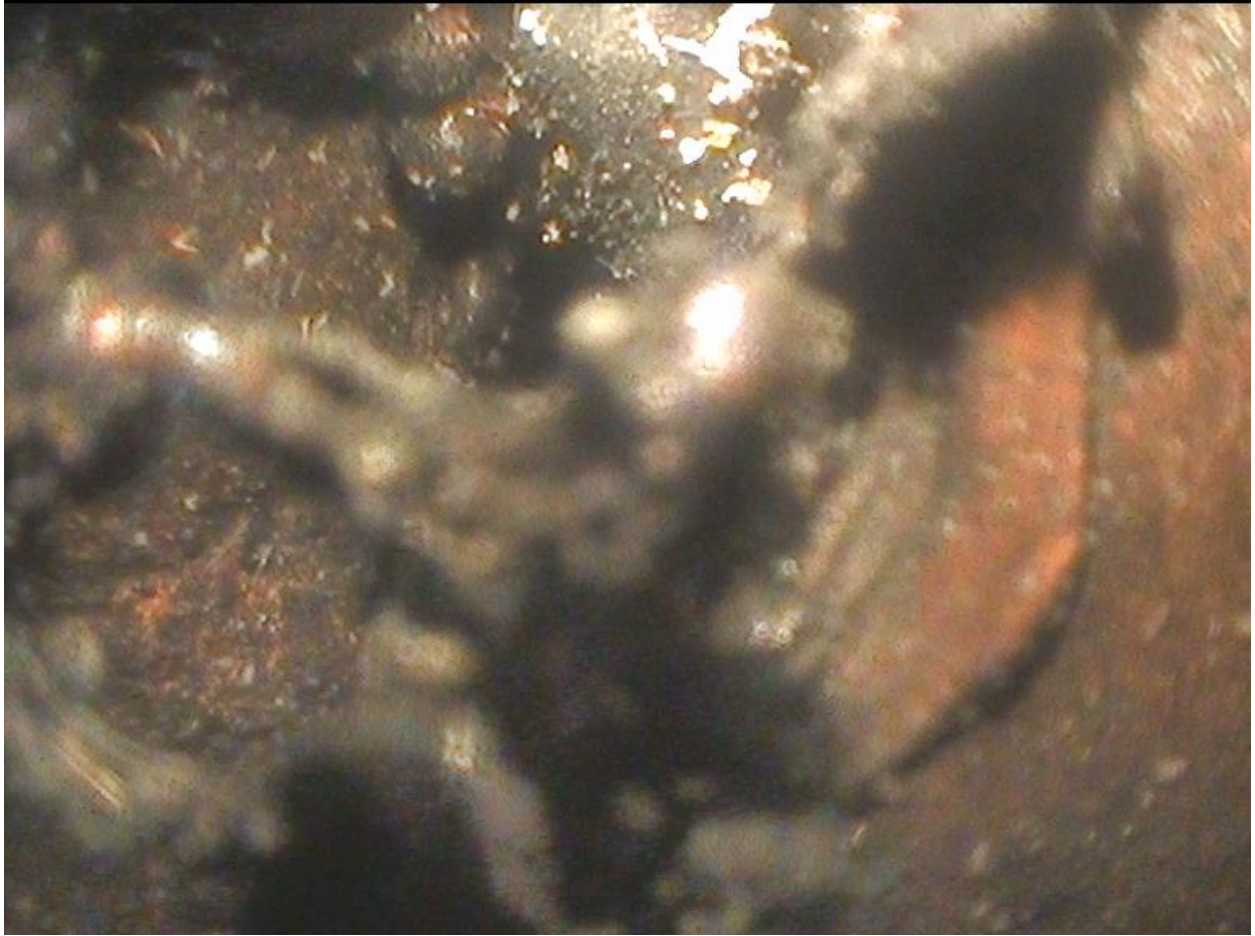
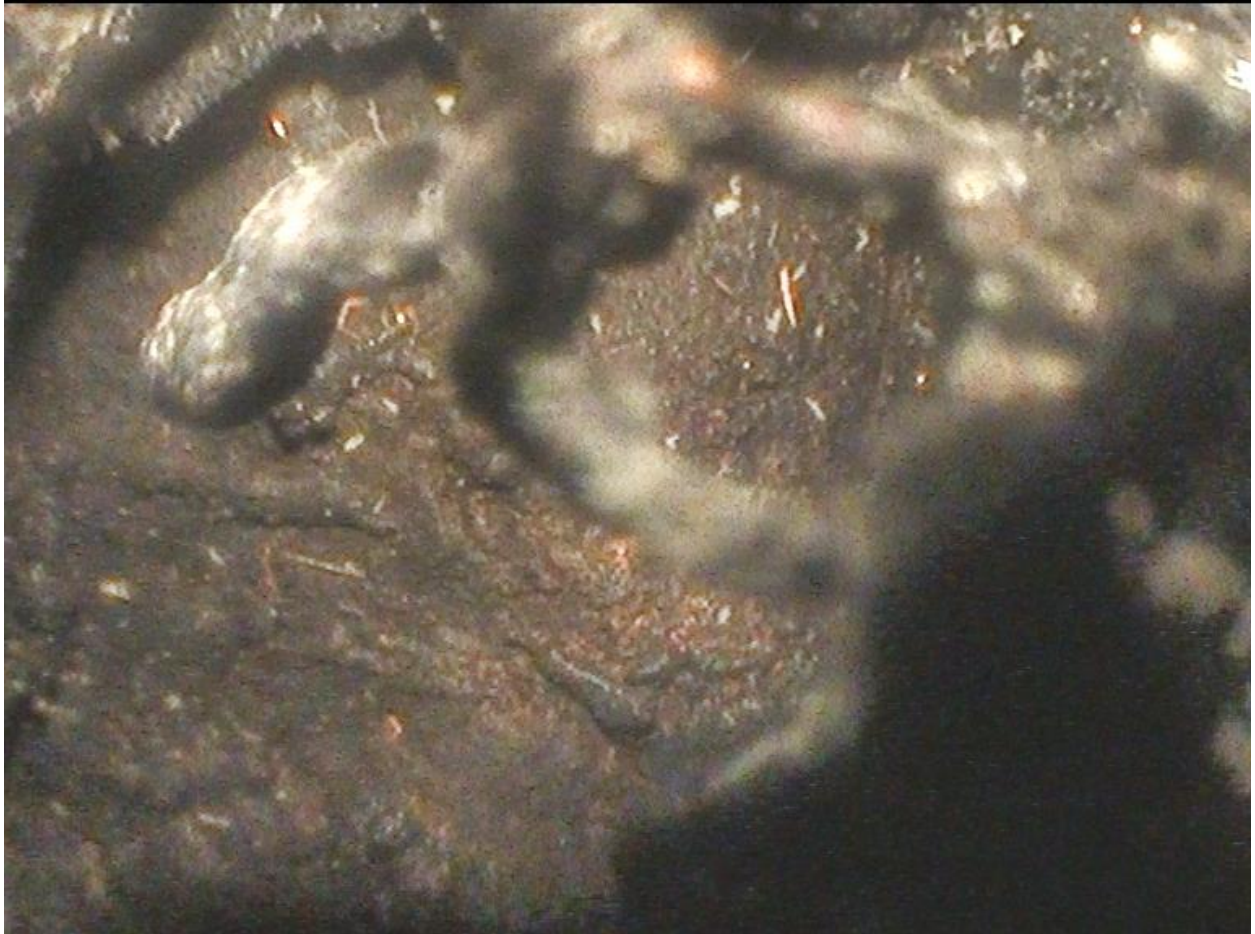
A low-vacuum pump was configured with a moisture/debris trap in order to selectively apply vacuum to conductor segment cooling paths (Figure 115). Each cooling path segment was vacuum tested at approximately 29 inches of mercury for 2 minutes (Table 9). One conductor segment cooling path failed to hold vacuum. The leaking conductor section was determined to be the cooling path with the internally observed void (Section A-B, Layer 3, Row 9, conductor #41).

1. Single Point of Failure: empirical evidence indicated one location where the cooling channel was compromised with a void and was linked to other anomalies. This location was indicated by early radiography.

1. The evidence indicates a single point of failure as indicated by a void in a conductor coolant path sidewall.
2. It is probable that electrical activity at the void location resulted in molten debris that blocked the cooling path at restrictions in the conductor braze joints.

Figure 108 – Void – view from plane B

Figure 109 – Void – view from plane A

Figure 110 – Void – side view

Figure 111 – Void – side view

Figure 112 – Void – side view

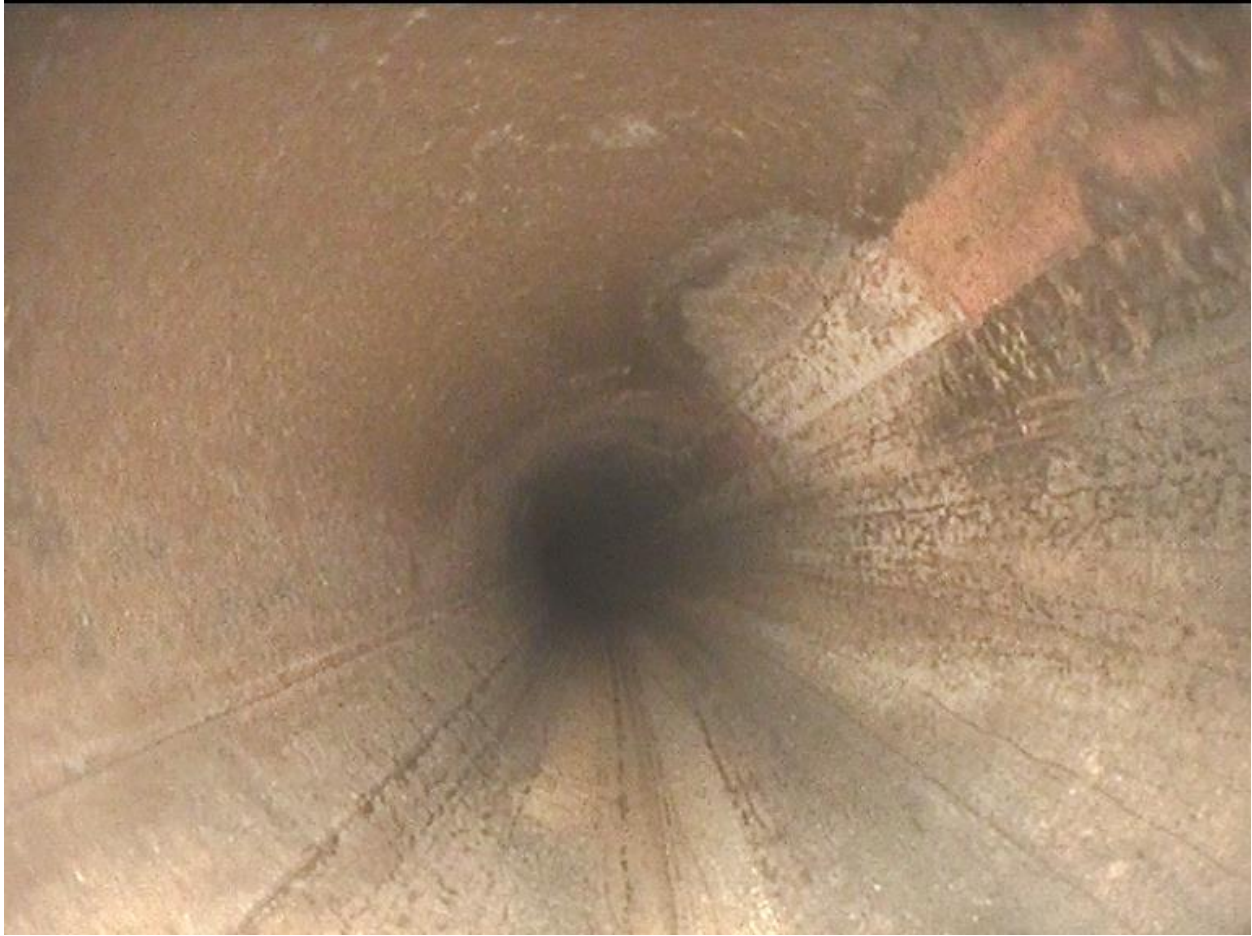
Figure 113 – Discoloration proximal to void in adjacent cooling path
