Design Verification & Validation Review

Magnet Systems

Existing Inner PF Coils Issue & Gaps

NSTX-U Recovery Project

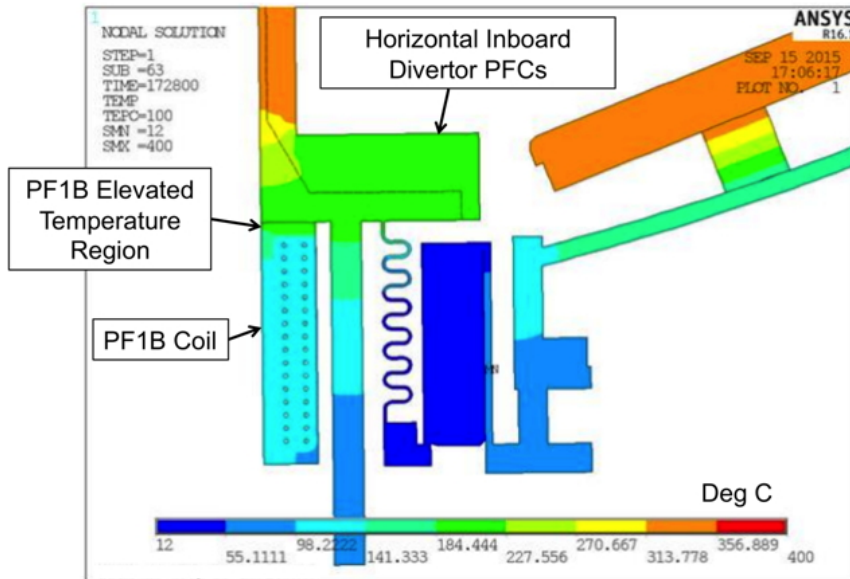
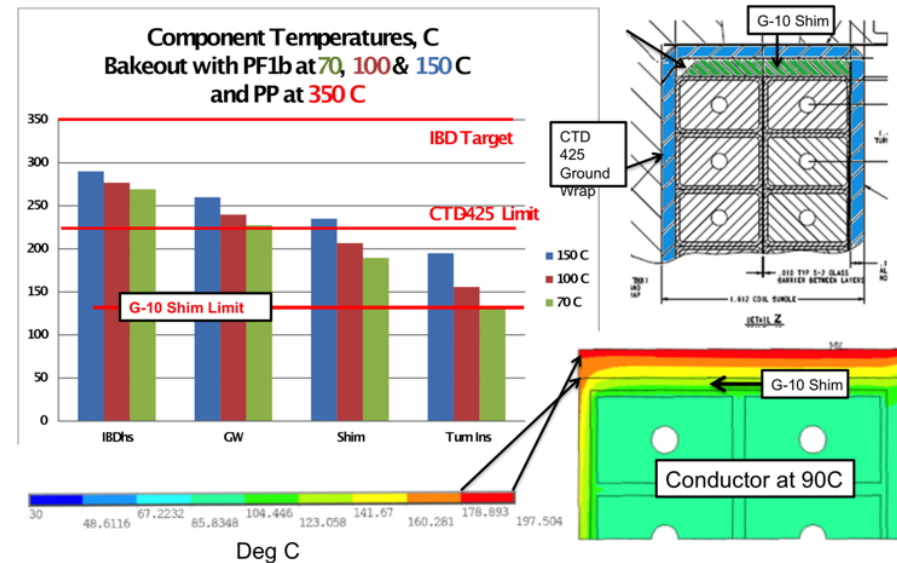
PF1B Bakeout Issue

- Design issue related to ability to bake PFCs at 350°C vs. limit on PF1B temperature
 - Insulating materials exposed to relatively high temperatures

Temperature	G-10 Shims	CTD-425 Ground and Turn Insulation
Calculated maximum temperature	Between 160 - 179°C	Between 179 - 198°C
Rated service temperature (taken to be equal to glass transition temperature)	140°C	185°C

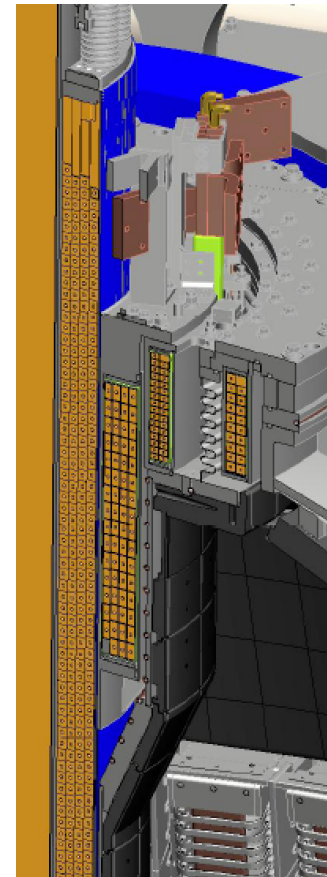
Exposure to Water after OH fault on April 24, 2015

- Water return lines (4 of 8) were breached and a significant quantity of water was released
- PF1CU sits in a can that forms a reservoir and was submerged
 - this did not cause any hipot problem until 10 months later
- After event ~ 1 month of drying with fans was required before the inner VV could pass 5kV hipot
- PF1AU coil got very wet, but whether or not the water pooled up such that the coil was submerged, is unclear

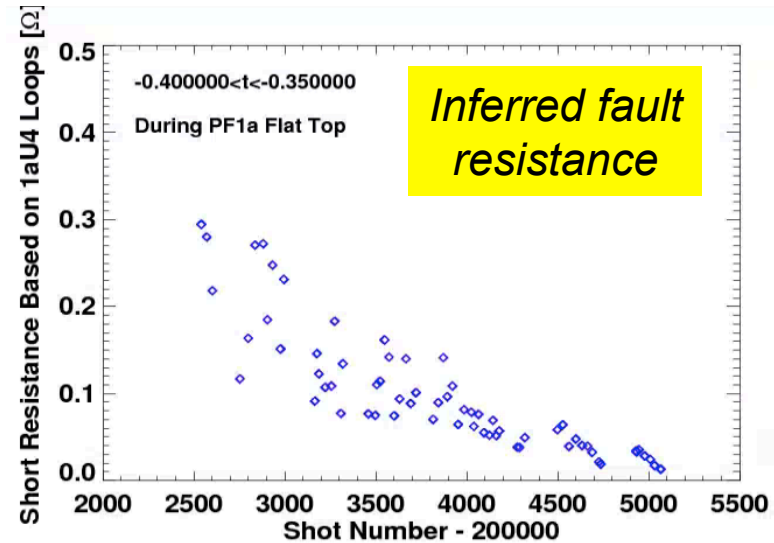
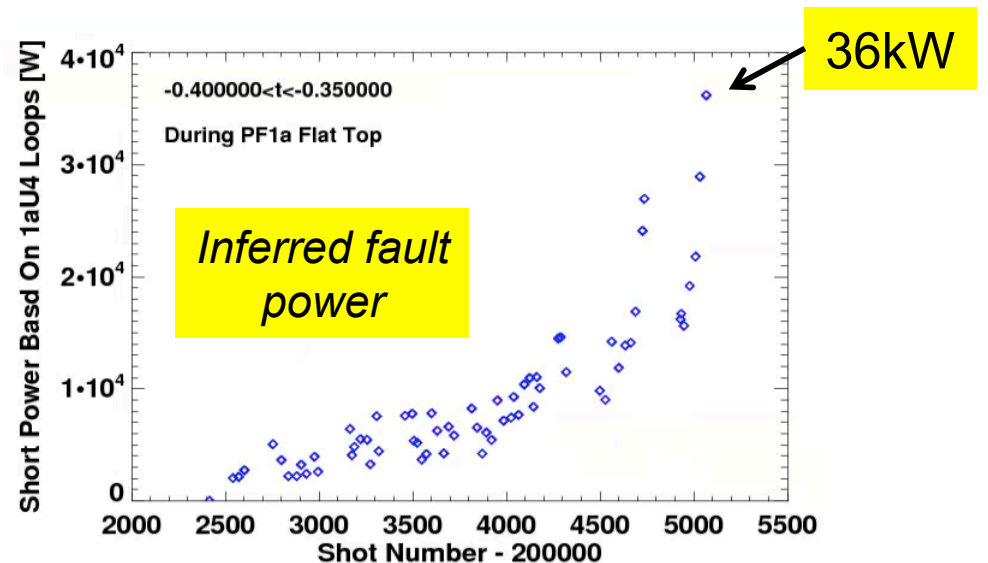
Morning Test Shots Show Degradation of the Coil Over Time

- Based on daily 100% test shots
 - Portion of shot w/steady PF1AU current
- Flux loops on the coil
 - showed a decrease in flux per unit current (inductance) over time
- Assume 18 turns shorted and fit the resistance of the short

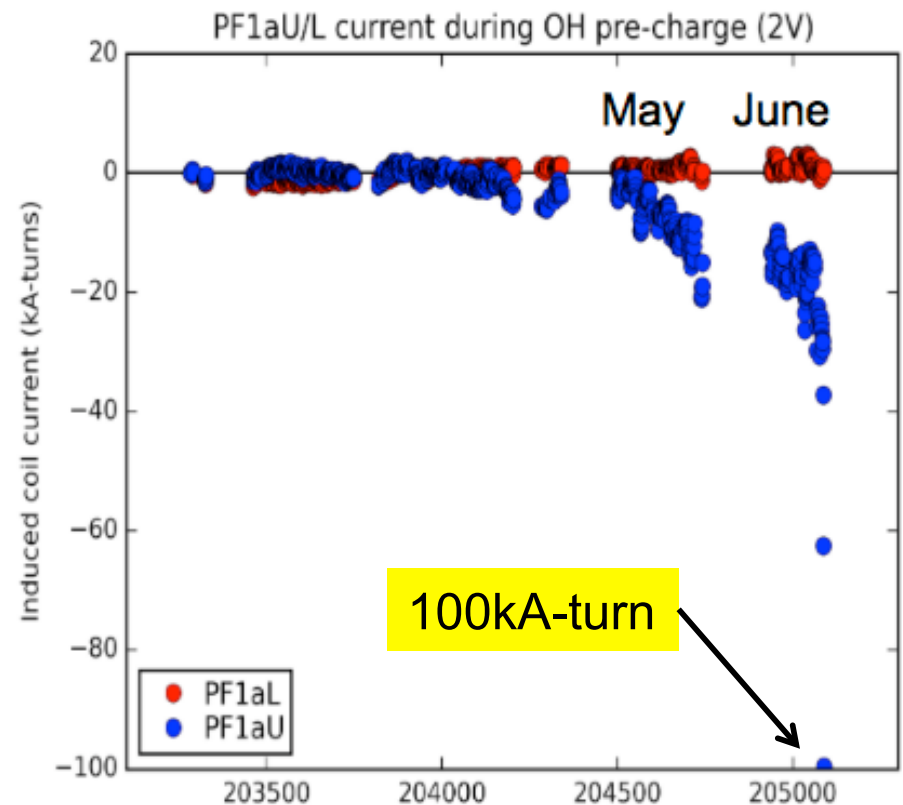
Induced Current Grew Rapidly on the Final Shots

- Based on OH pre-charge phase of the discharge
 - PF-1aU rectifier controlled to zero during this time
- Infer current induced in shorted turns from flux loops
 - Reached 100kA-turns (6kA/turn assuming 18 turns)
- Rapid degradation of the coil in the final shots
 - Indicates substantially more power was dissipated on the final shots

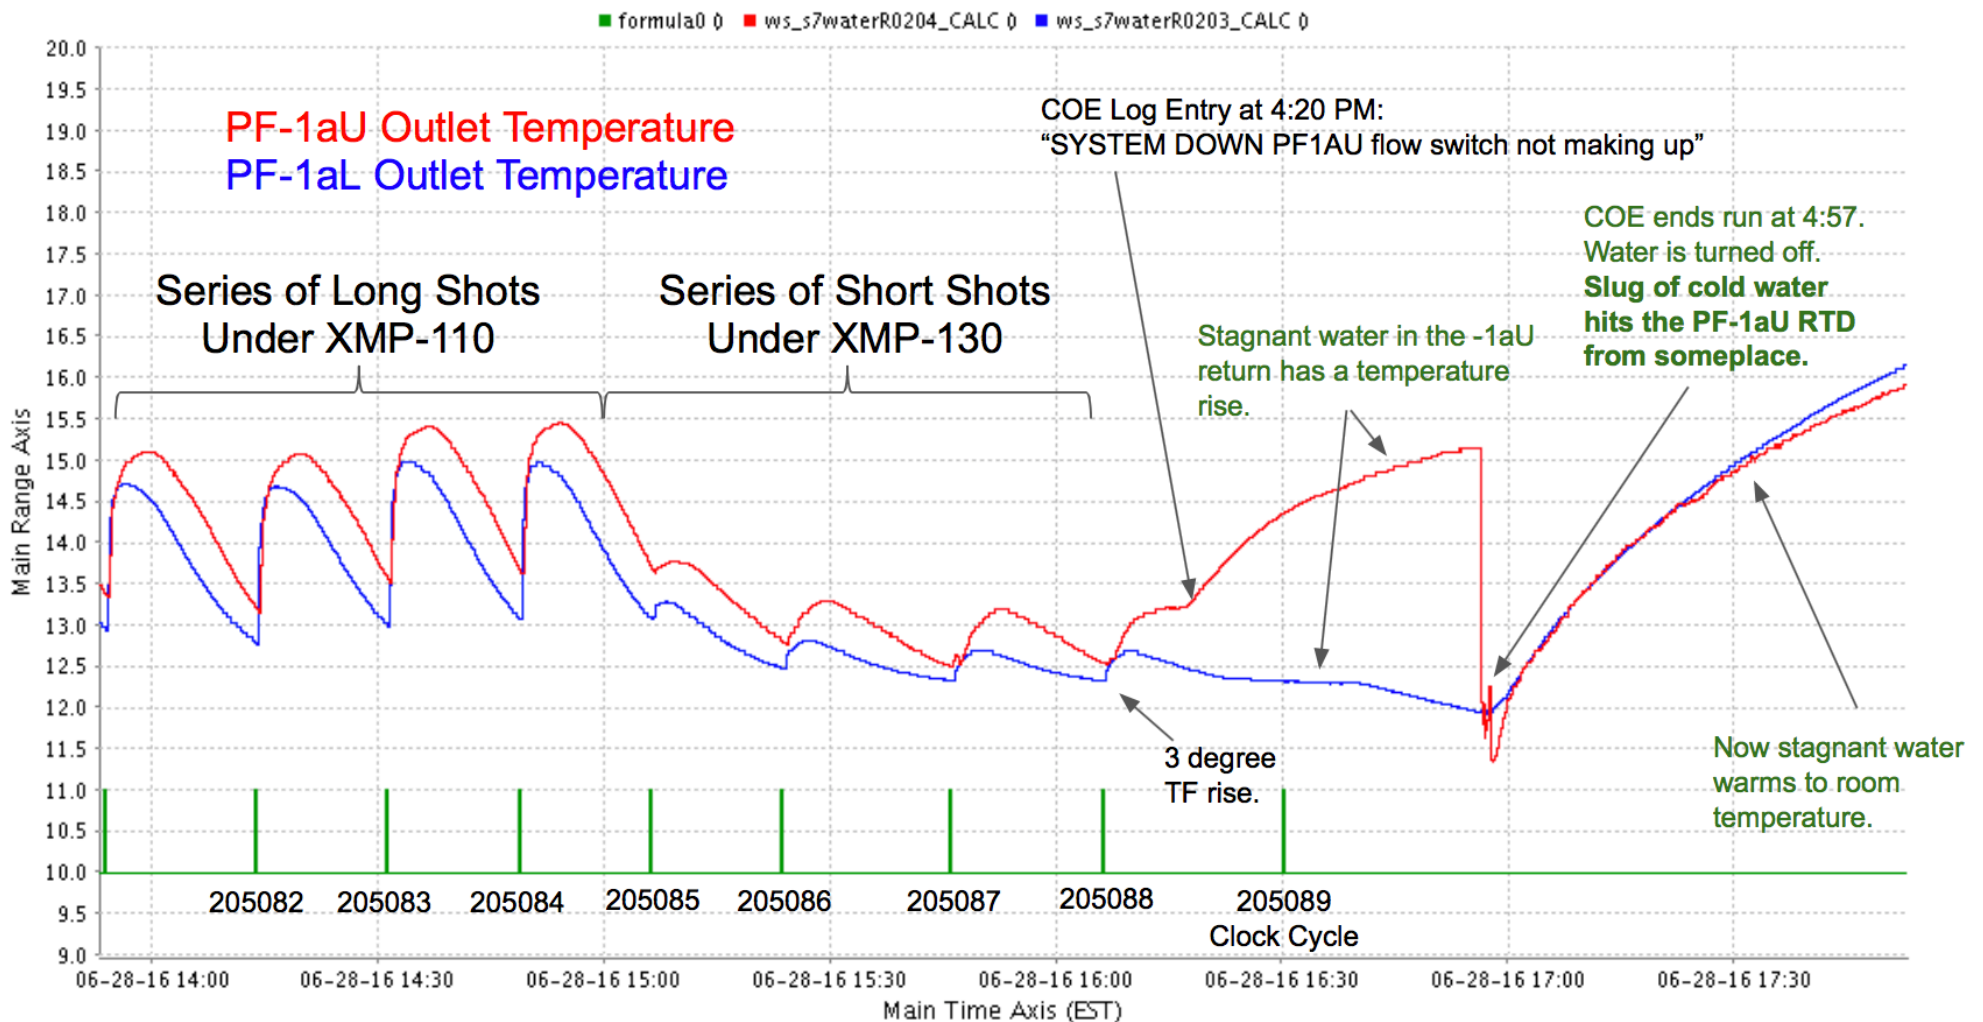
Water Flow Was Only Plugged After Final Shot

Temperature on outlet side at the water manifolds, many meters from coil

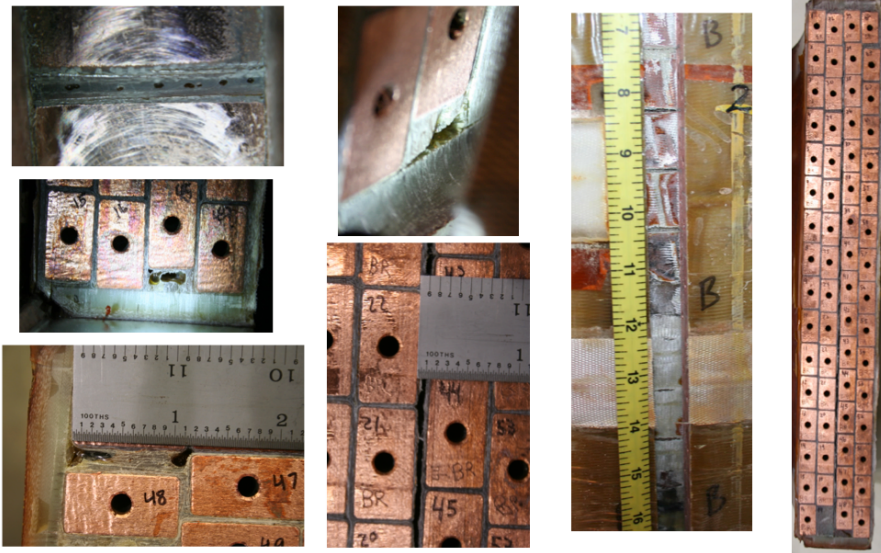
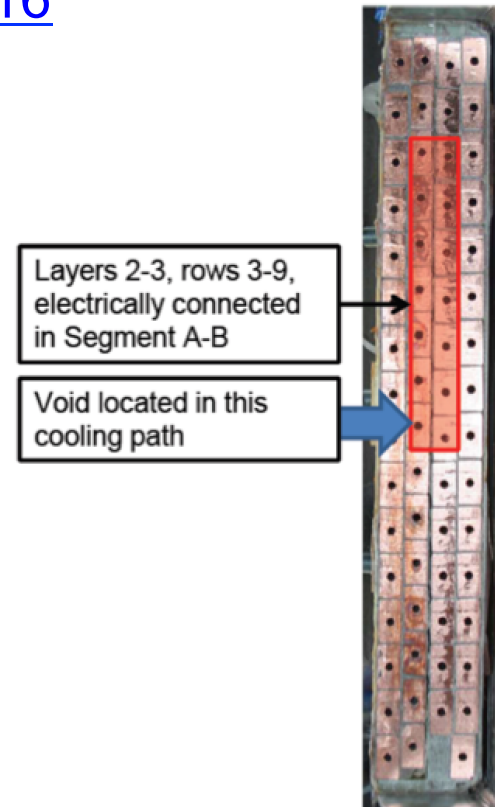
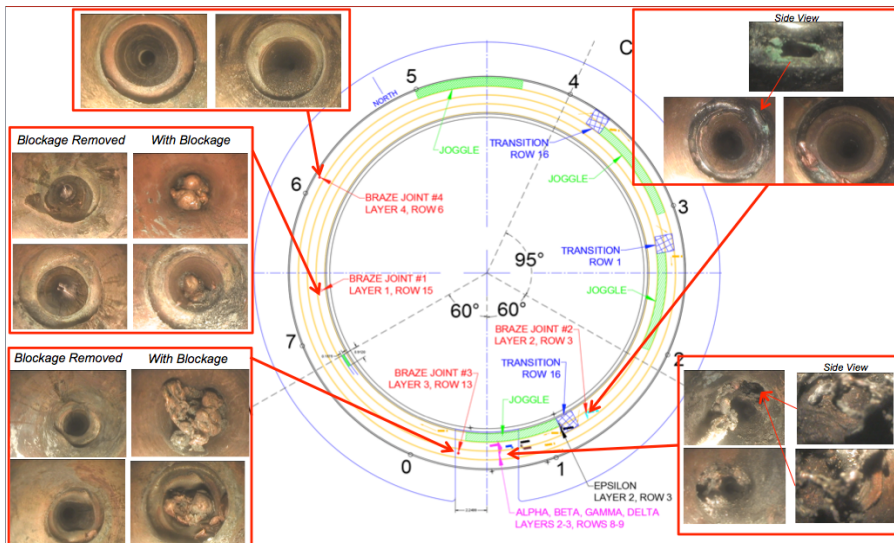
Forensic Analysis of the NSTX-U PF1A-Upper Coil Failure, I. Zatz, J. Petrella, 11/18/16

- Revealed poor quality
 - VPI
 - Braze joints
- Identified fault zone

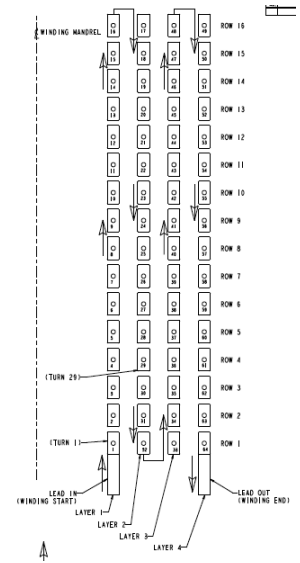
Layers 2-3, rows 3-9, electrically connected in Segment A-B

Void located in this cooling path

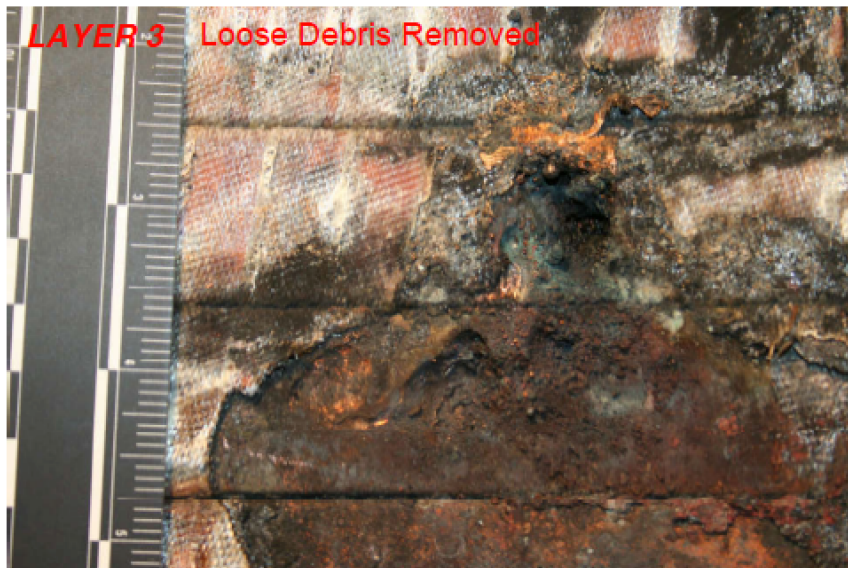
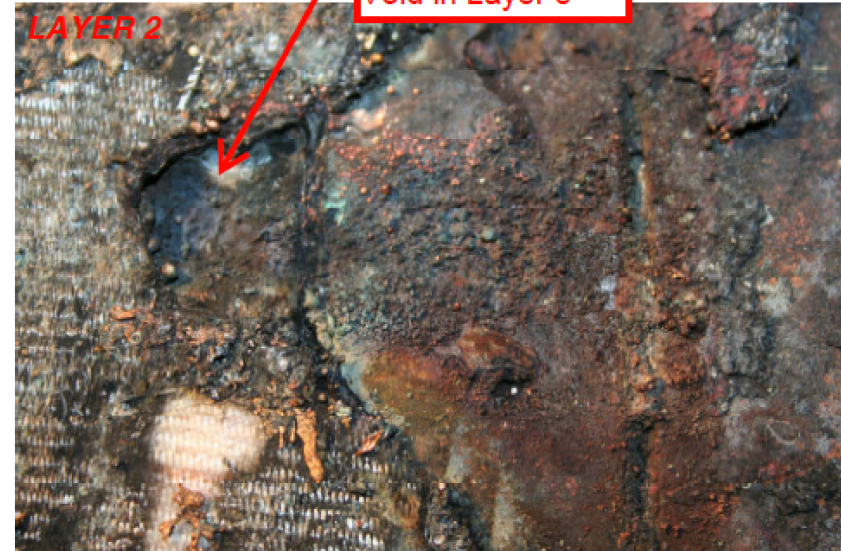
Divot Aligning with Void in Layer 3

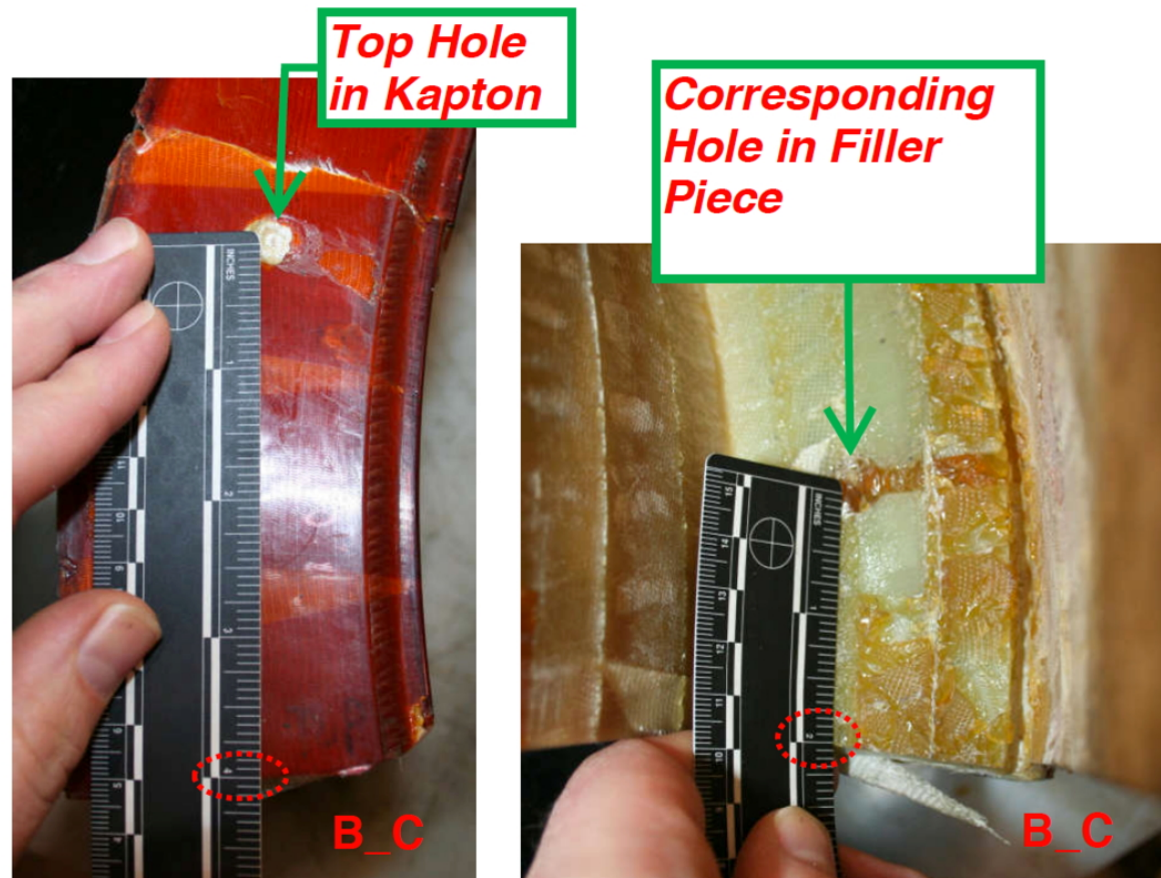
- Holes misaligned by 1.75" inches on PF1AU top flange, 0.625" on bottom flange

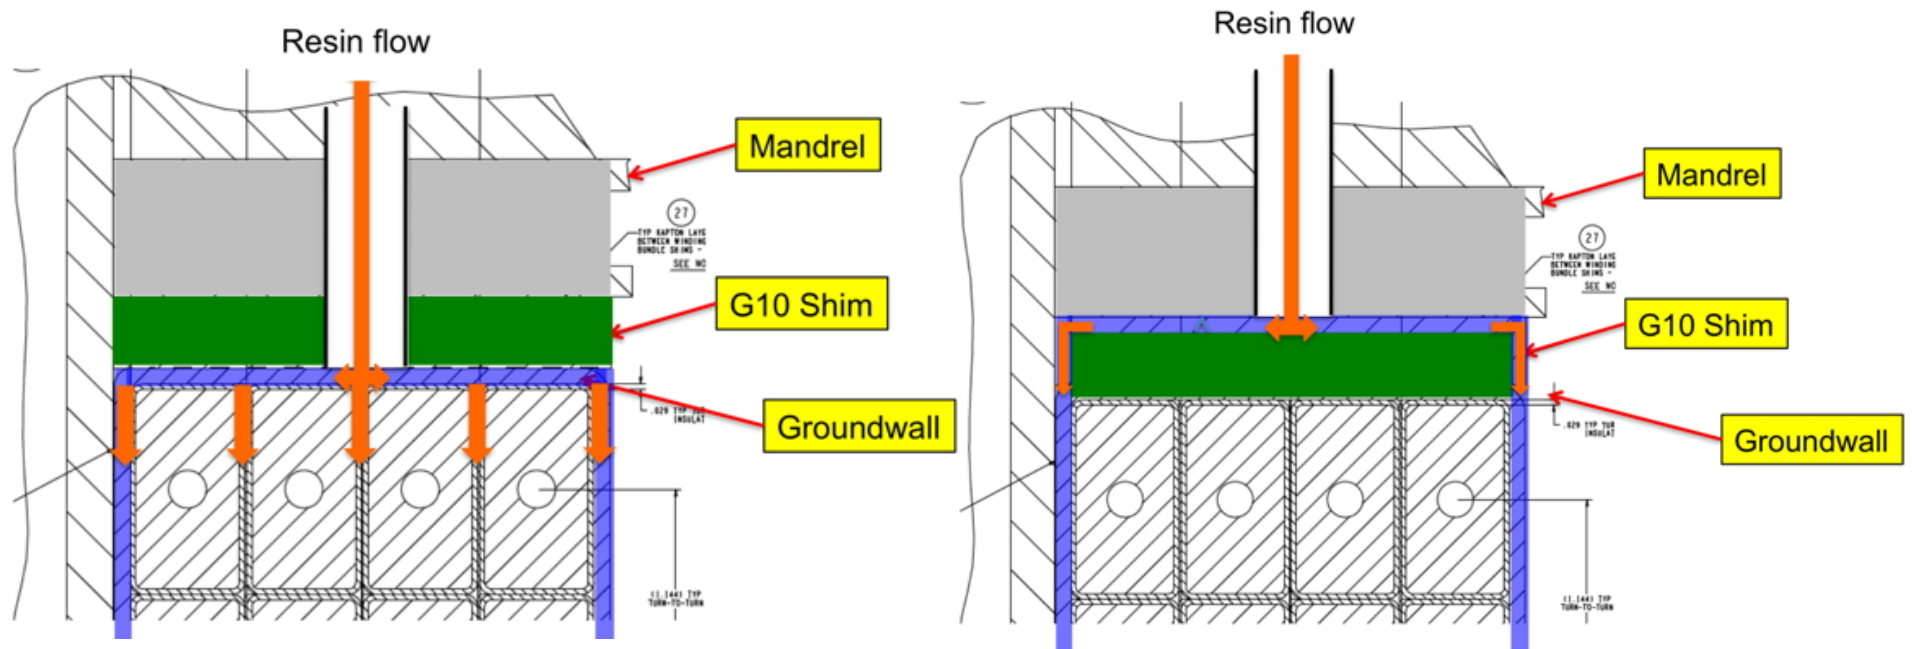
- Sprue hole misalignment increased impedance to resin flow but there was still a path

As-built configuration and resin flow path

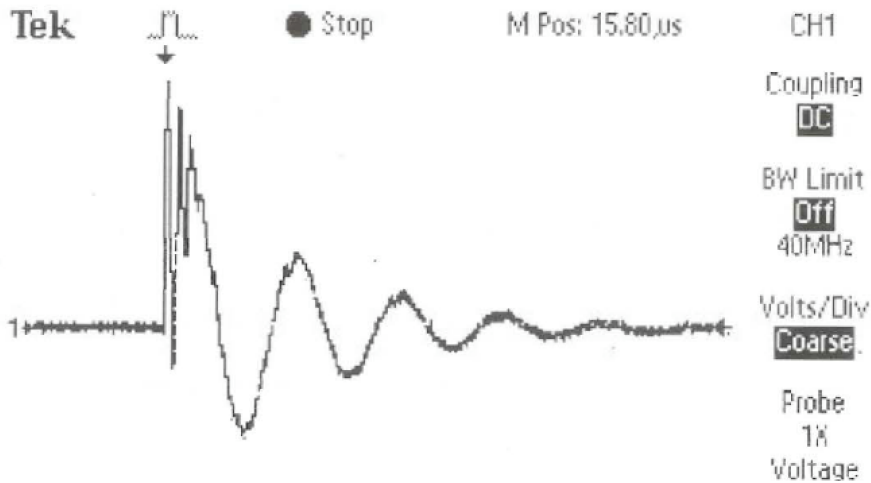
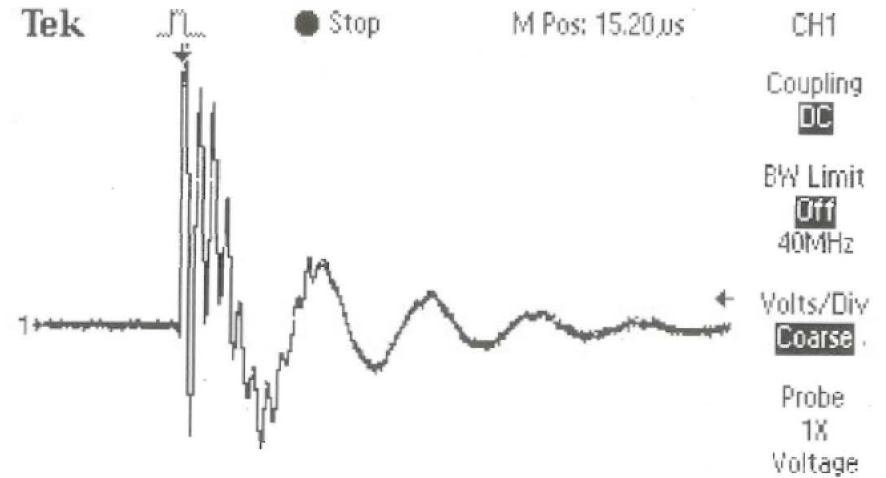
Ring Test - PF1AL

Reported as 8 rings

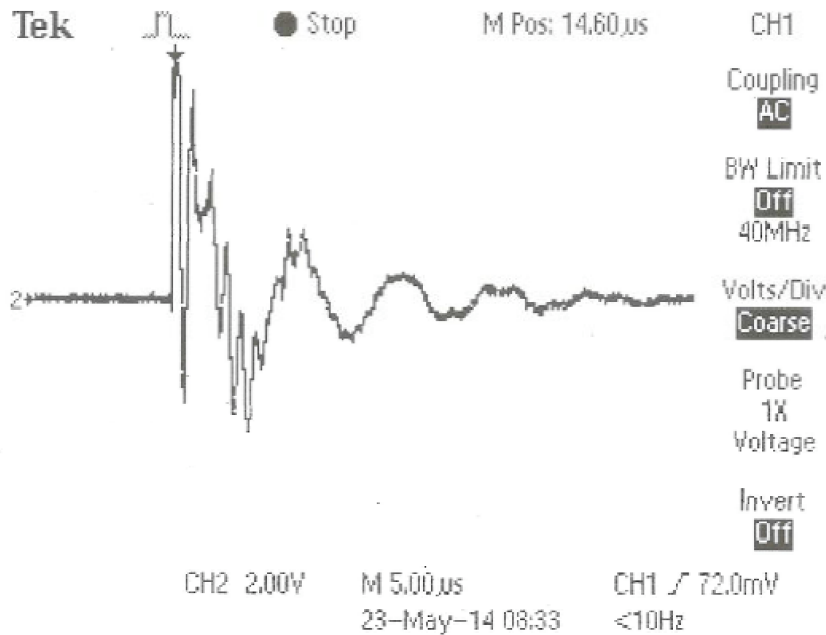
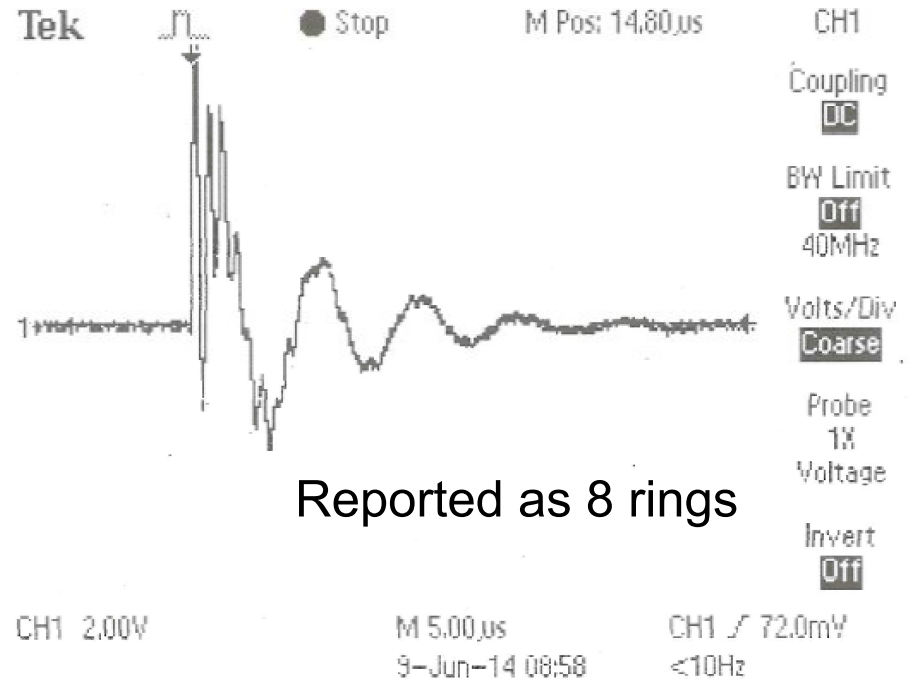
Ring Test - PF1AU

- The high frequency component increases from pre-VPI to post-VPI on PF1A-L but is similar on PF1A-U;
 - The pre-VPI high frequency component is more prominent on PF1A-U than PF1A-L;
