Forensic Analysis of the NSTX-U PF1A-Upper Coil Failure

Rev. 0

November 18, 2016

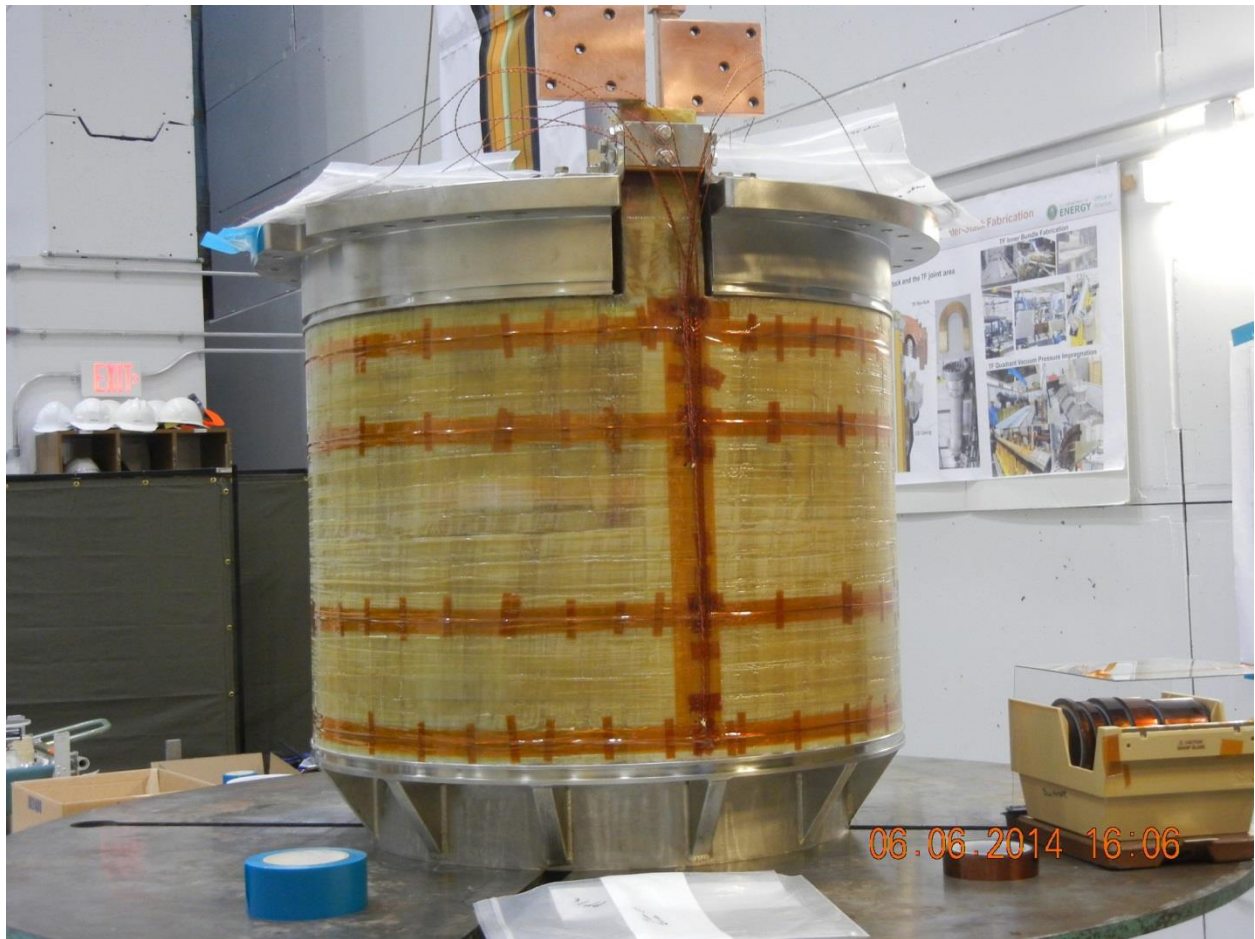
Figure 1 – The as-delivered PF1A-U coil

The coil conductors are wrapped around a stainless steel mandrel with upper and lower flanges that position the coil pack conductors and added stiffness during operations. The delivered coil is shown in Figure 1. A representative schematic of the coil is shown in Figure 2. The location of the PF1A-U coil on the center stack of NSTX-U is shown in Figure 3.

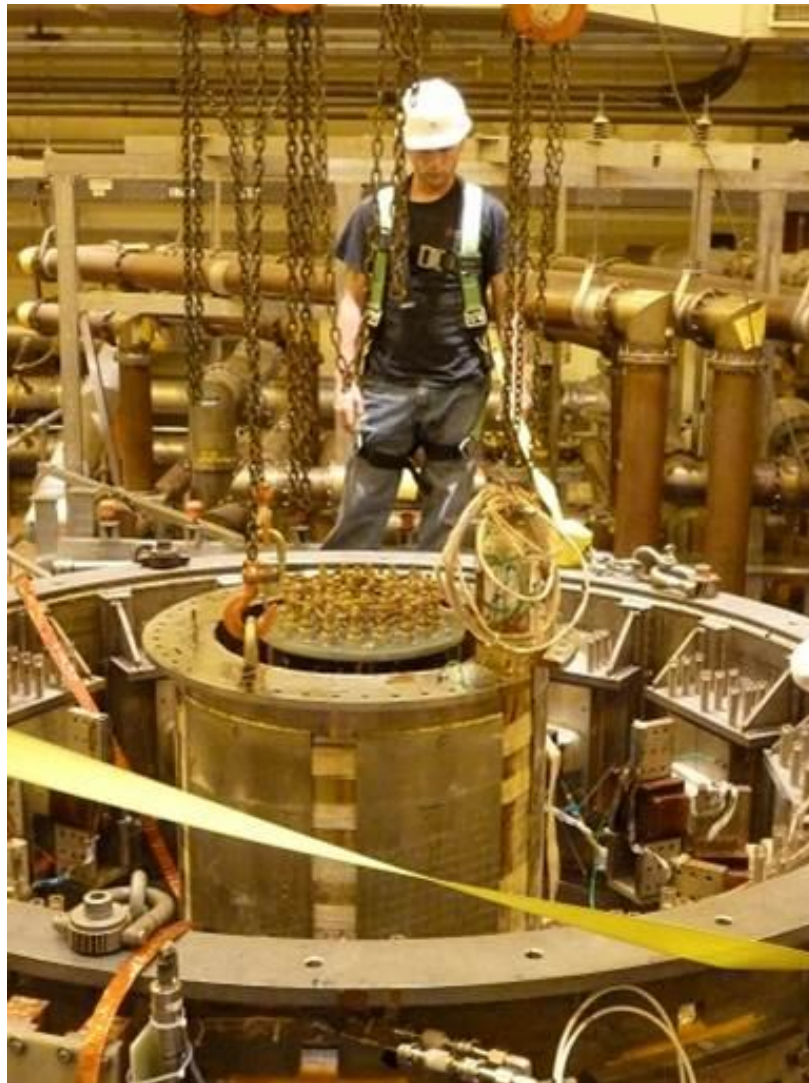
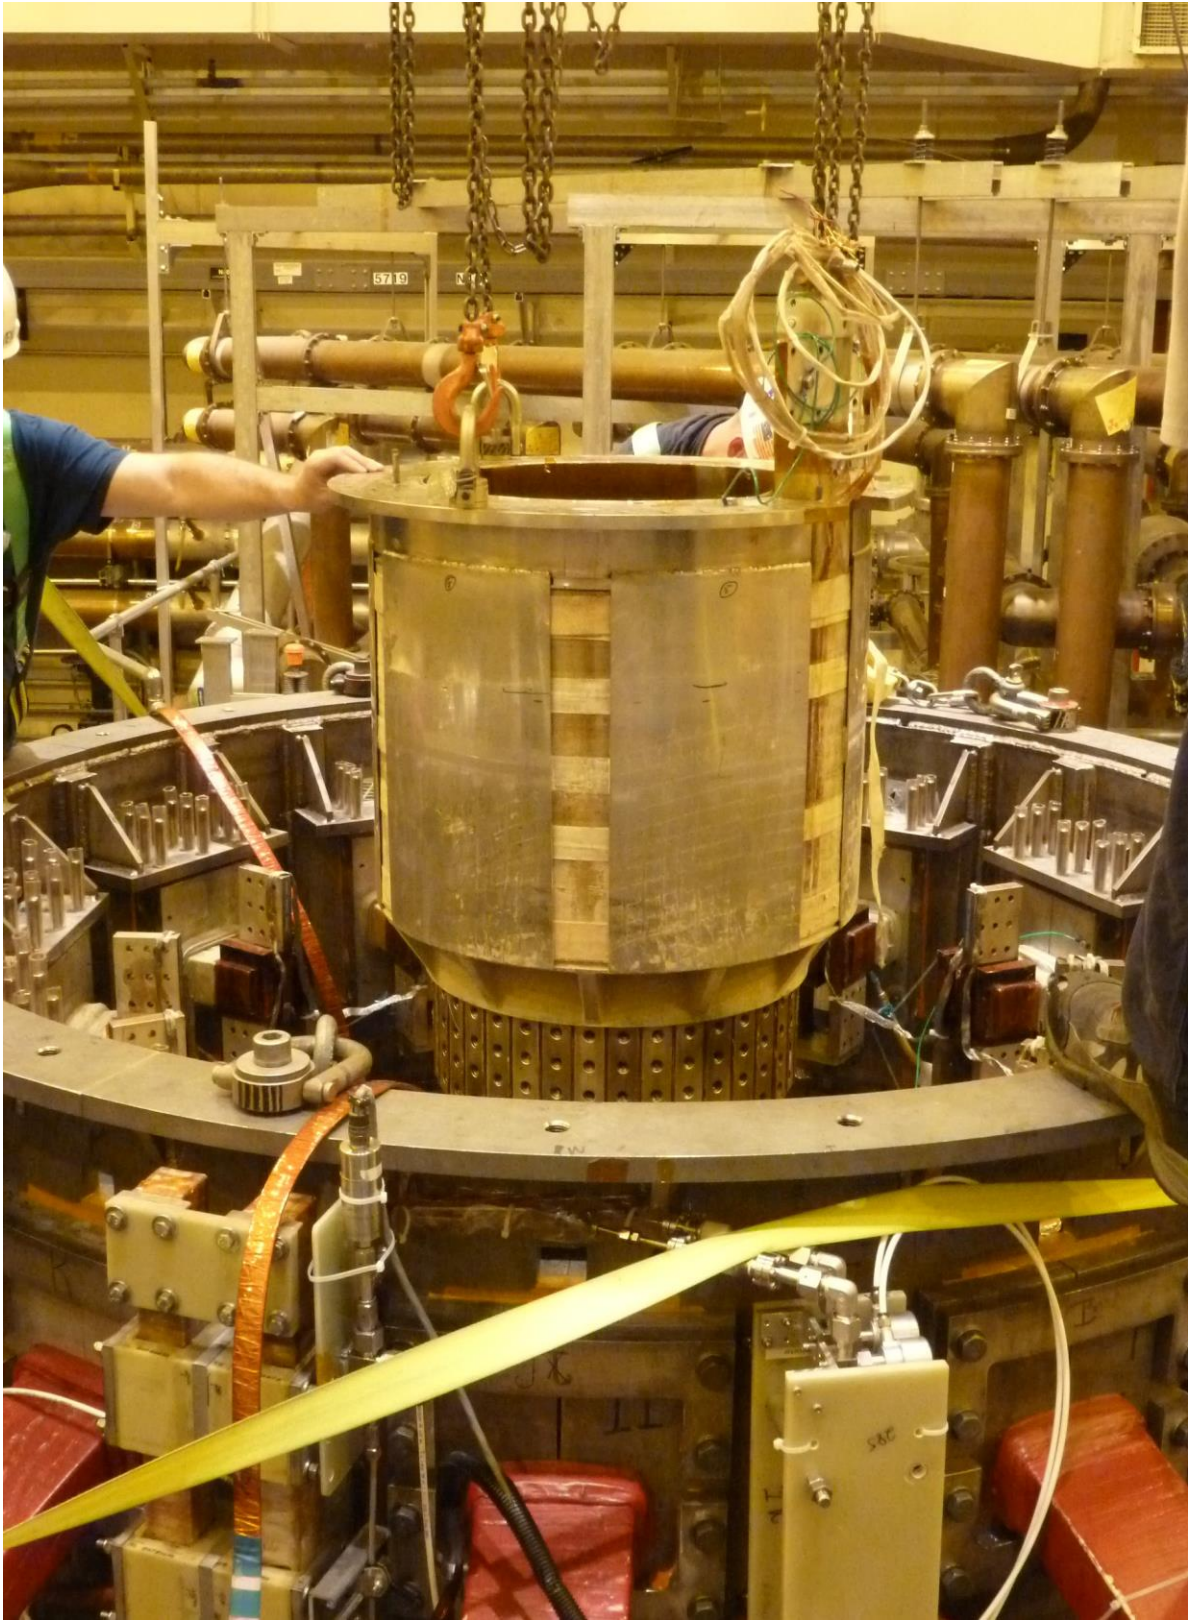
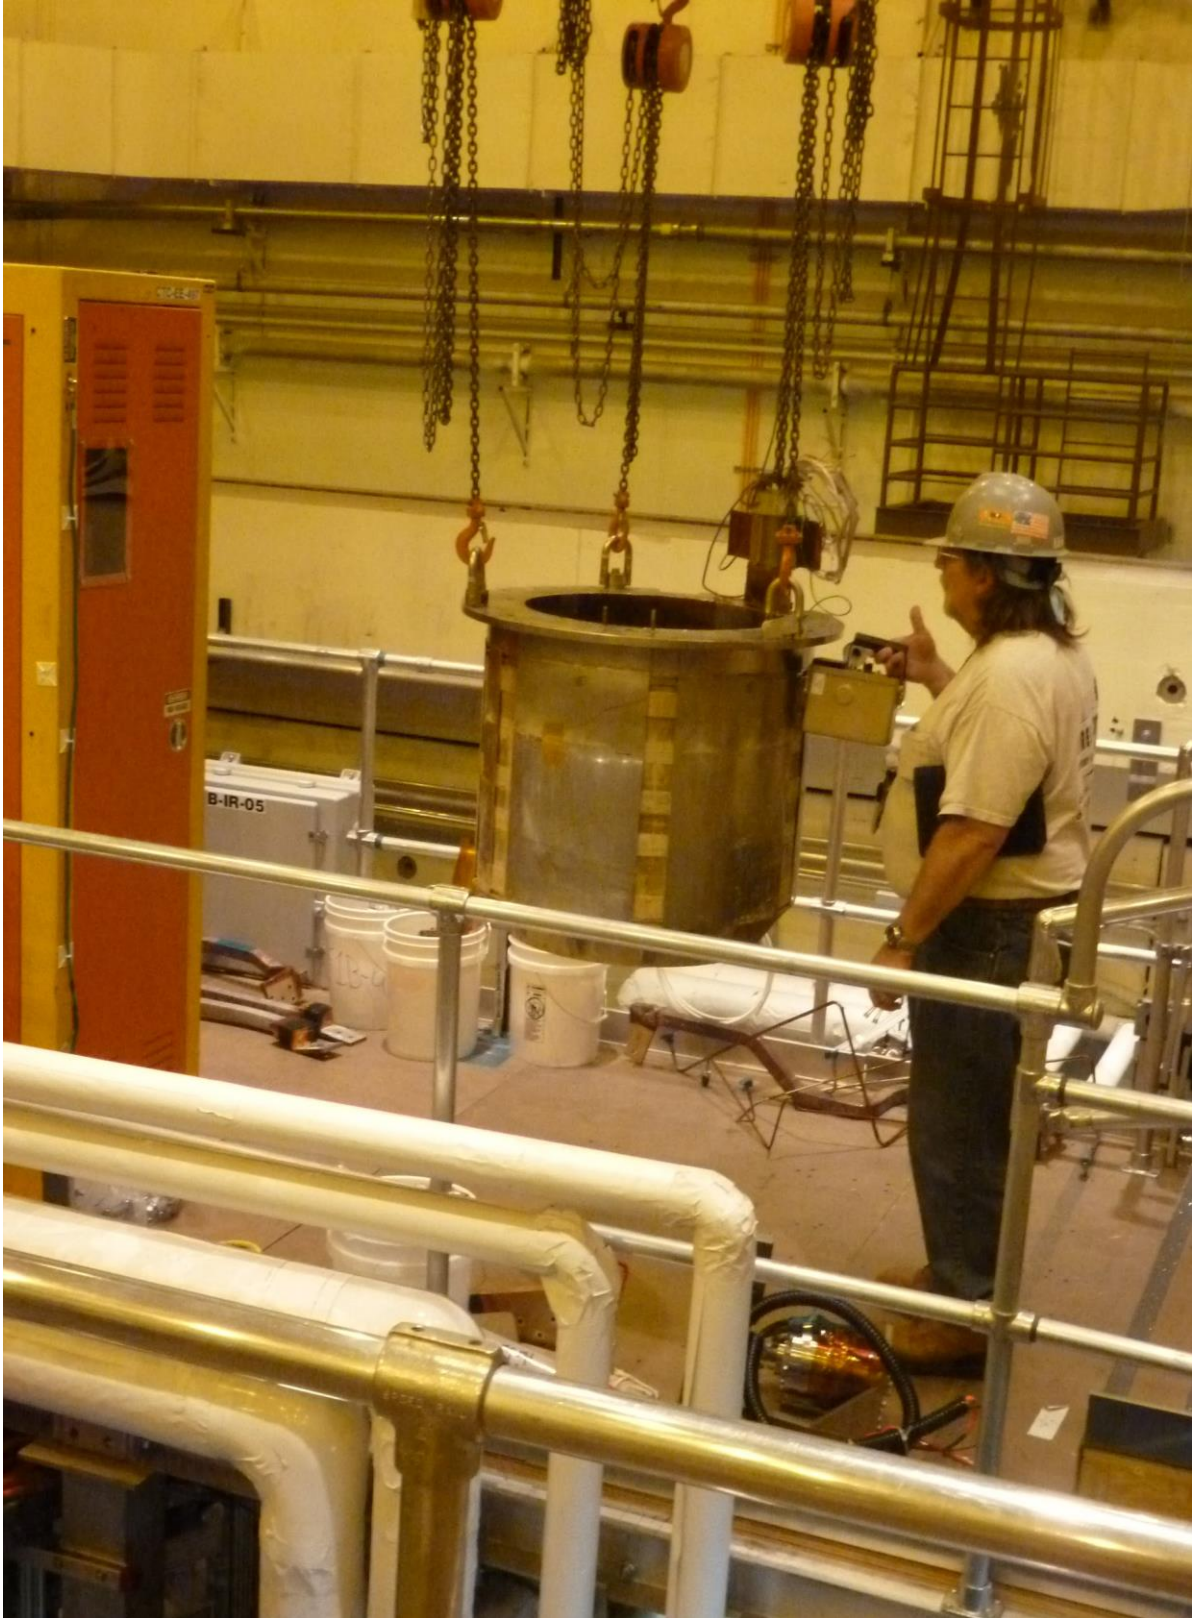
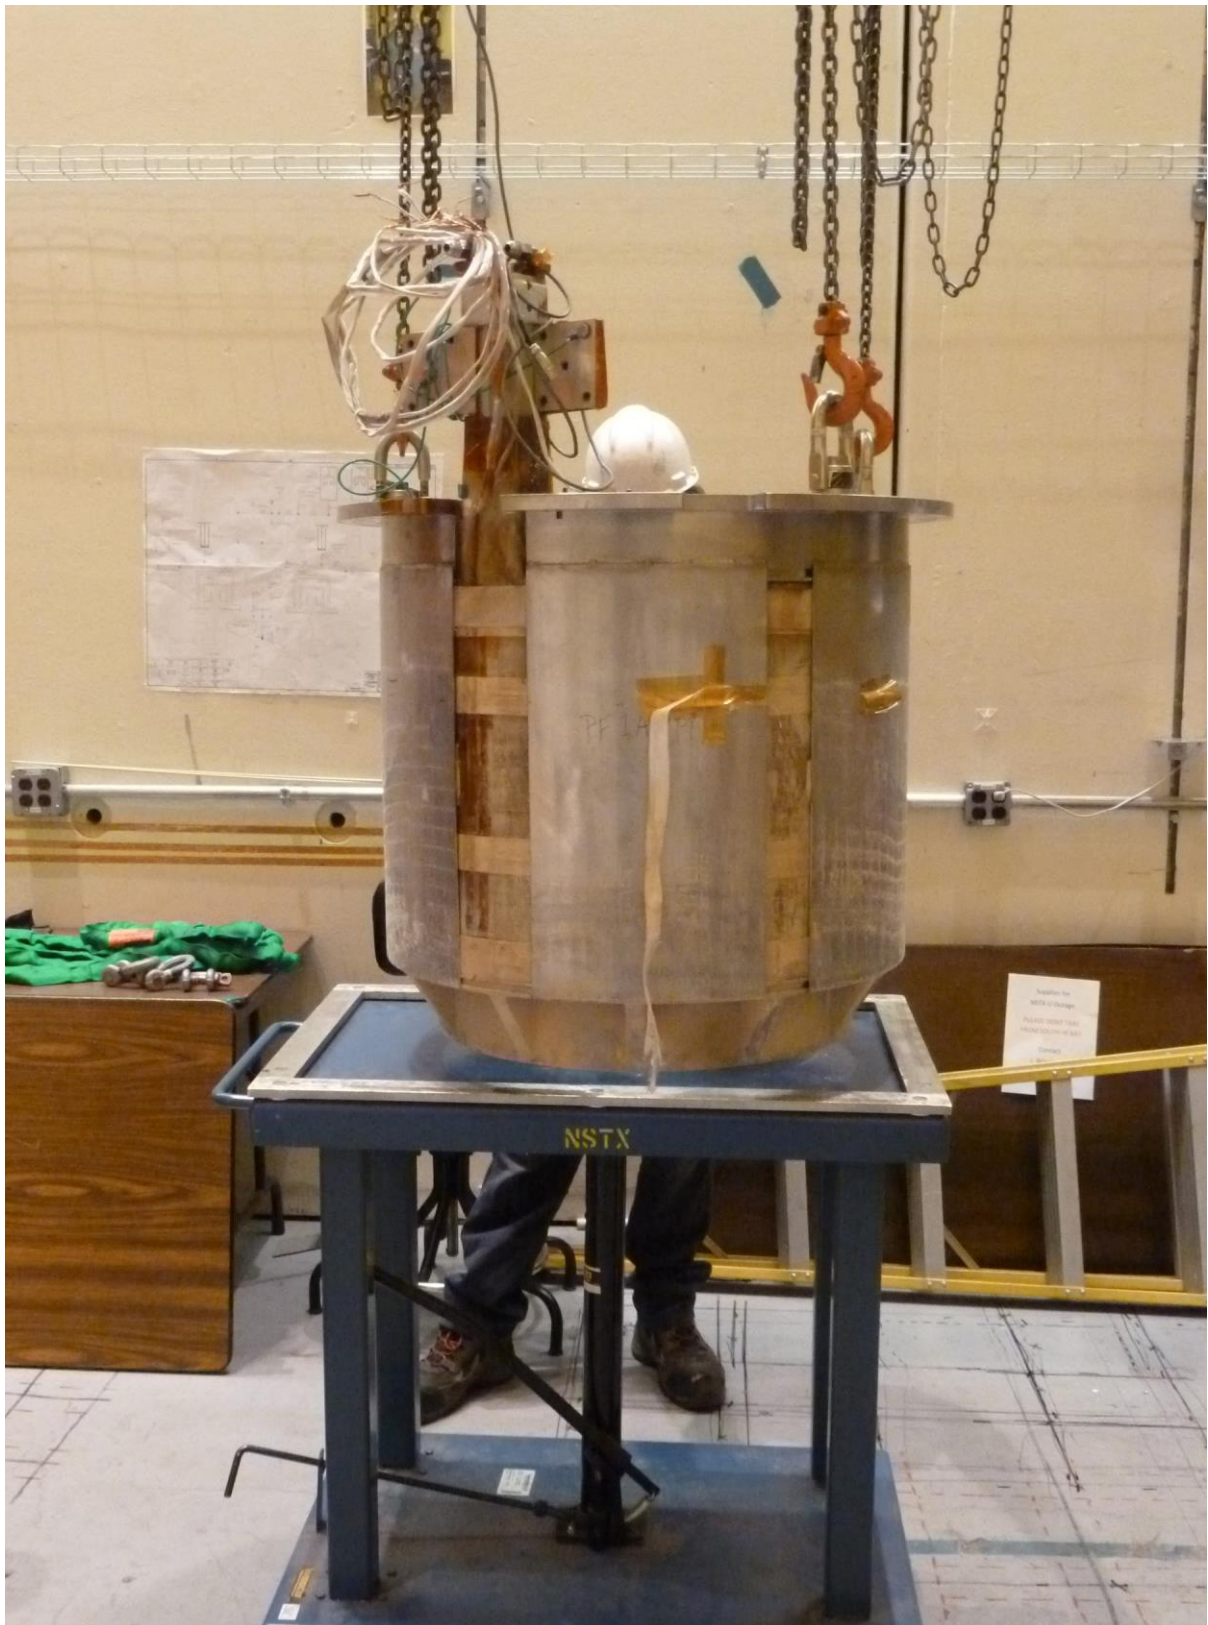
The PF1A-U coil was removed from the NSTX-U Center Stack on August 24, 2016. It was safely lifted, without incident, out of the test cell and onto a platform in the South High-Bay. The coil was surveyed for radiation activity and cleared by HP. Figures 7 thru 10 illustrate the removal and lift activity.

Figure 7 – Removal of PF1A-U from NSTX-U

Figure 8 – Removal of PF1A-U from NSTX-U

Figure 9 – HP surveying PF1A-U post-removal

Figure 10 – PF1A-U in the south high bay

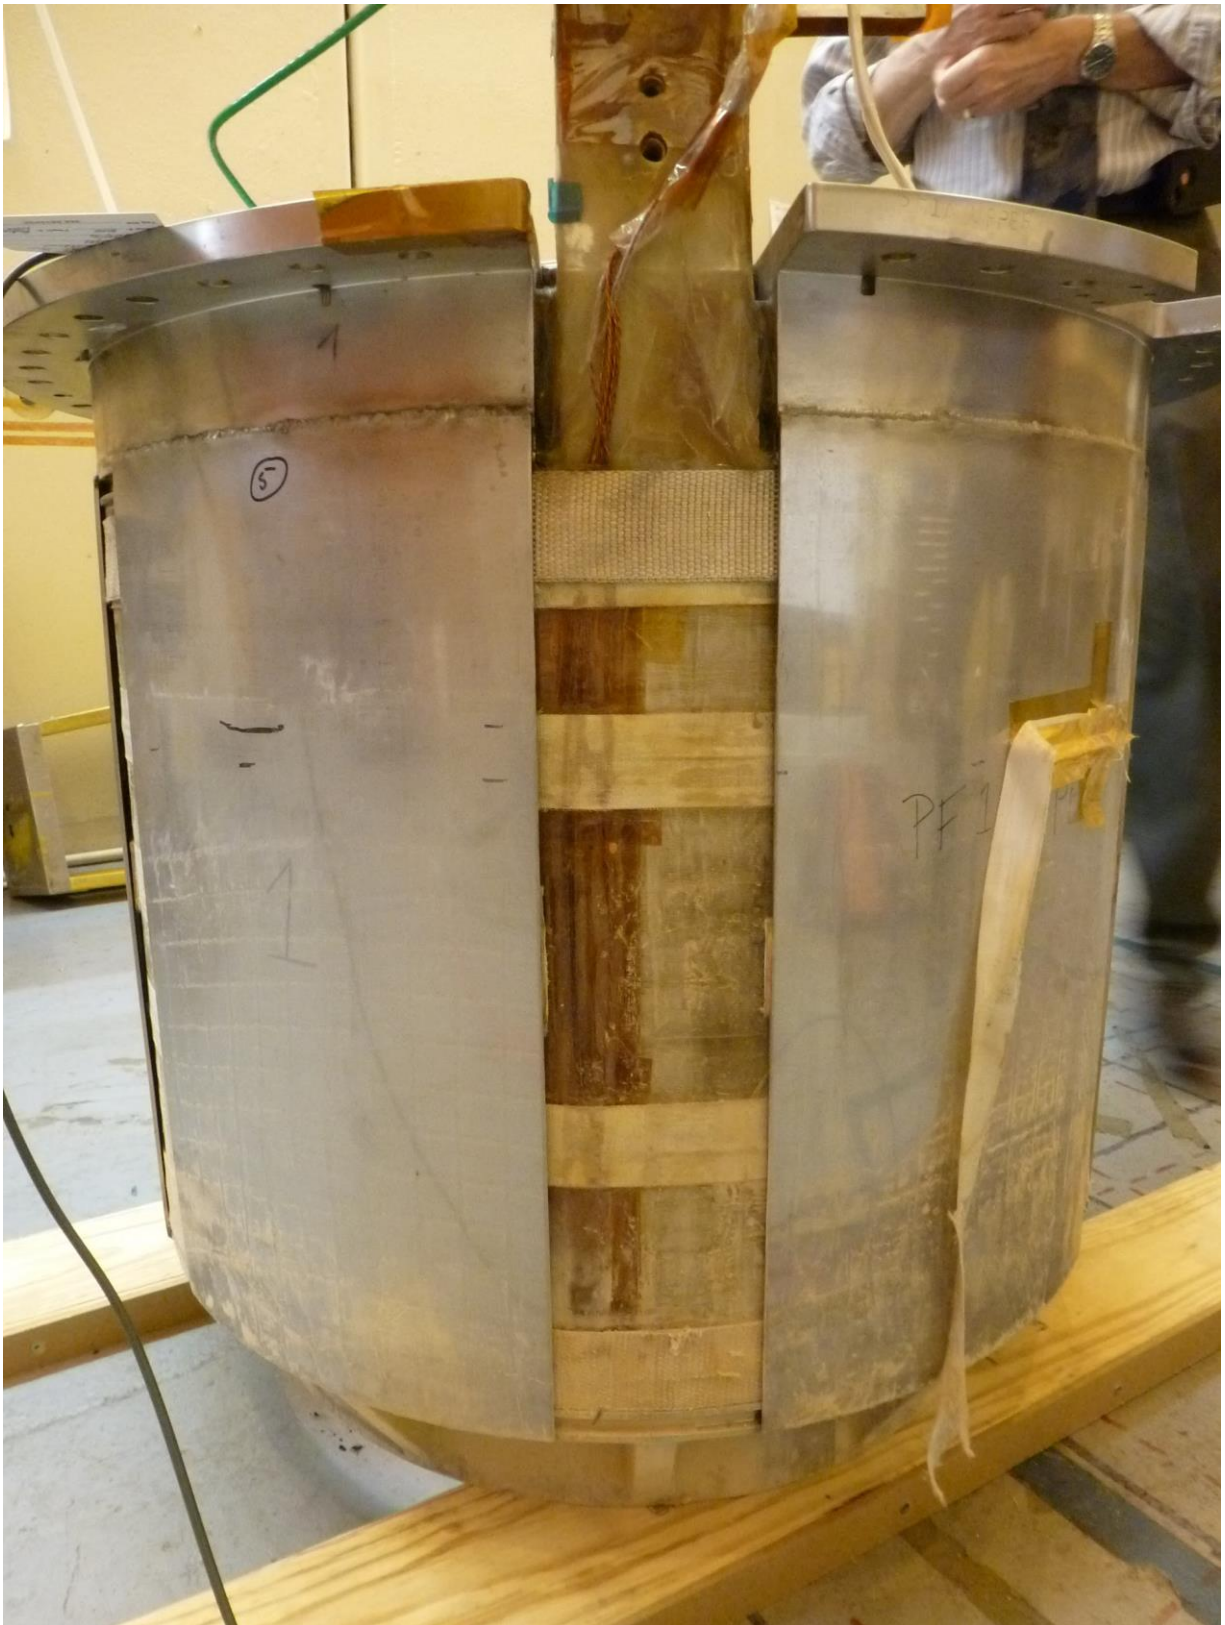
Figure 11 – Lead area

The PF1A-U was visually examined and extensively photographed (Figures 11 thru 13) in the South High Bay. It was noted that portions of the observable surfaces evidenced a powdered deposit indicative of dried sediment. An external visual inspection of the coil conductor leads was unremarkable (Figures 14 and 15). A majority of the electromagnet was not visible due to the shields that cover the perimeter of the coil. These shields are welded to the upper and lower flanges of the mandrel. Nevertheless, areas of surface delamination and discoloration were observable in the gaps between the shields. Prior to removal of the shields, the lead-to-lead electrical coil resistance was measured with a Megger 10A DLRO micro-ohmmeter to be 5.942 milliohms on August 24, 2016. High-pot electrical tests at voltages ranging from 500 to 5,000 volts were performed and the data recorded for comparative purposes (Table 1). The shields were then removed with a die-grinder, thereby exposing the overall circumferential surface of the coil pack (Figures 16 thru 19). Blue tape was placed over sharp mandrel edges left by the grinder process as a safety precaution. High-pot electrical tests at voltages ranging from 500 to 5,000 volts were repeated on the shield-less coil on August 26, 2016 and compared to the previous tests. The comparison of the electrical tests was unremarkable (Table 1).

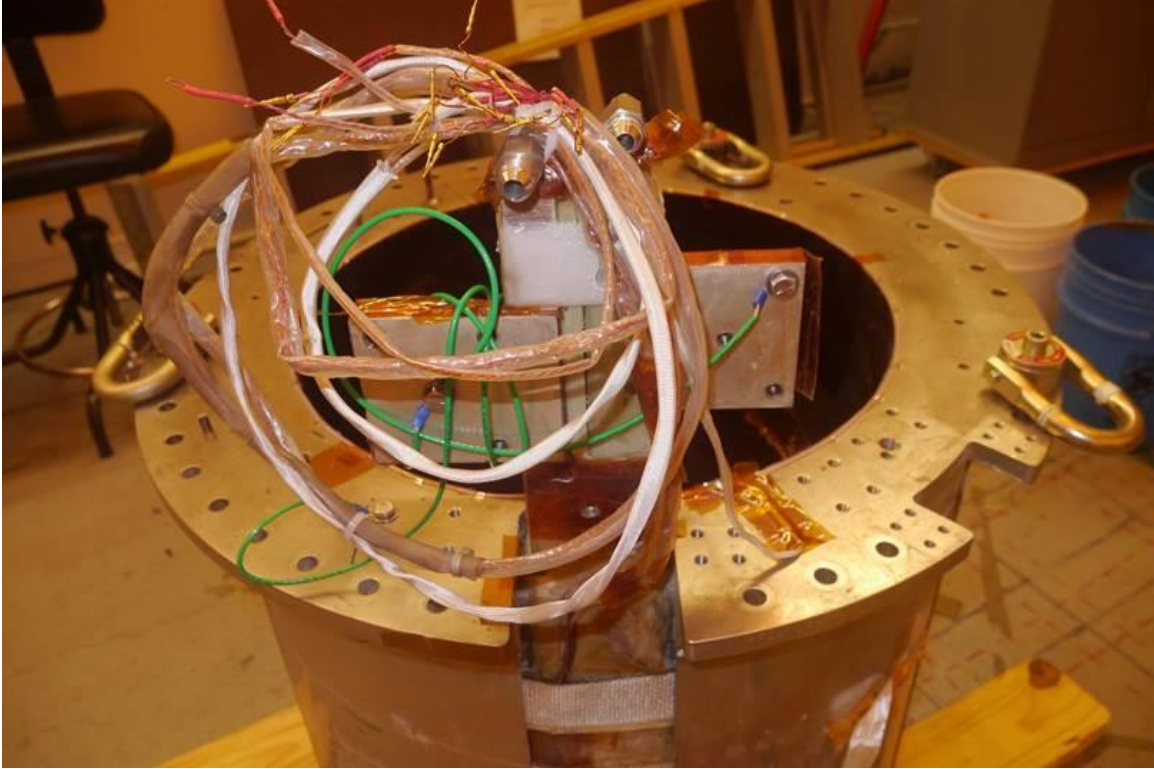
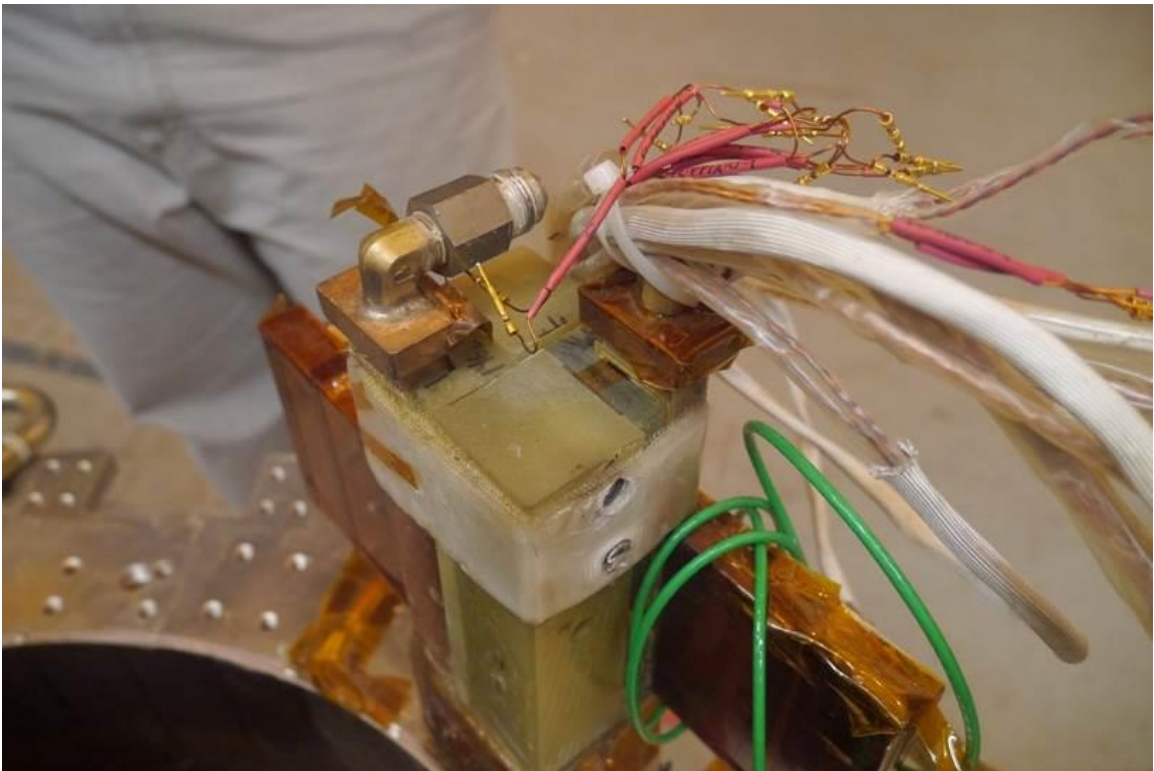
Figure 14 – PF1A-U Leads

Figure 15 – PF1A-U Leads

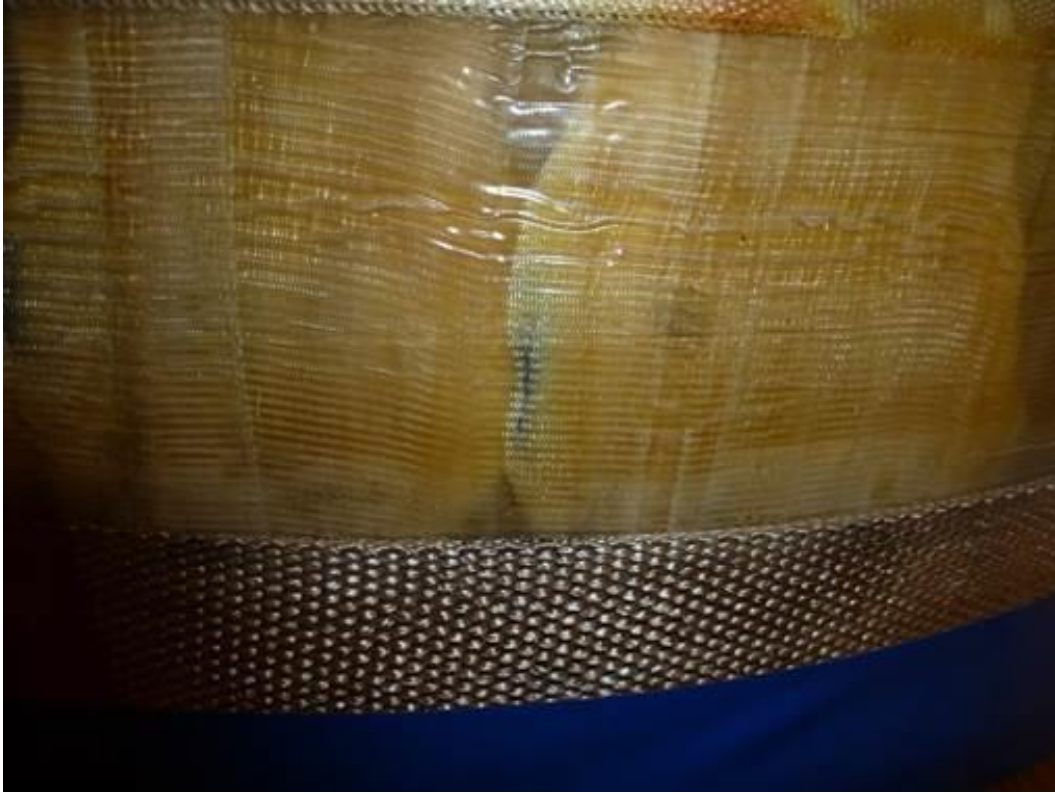
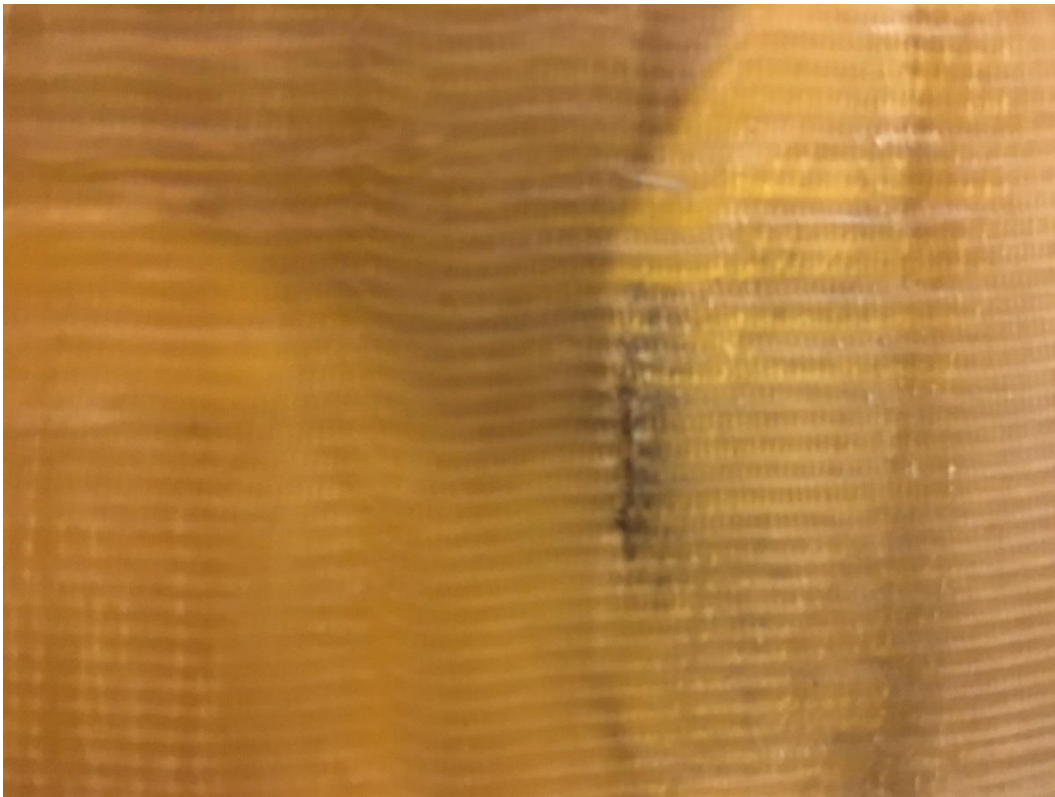
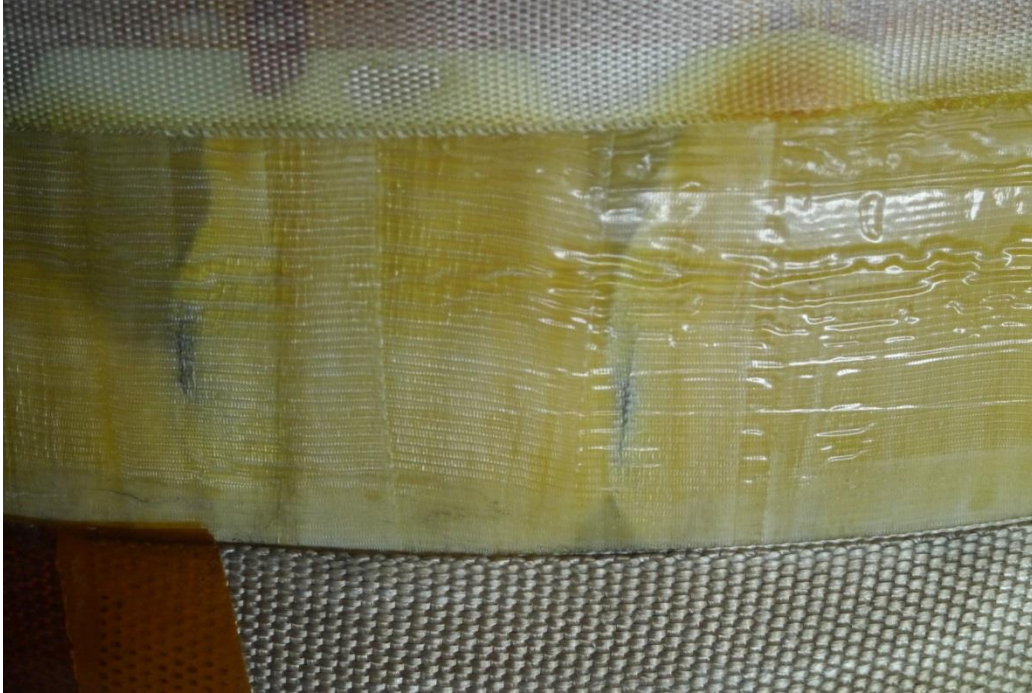
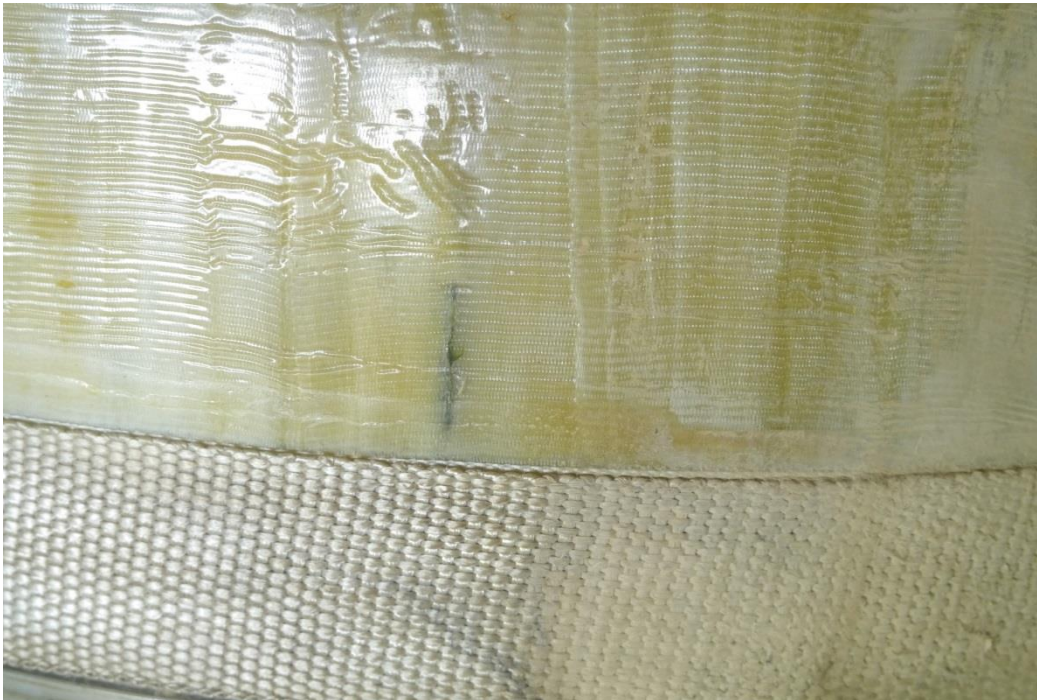
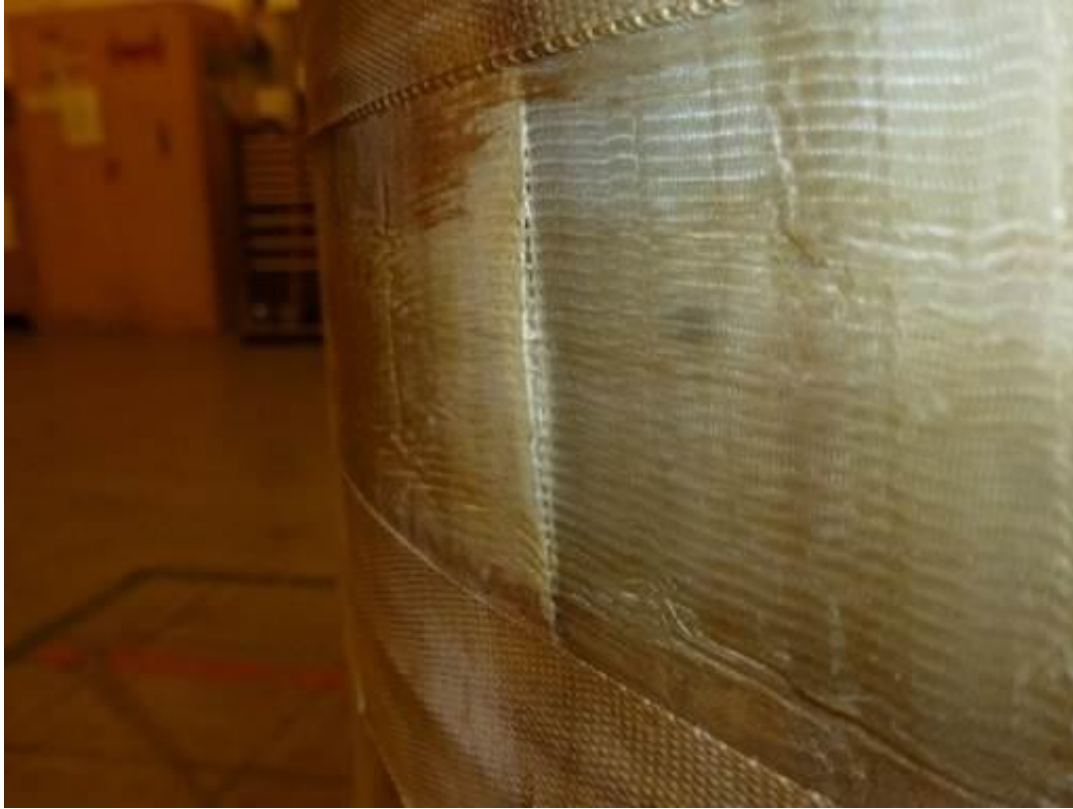
Figures 20 thru 24 illustrate focused views of the outside surface of PF1A-U coil. Short, dark vertical lines were observed that evidence separations/tears in the ground layer wrap. An internal coolant path leak in the electromagnet may communicate with these separations as potential exit points for coolant. Removal of the shields evidenced numerous ground wrap delamination areas identified by their lighter color and confirmed by lightly tapping the areas with a tool that audibly noted hollows beneath the ground layer.

Figure 20 – PF1A-U ground wrap delamination

Figure 21 – PF1A-U ground wrap delamination

Figure 22 – PF1A-U ground wrap delamination

Figure 23 – PF1A-U ground wrap delamination

Figure 24 – PF1A-U ground wrap delamination

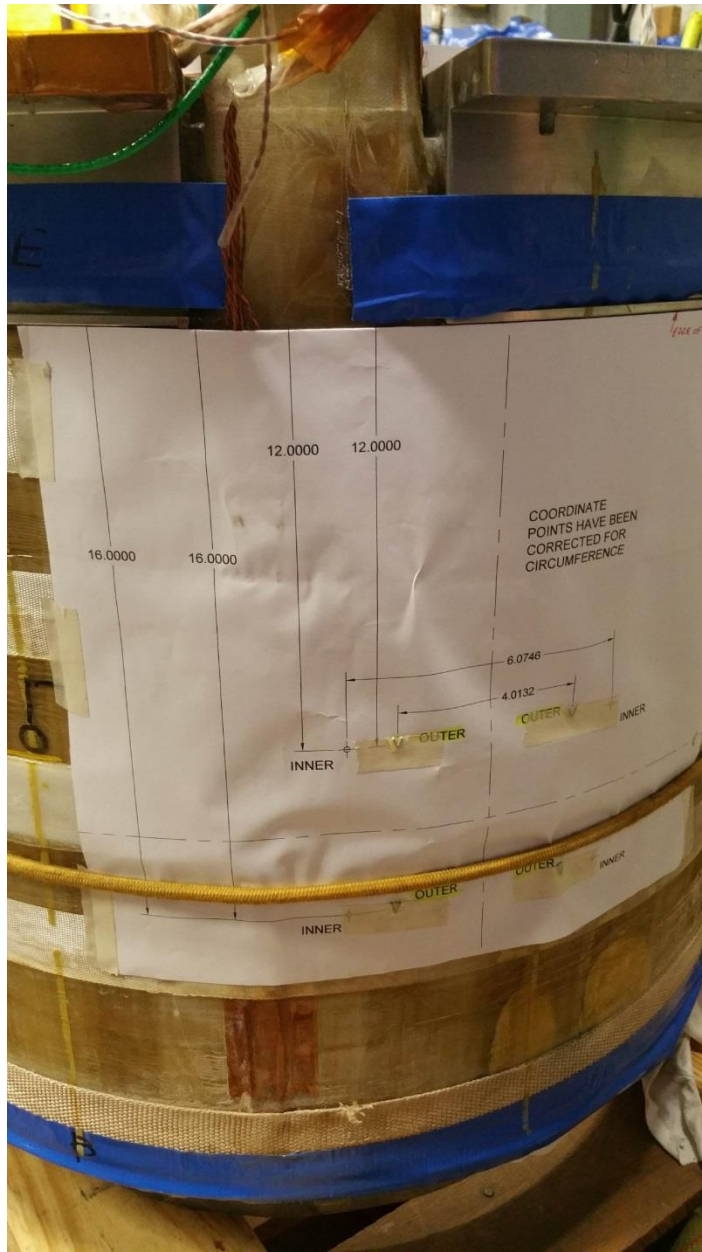
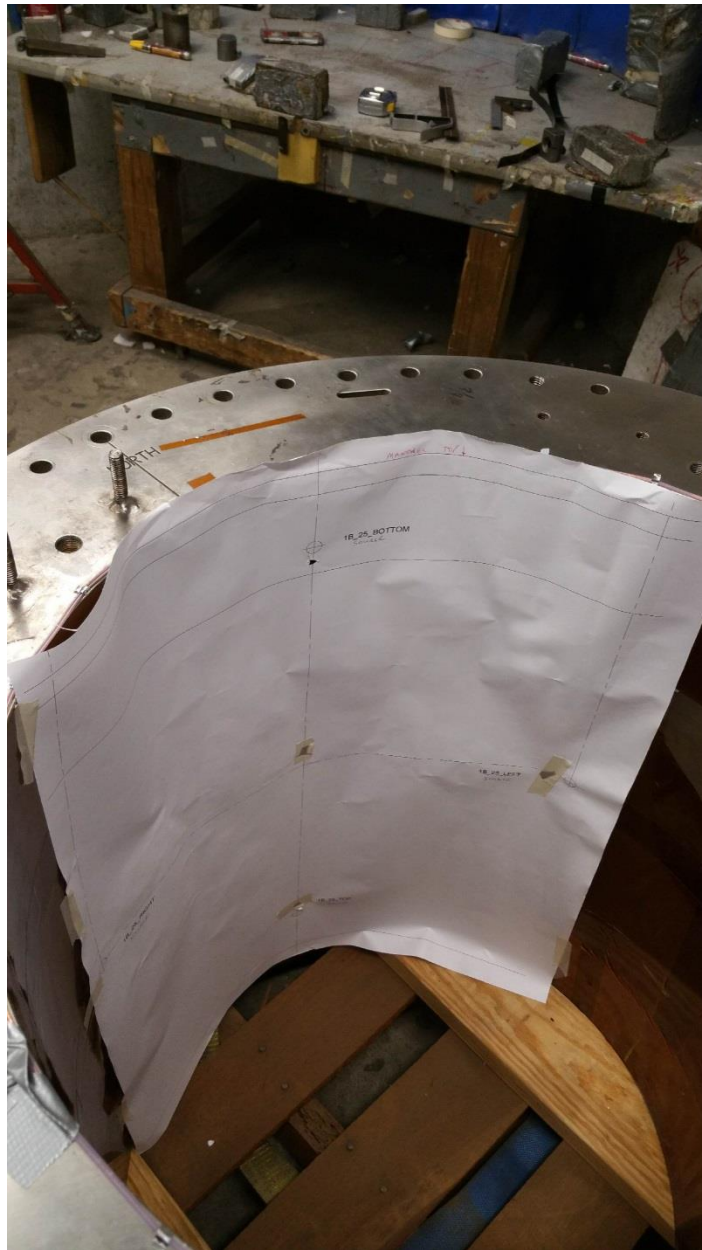
On September 8, 2016, Petrella again traveled to Mistras to observe a re-survey of the anomalous region and employ a triangulation analysis method developed at PPPL for determination of the radial position of the anomalies. Scale paper templates were used to position reference indices and the iridium-192 radioisotope source to create an intentional 25-degree parallax of the anomalous region (Figures 31 thru 32). A total of thirteen (13) new images were recorded and were indexed in a similar fashion to the previous radiograph images with scale reference and the addition of a parallax notation. The scaled images were digitally imported into an AutoCAD drawing. The anomalous regions angularly proximal to the lead-in/out area were divided into visually perceivable density variations "alpha" through "epsilon". In-line braze joint number two (2) was visible in the imaging and was also included in the triangulation analysis. Circles

Figure 31 – Outer radius triangulation template for anomalous region 0_1A

Figure 32 – Inner radius triangulation template for anomalous region 0_1A

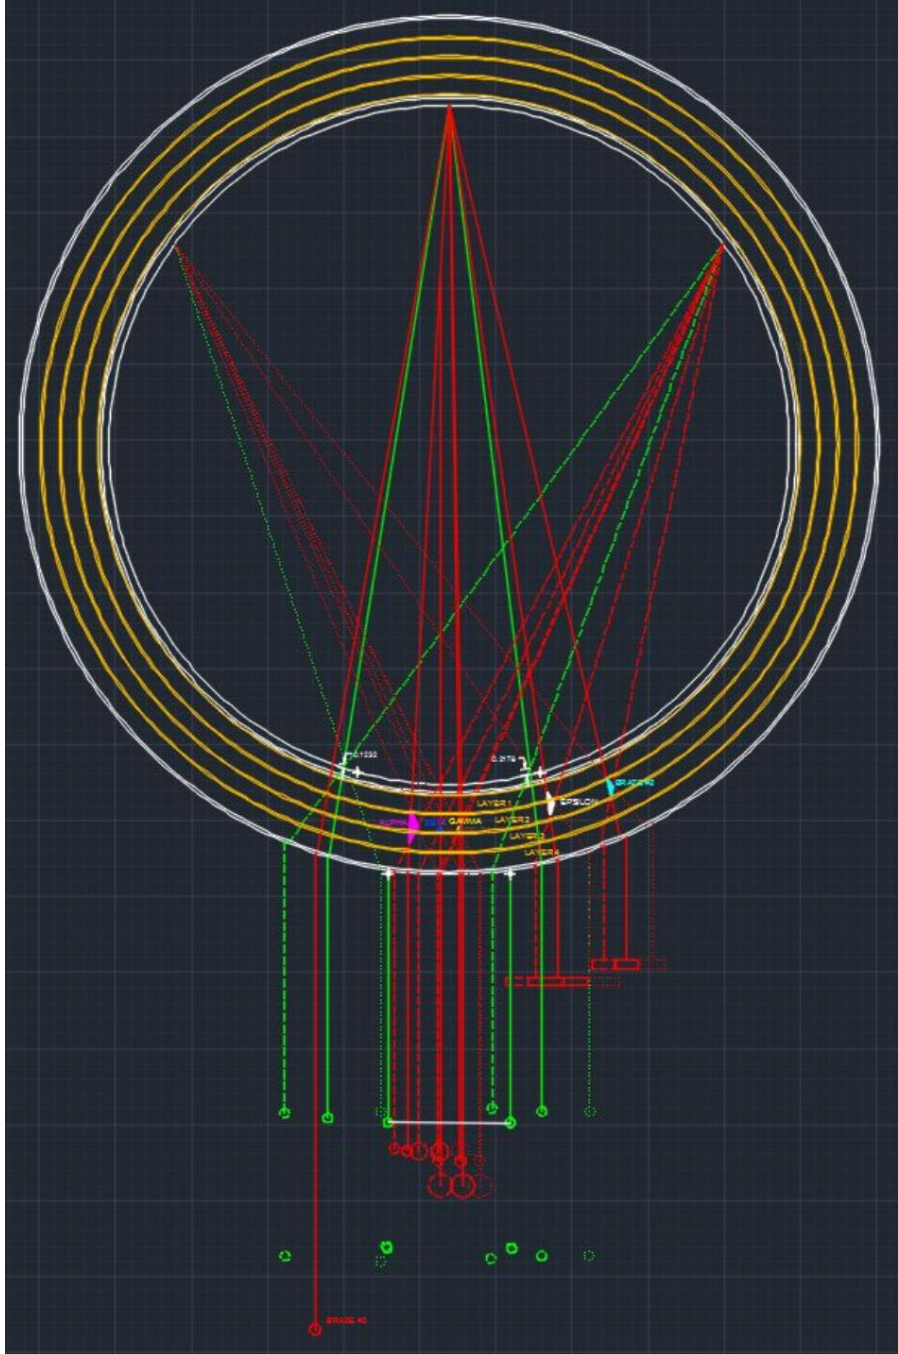
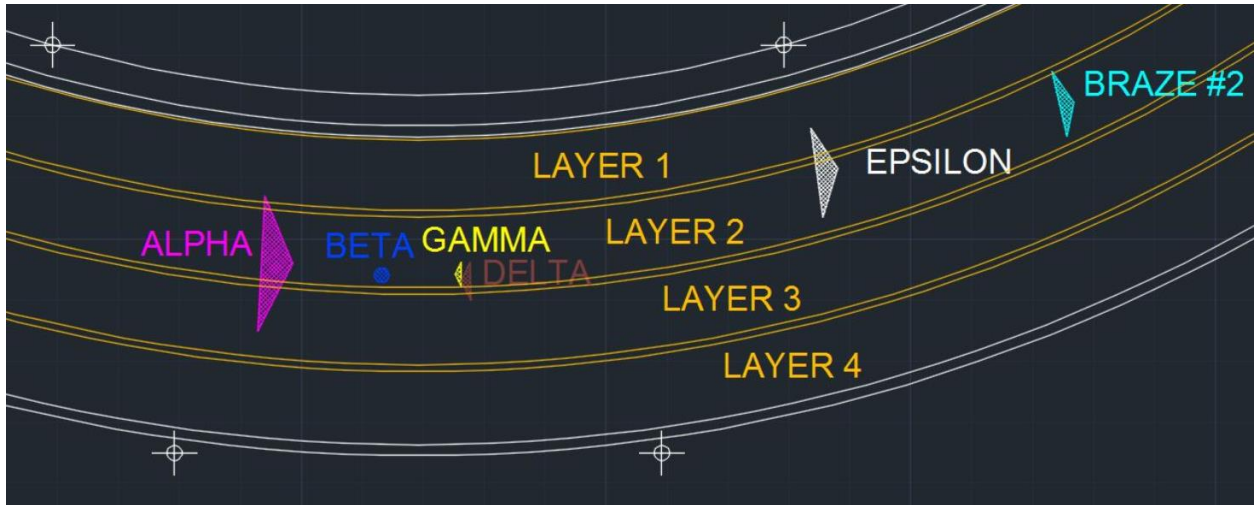
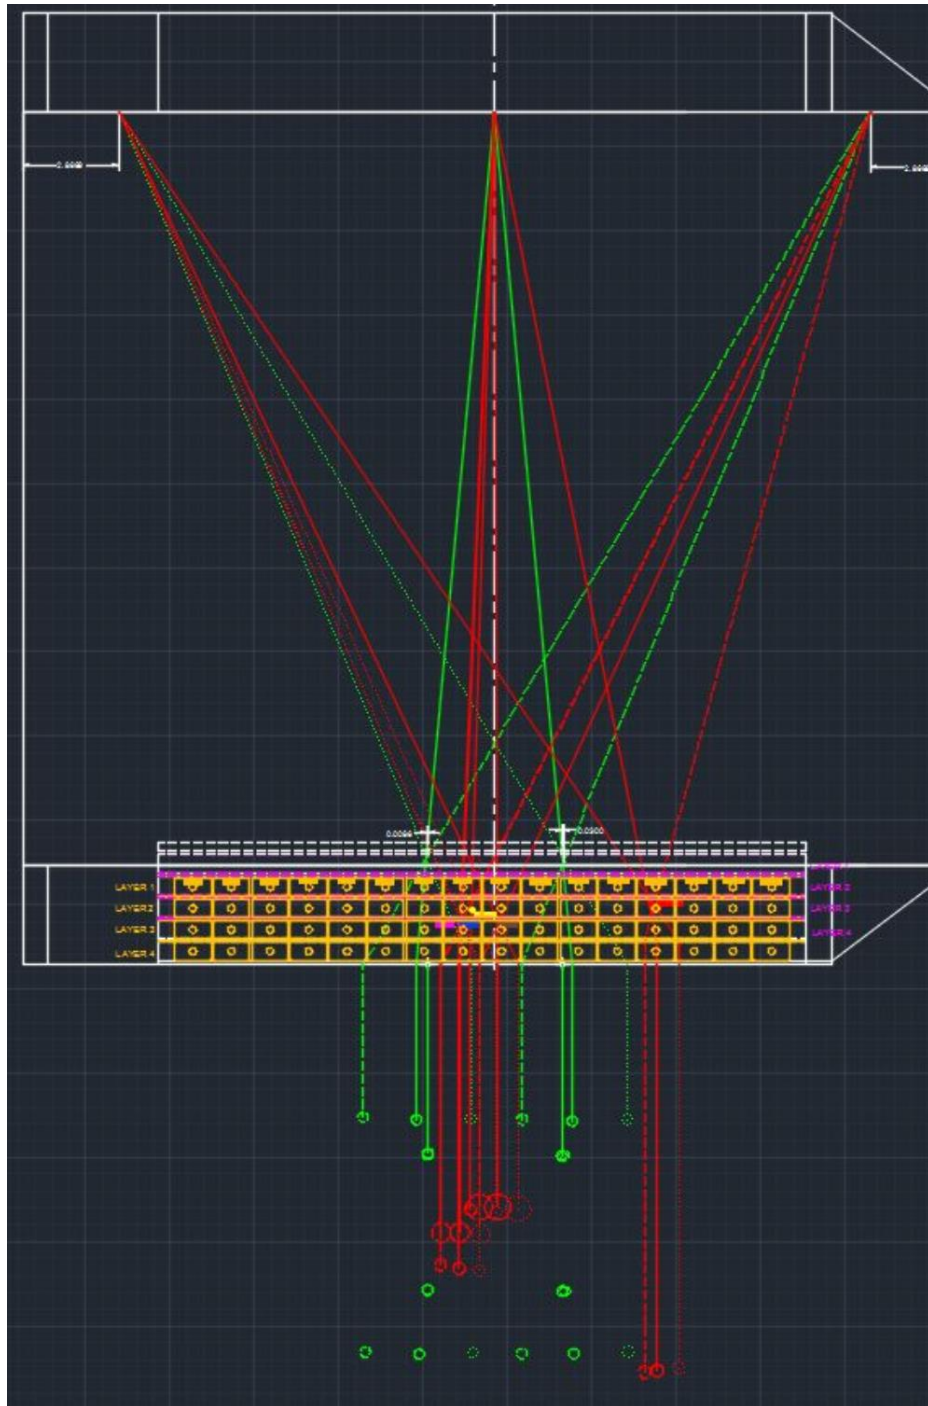
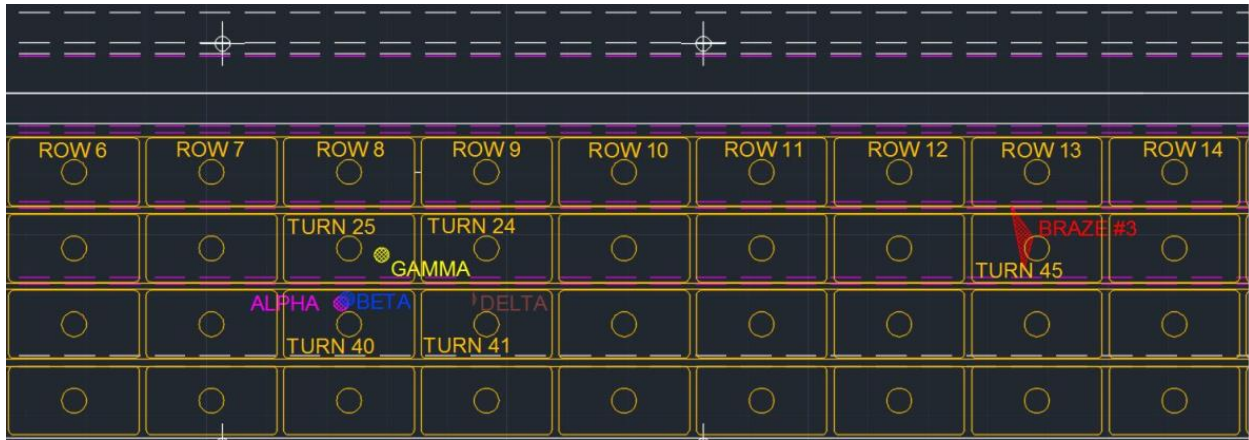
and rectangles were drawn over the observed density variations to optically determine an approximate center point reference for each area (Figure 33). A triangulation analysis was performed to determine proximate radial positions of the observed anomalies (Figures 34 thru 37). The analysis indicated that the regions alpha through gamma were proximal to conductor rows eight (8) and nine (9), and between conductor layers two (2) and three (3). The analysis also indicated that braze joint number two (2) was radially proximal to layer two (2). This geometric approximation corresponded to the ETI MPO [6] documentation for braze joint number two (2), validating the radial positional interpolation of regions alpha through epsilon.

Figure 34 – AutoCAD-based triangulation of anomalous region 0_1A

Figure 35 – AutoCAD-based triangulation of anomalous region 0_1A

Figure 36 – AutoCAD-based triangulation of anomalous region 0_1A

Figure 37 – AutoCAD-based triangulation of anomalous region 0_1A
