Forensic Analysis of the NSTX-U PF1A-Upper Coil Failure

Rev. 0

November 18, 2016

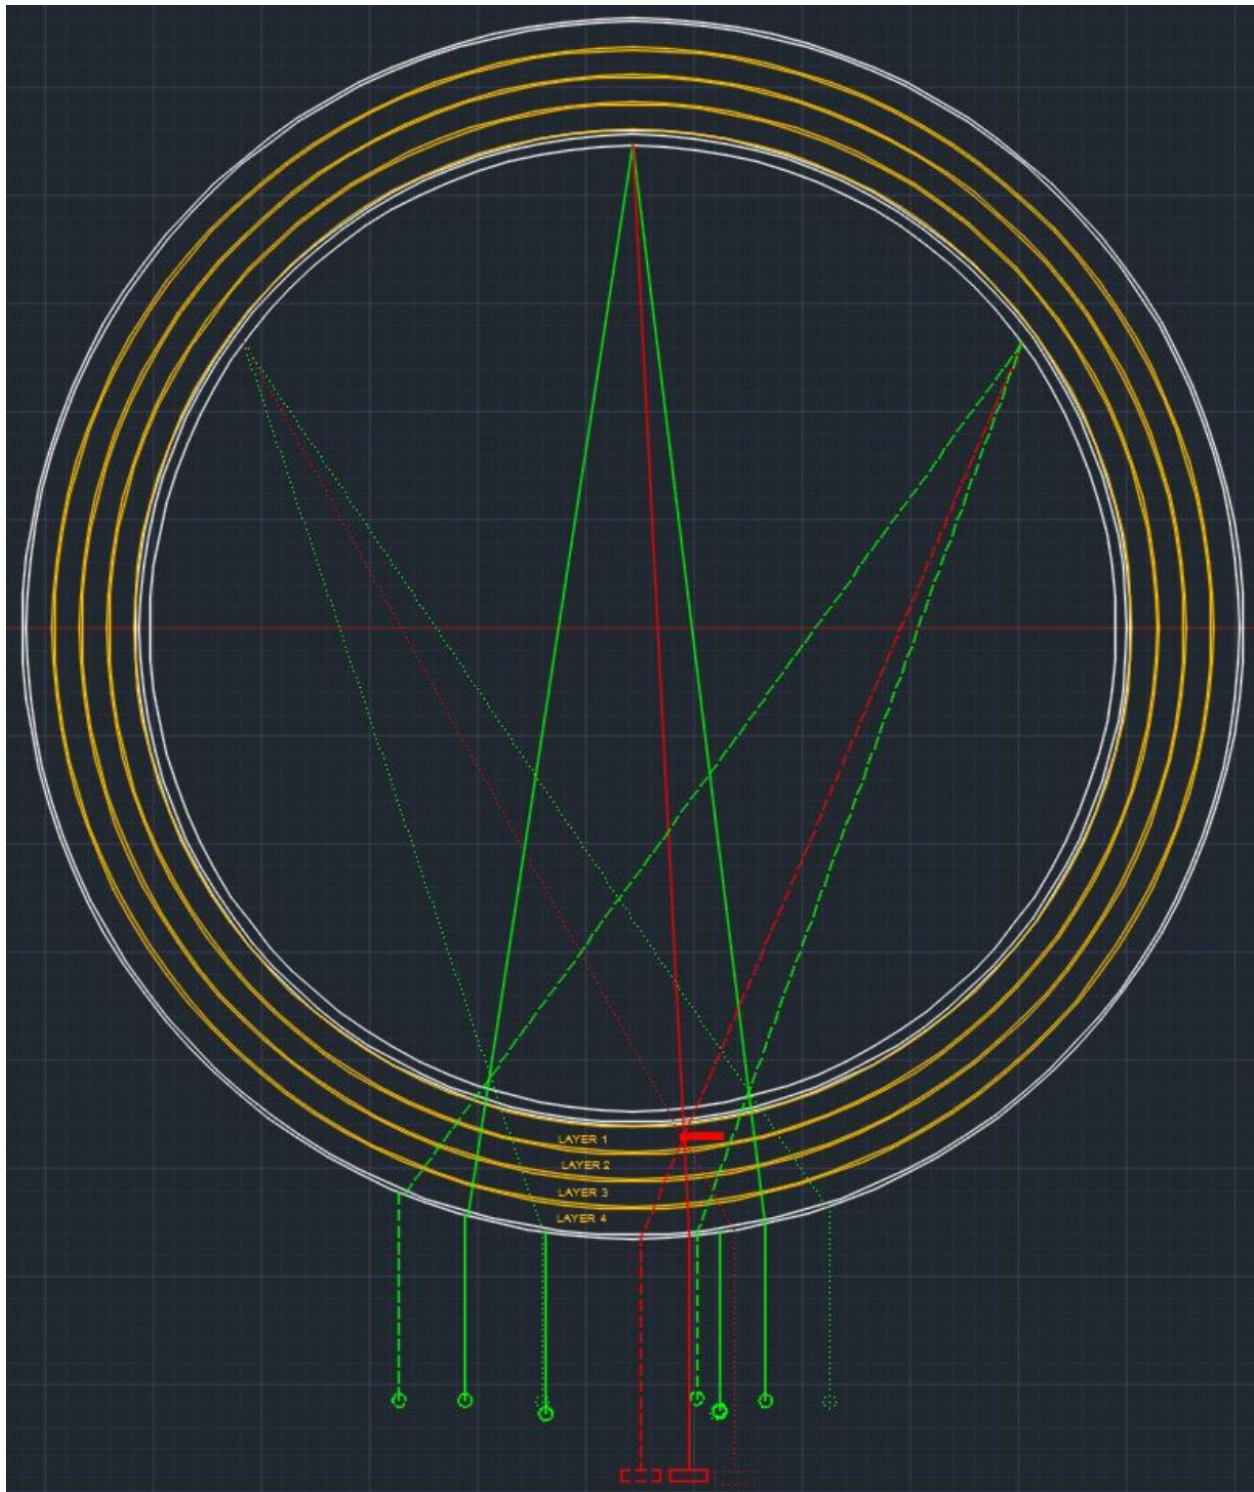
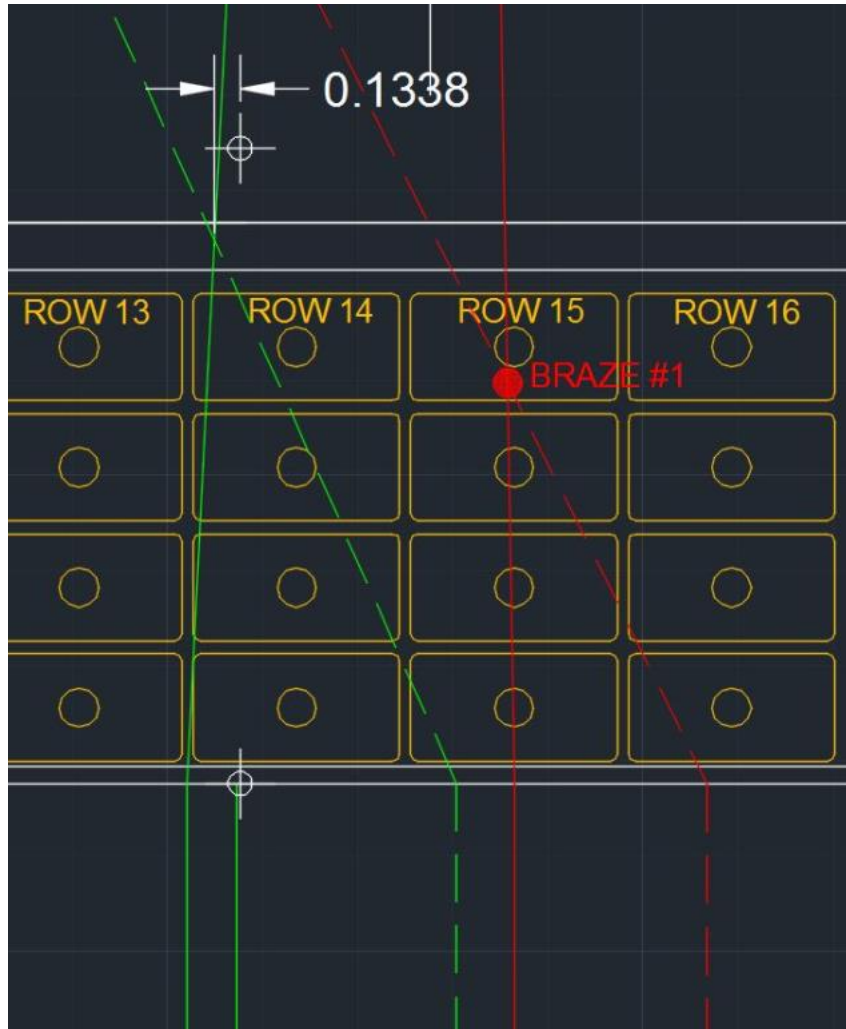
Further validation of the triangulation method was performed by surveying in-line braze joint number one (1) with the triangulation approach and comparing the results with the ETI MPO. The geometric approximation using the triangulation imaging technique proximally identified braze joint number one (1) in the reported radial position, thereby further validating the triangulation method used (Figure 38 and 39).

Figure 38 – AutoCAD-based triangulation of Braze Joint #1

Figure 39 – AutoCAD-based triangulation of Braze Joint #1

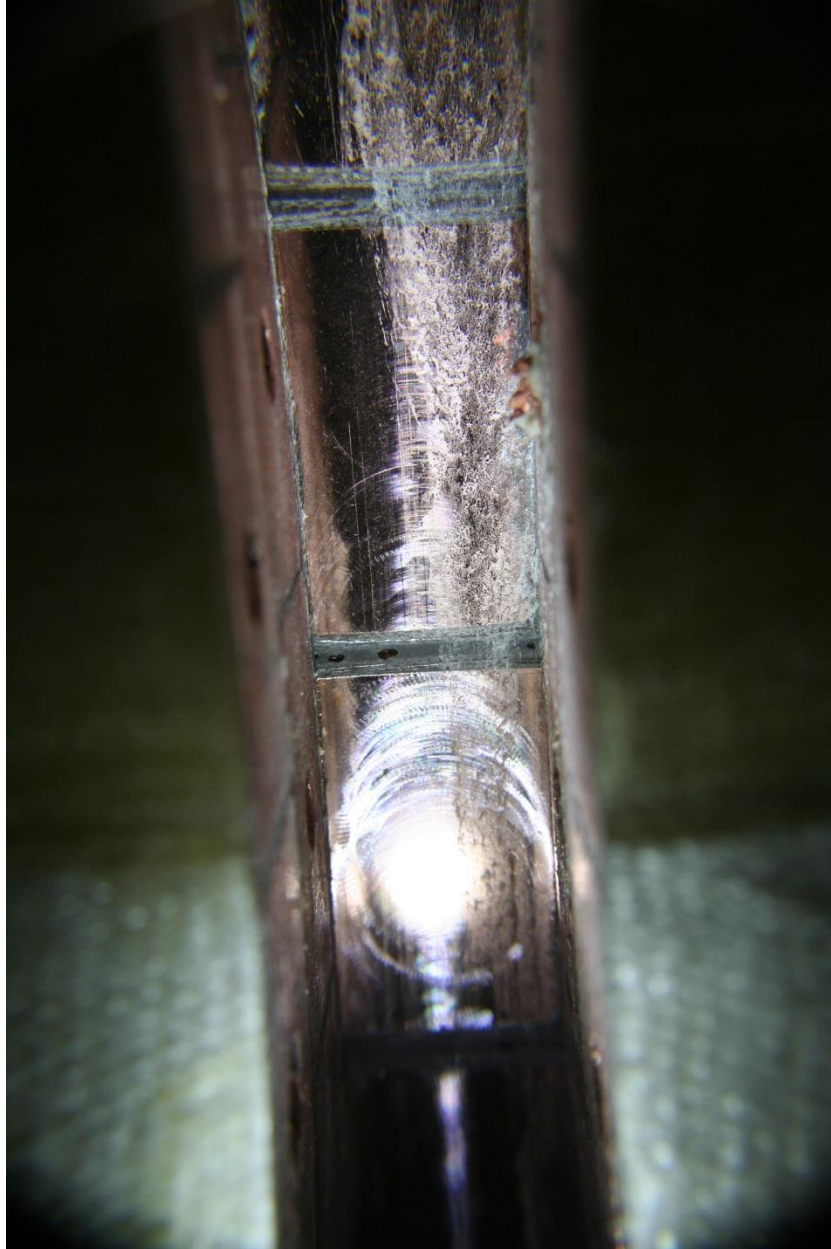
Cutting Plane A	Voids in the turn-to-turn insulation layer	Figures 44-45
Cutting Plane A	Voids in the insulation layer proximal to the bottom row	Figure 46
Cutting Plane A	Ballooning of the half-lap insulation layer	Figure 47

Figure 44 – Cutting Plane A void

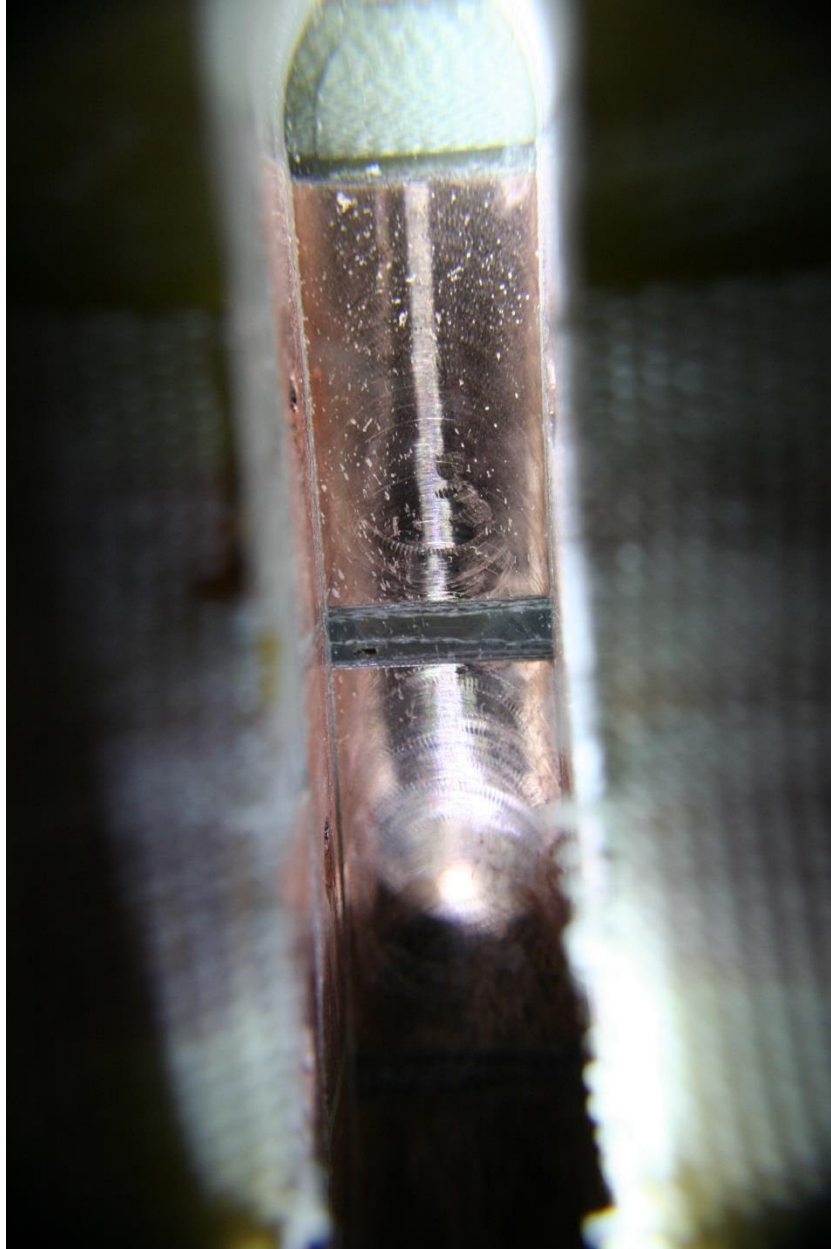
Figure 47 – Cutting Plane A half-lap ballooning

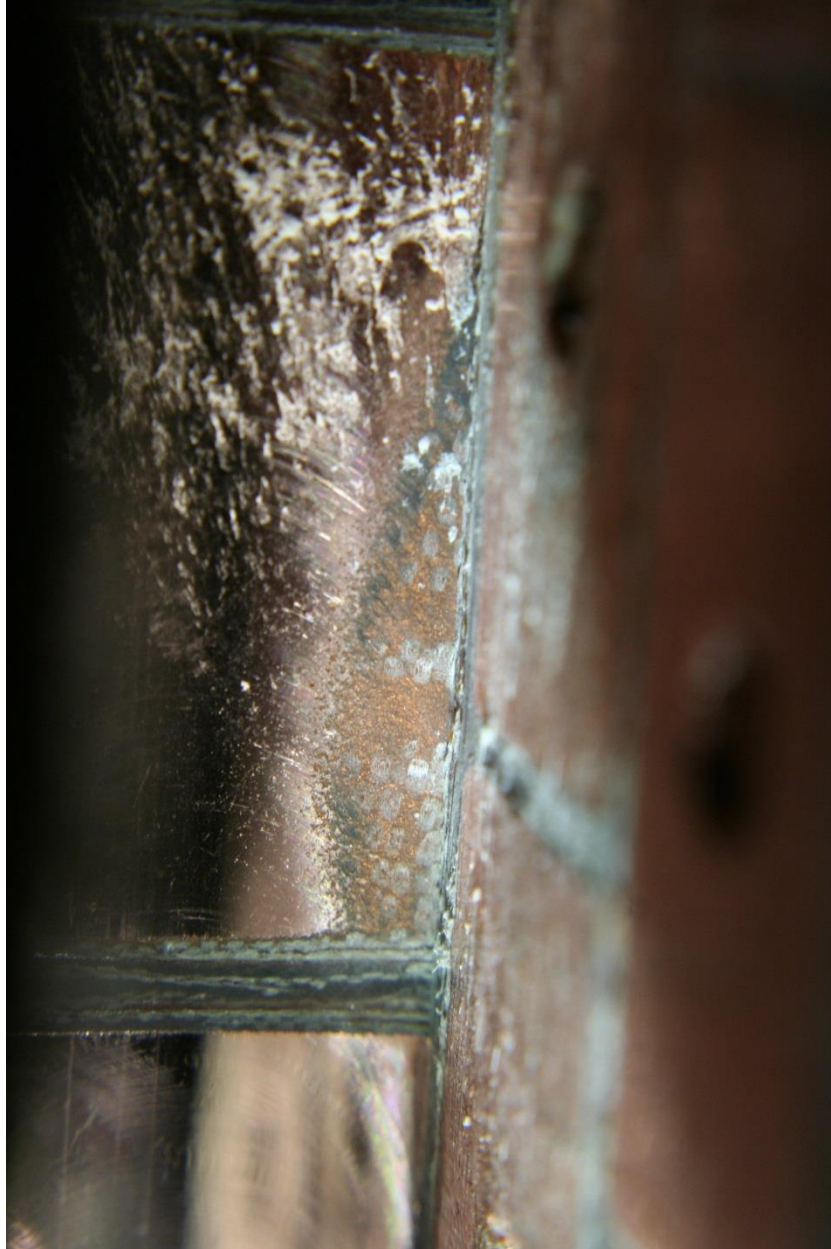
Figure 48 – Cutting Plane A adhesion issue

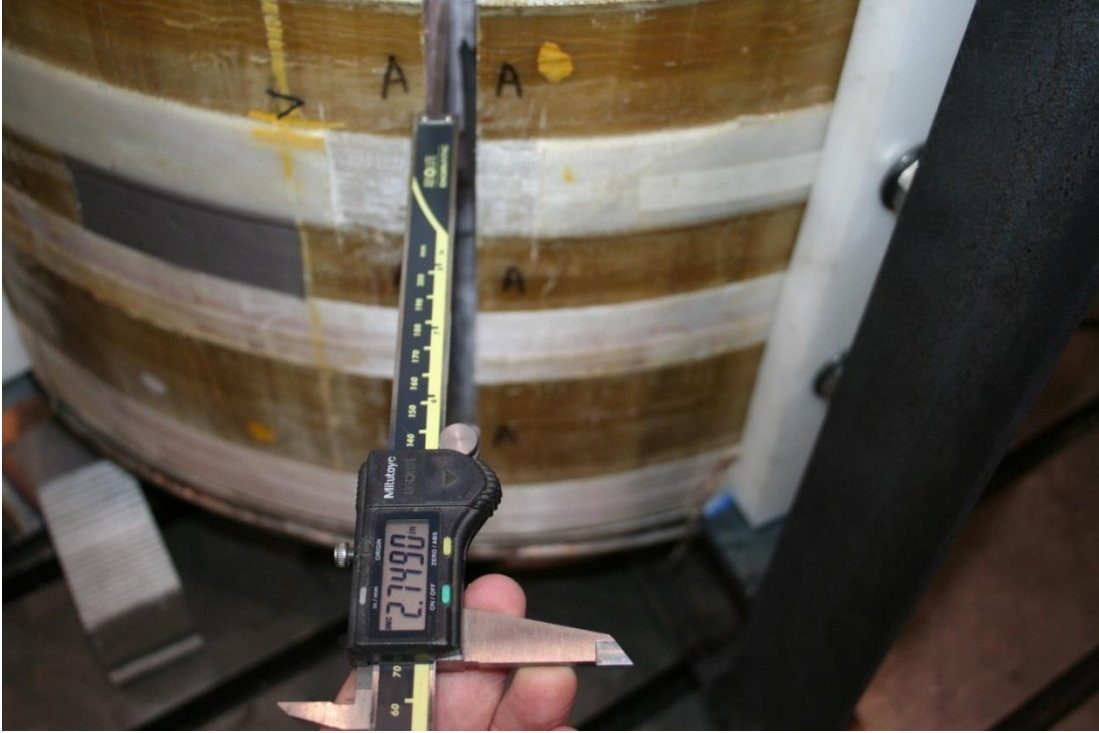
Figure 49 – Cutting Plane A coil pack depth

Cutting Plane A	Probable lack of adhesion of insulation layer to primed conductor	Figure 48
Cutting Plane A	Exterior ground-wrap to mandrel depth: approximately conductor row 1, conductor row 7, conductor row 16	Figures 49-51
Cutting Plane B	Resin rich area with crack/void in insulation space	Figures 52-53
Cutting Plane B	Delaminated and un-wetted insulation layer between conductor layers 2 and 3	Figure 54
Cutting Plane B	Unwetted insulation glass fibers between conductor layers 2 and 3	Figure 55
Cutting Plane B	Samples collected from delaminated insulation layer between conductors layers 2 and 3	Figures 56-58
Cutting Plane B	Debris observed suspended on surface of conductor layer 2 (from behind removed sample at 5")	Figure 59
Cutting Plane B	Discolored area proximal to rows 14-16 on the surface of layer 2	Figure 60
Cutting Plane B	Delamination gap and depth measurements	Figures 61-63
Cutting Plane B	Insulation void/crack at bottom of conductor layer 3	Figure 64

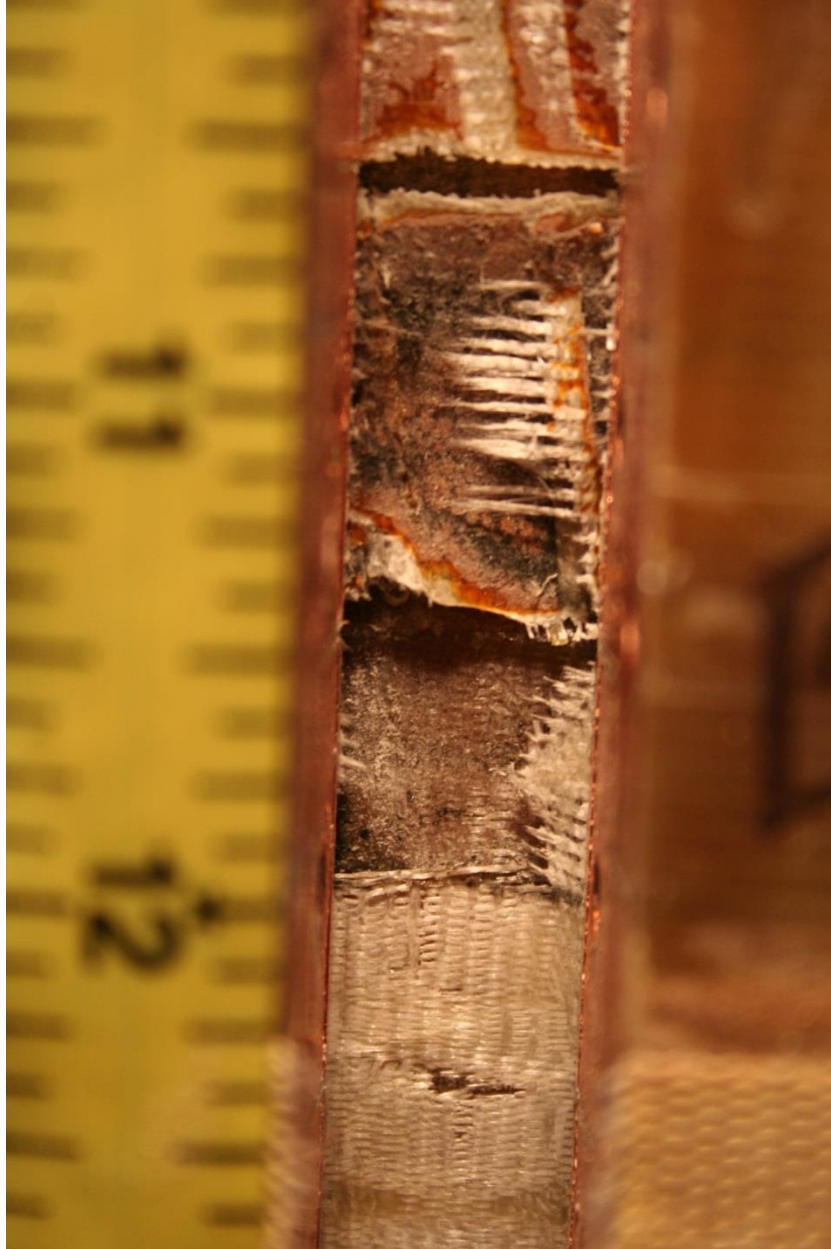
Figure 55 – Cutting Plane B unwetted region

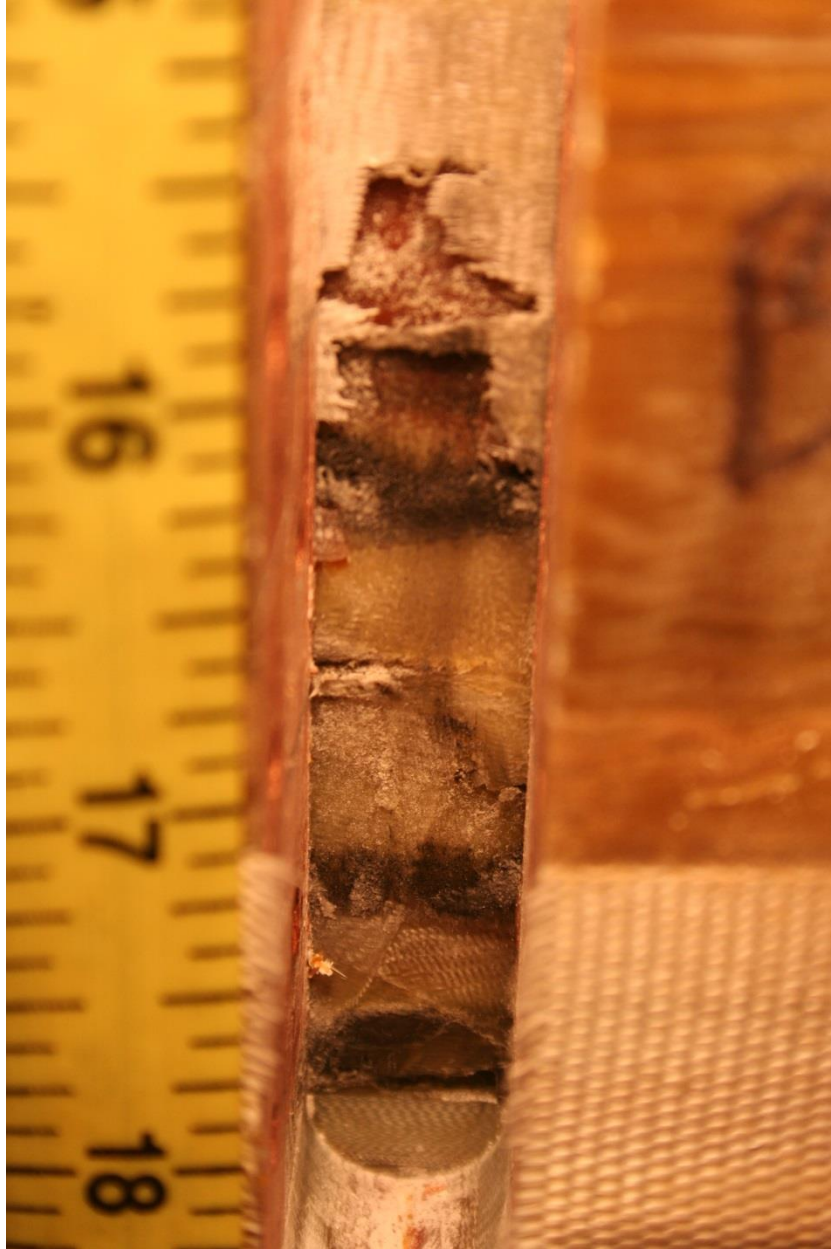
Figure 60 – Cutting Plane B discolored area

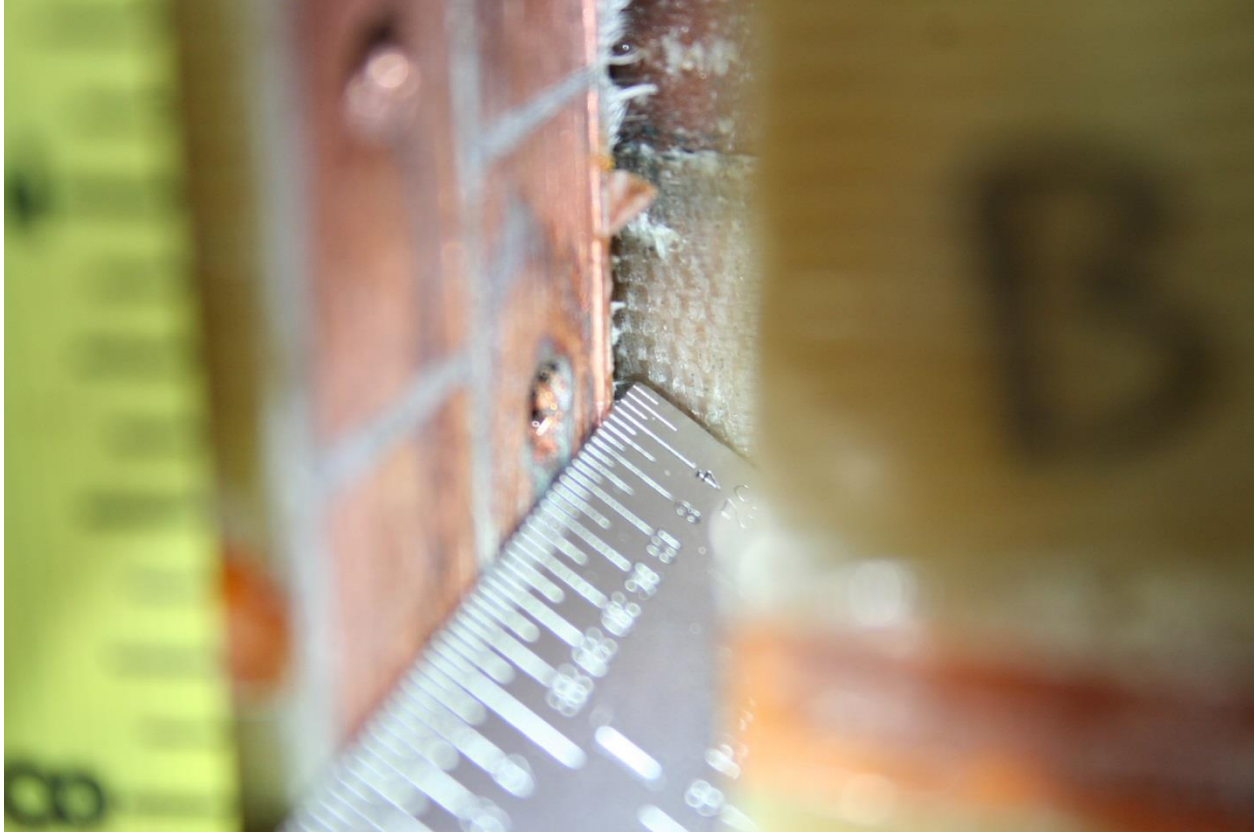
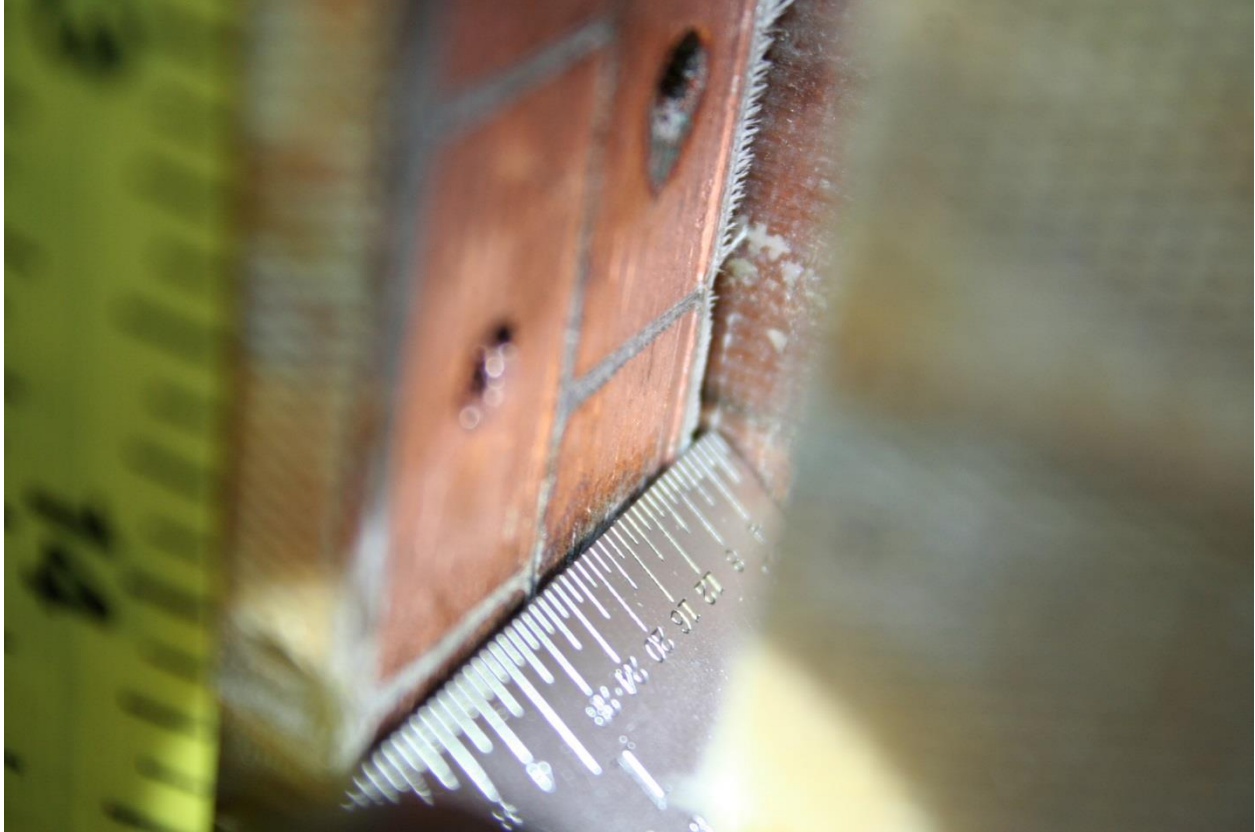
Figure 61 – Cutting Plane B gap measurements

Figure 62 – Cutting Plane B gap measurements

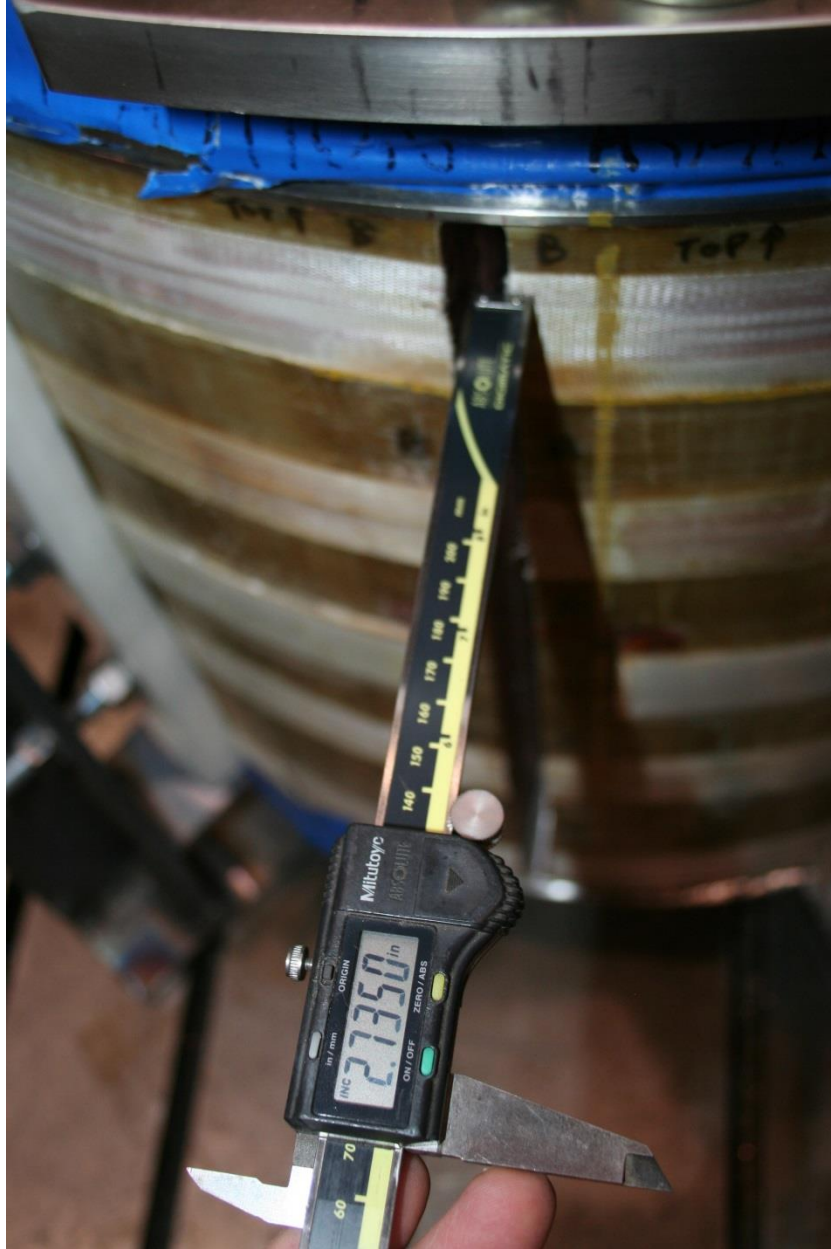
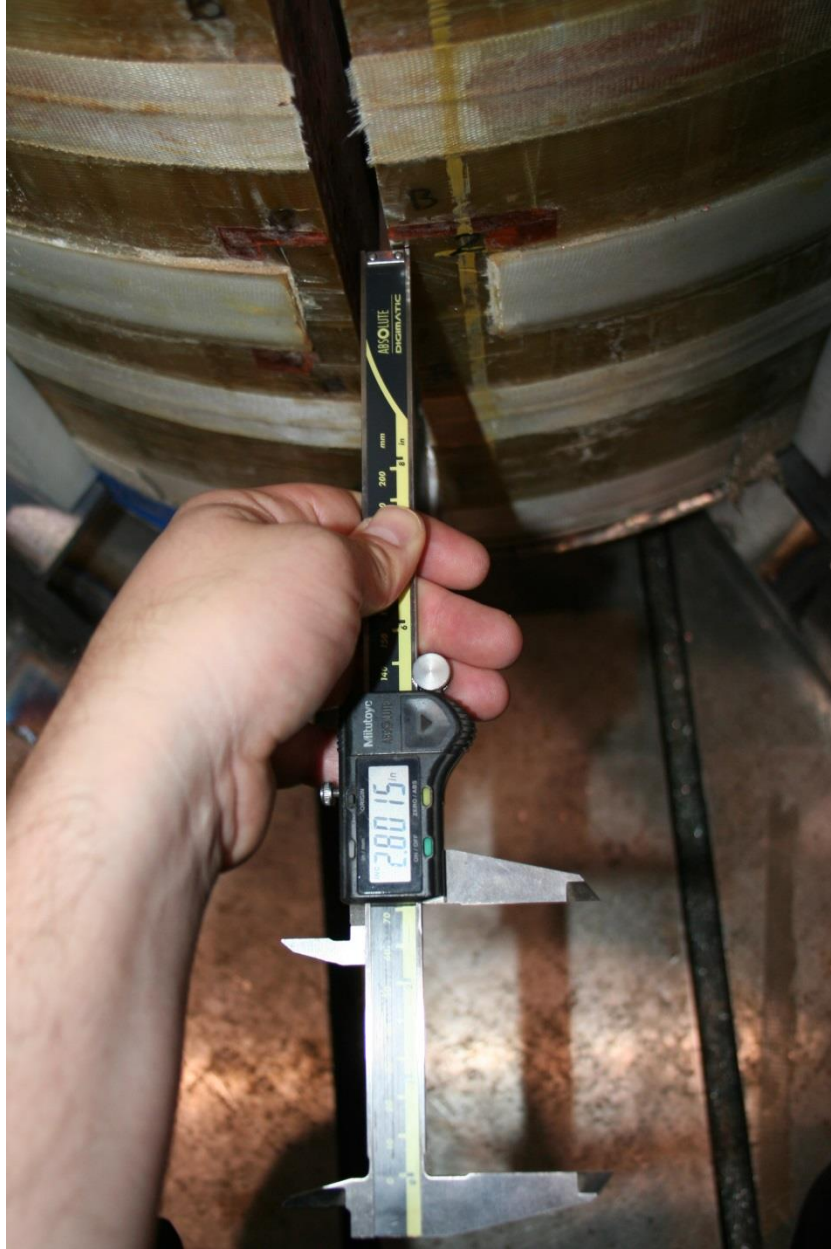
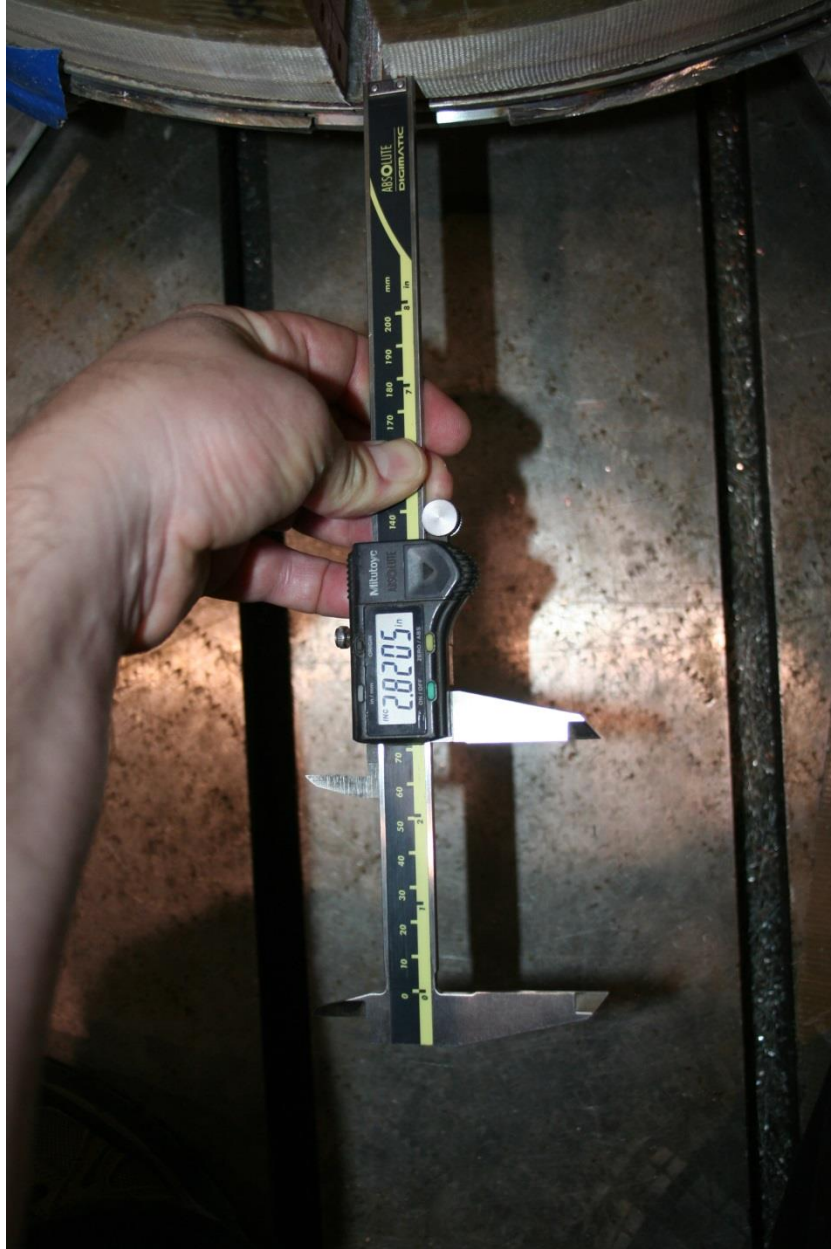
Cutting Plane B	Exterior ground-wrap to mandrel depth: approximately conductor row 1, conductor row 7, conductor row 16	Figures 65-67
Cutting Plane C	Exterior ground plane insulation delamination	Figures 68-69
Cutting Plane C	Conductor layer 3 to layer 4 transition	Figure 70
Cutting Plane C	Exterior ground-wrap to mandrel depth: approximately conductor row 1, conductor row 7, conductor row 16	Figures 71-73

Figure 65 – Cutting Plane B coil pack depth

Figure 66 – Cutting Plane B coil pack depth

Figure 67 – Cutting Plane B coil pack depth

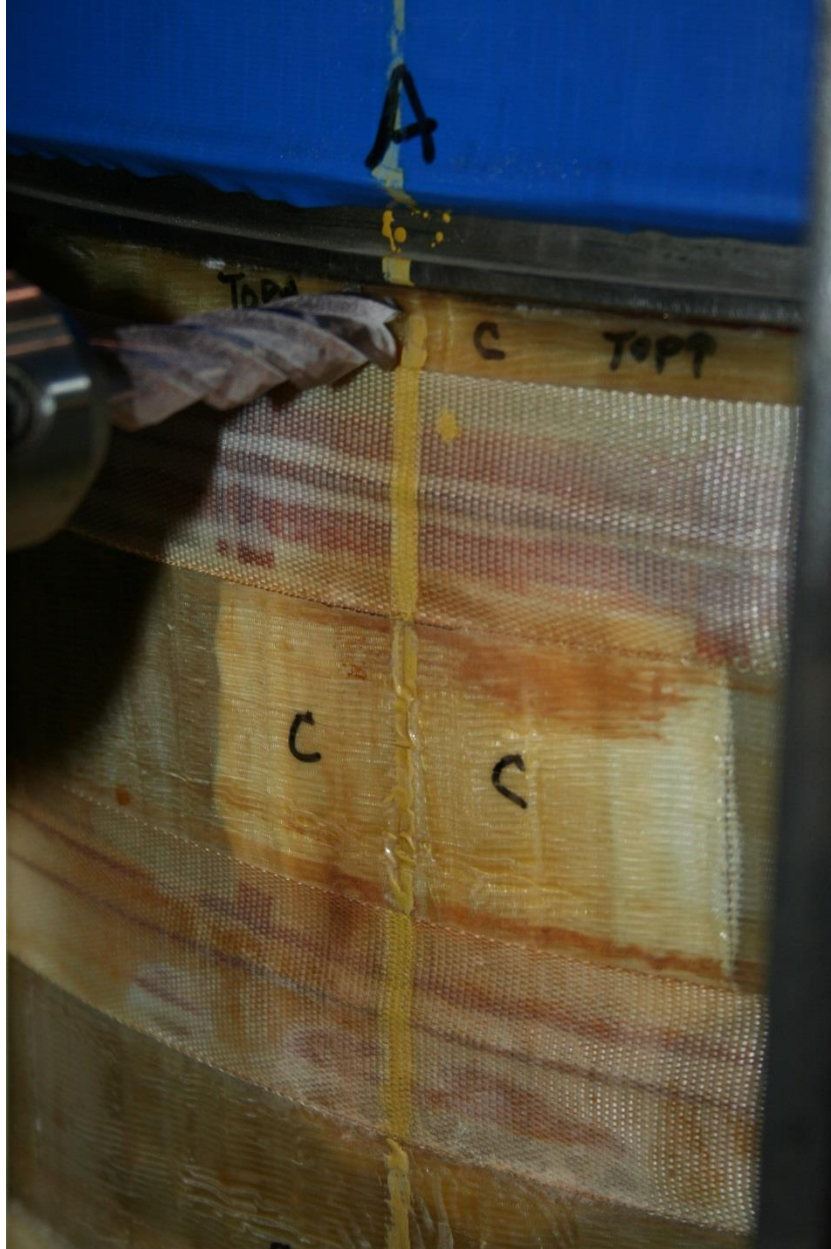
Figure 68 – Cutting Plane C ground wrap delamination

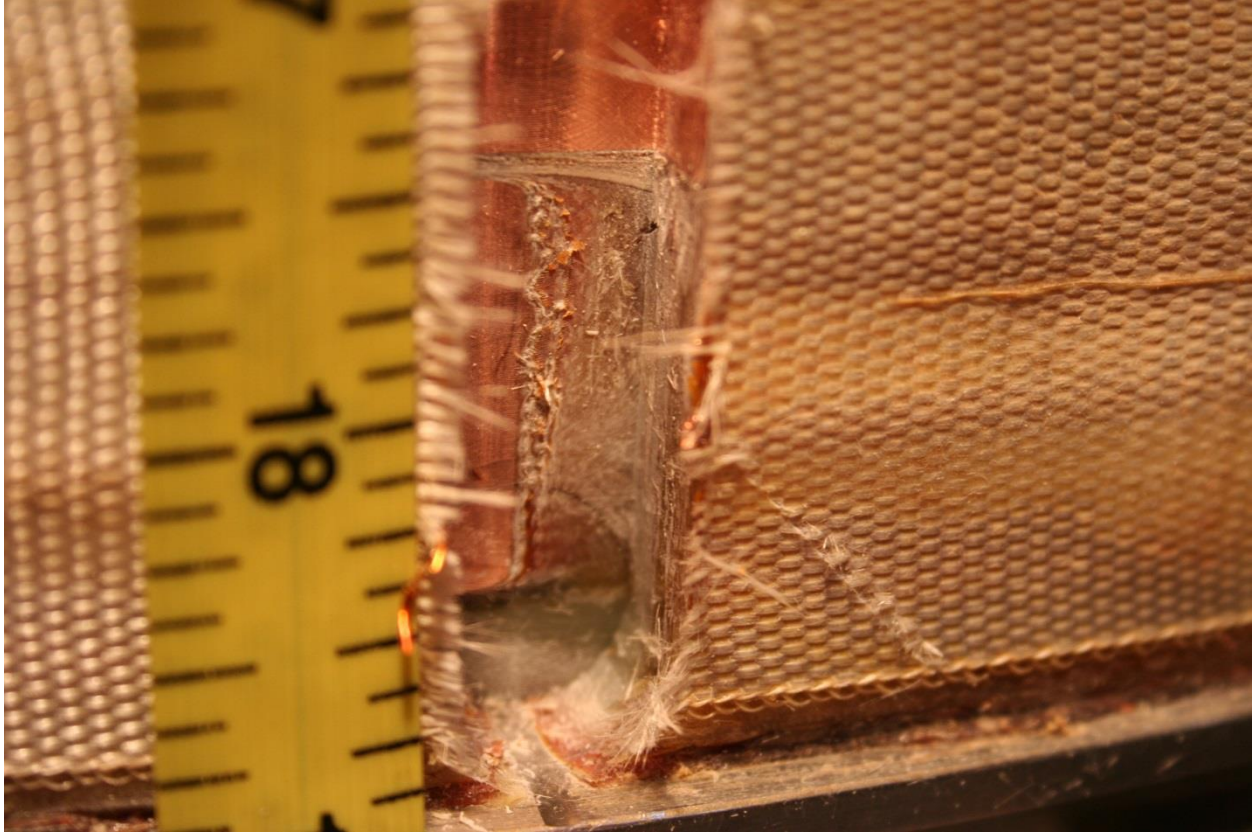
Figure 70 – Cutting Plane C layer 3 to 4 transition

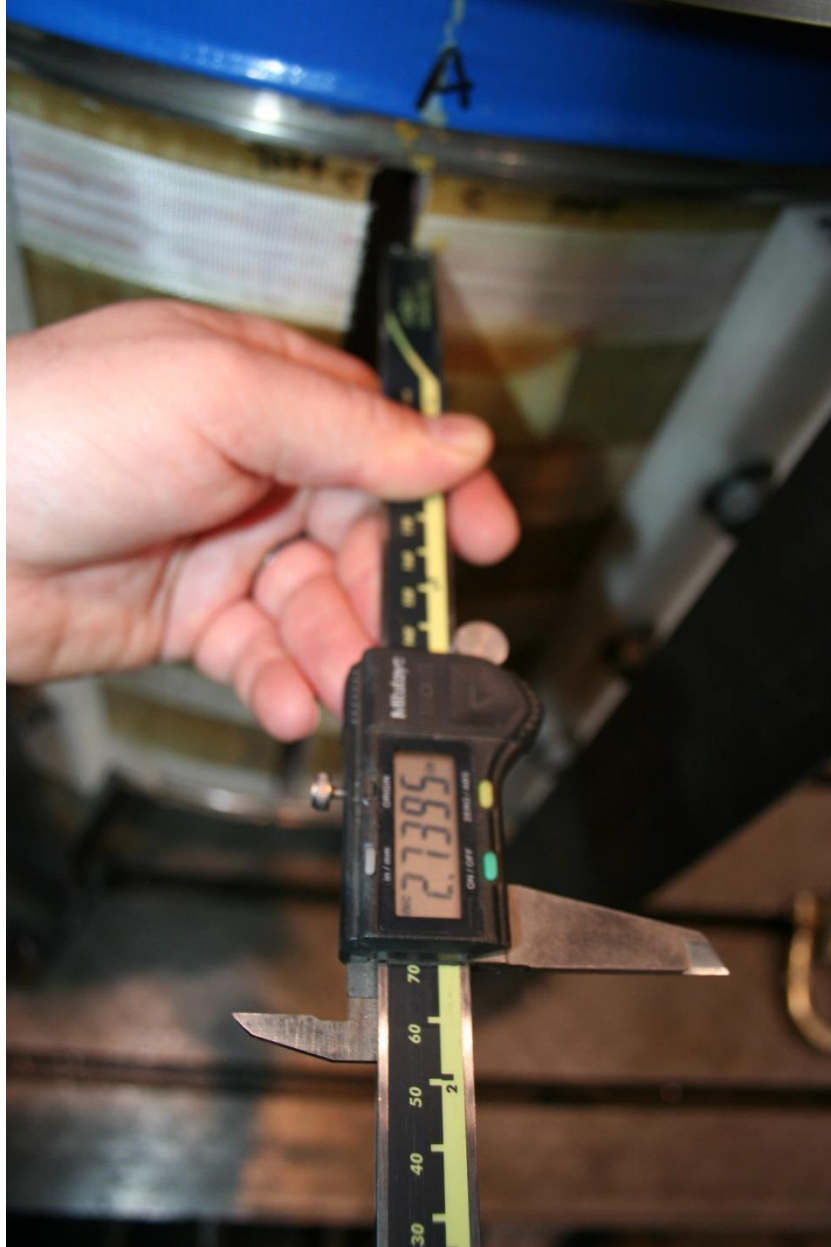
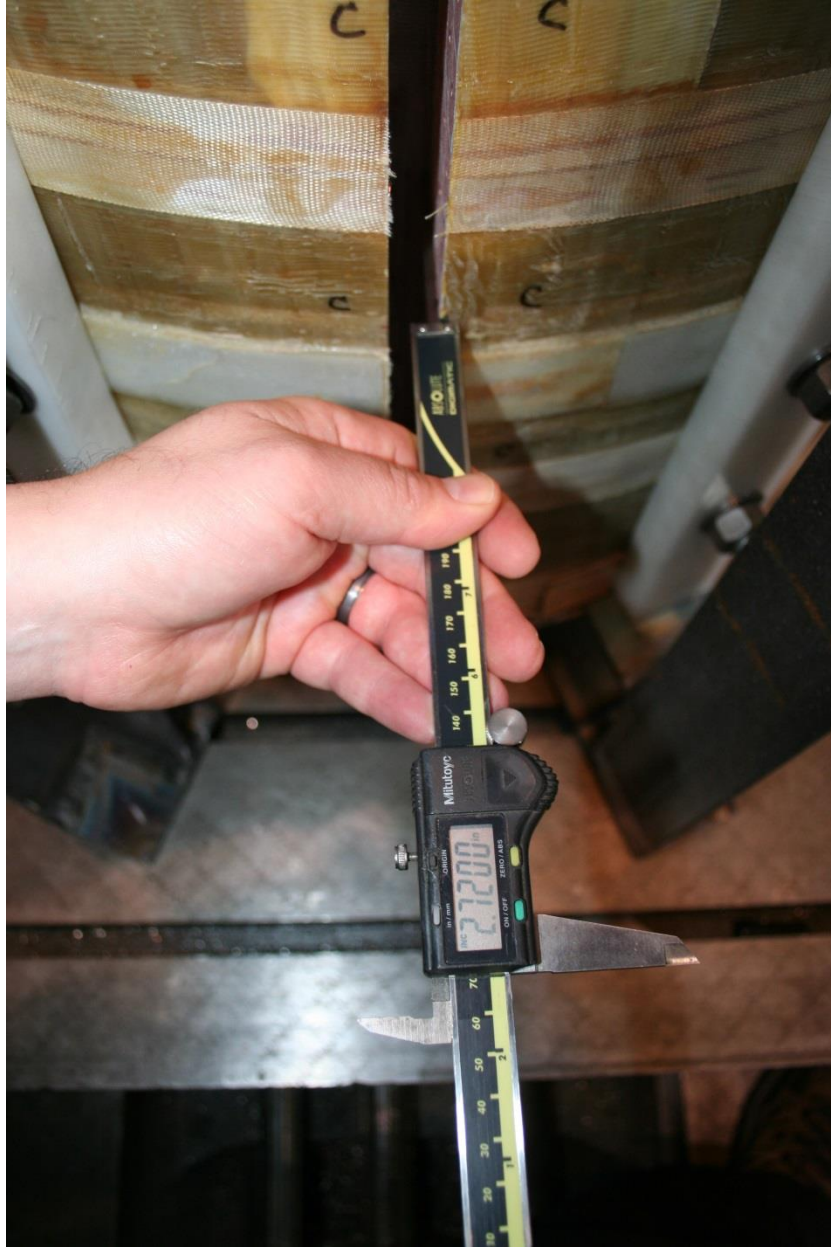
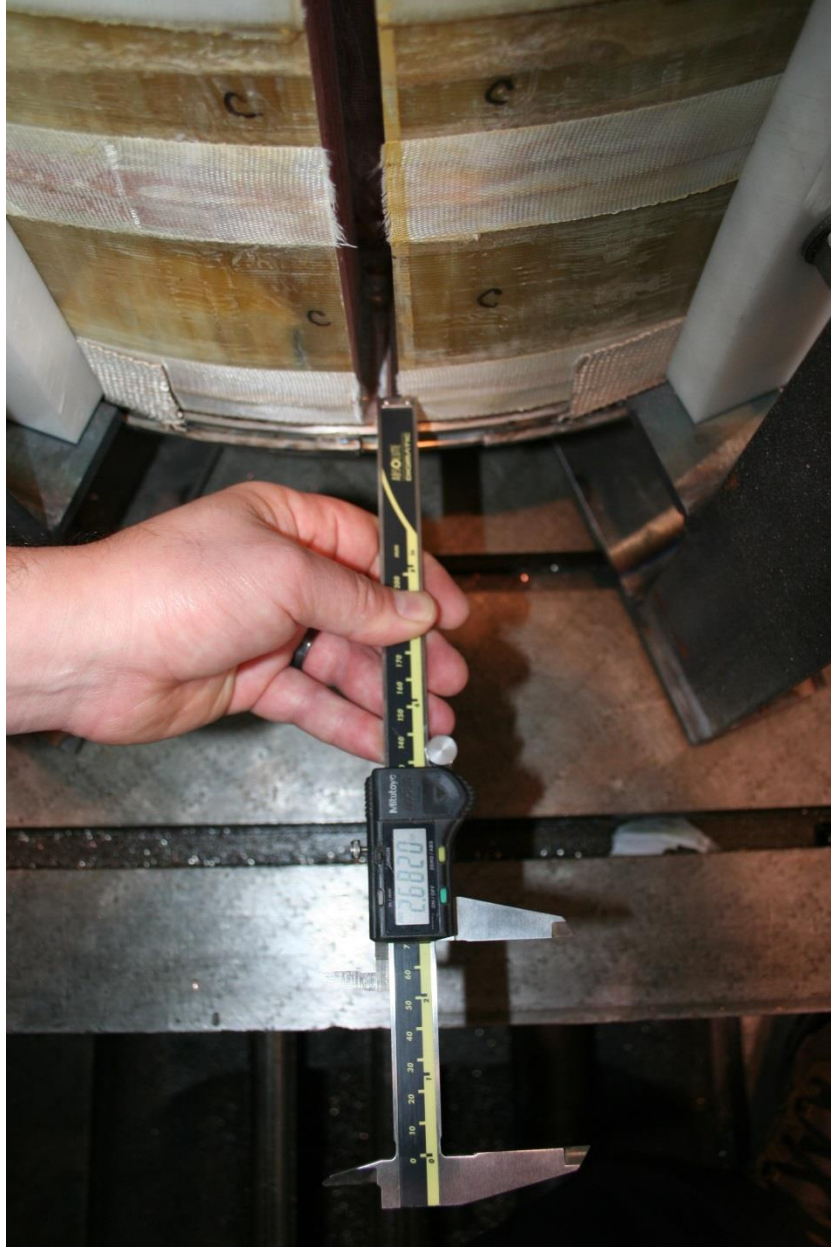
Figure 71 – Cutting Plane C coil pack depth

Figure 72 – Cutting Plane C coil pack depth

Figure 73 – Cutting Plane C coil pack depth

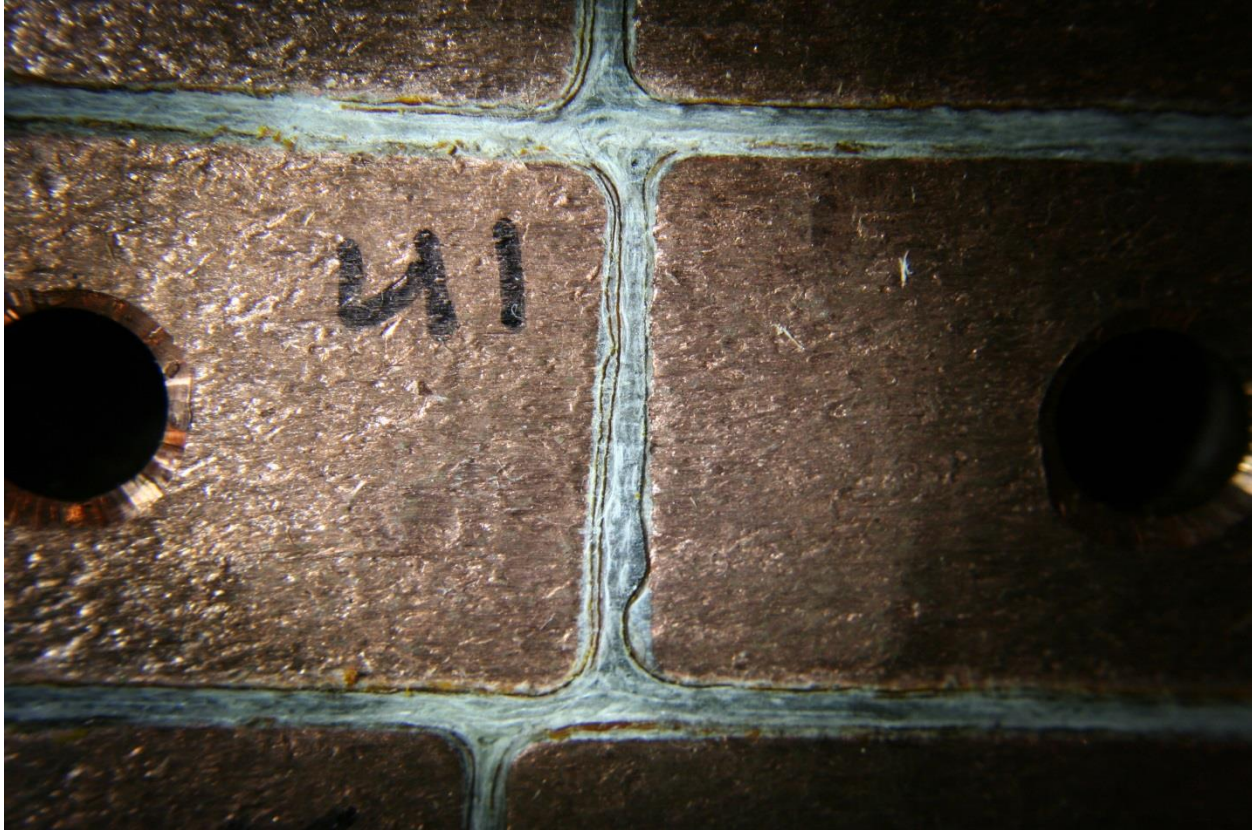
Exterior visual examination of cutting planes A and C, left and right, evidenced similar insulation anomalies observed during the milling process (Figures 84 thru 87). Cutting plane B, left and right, evidenced a separation between conductor layers two (2) and three (3) from approximately conductor row three (3) to conductor row sixteen (16) (Figures 88 and 89). Observed conductor spacing, insulation characteristics, and conductor keystoneing were noted and photographed (Figures 90 thru 93). Examination of the insulation wrap sequence evidenced that each conductor was wrapped with a half-lap co-wound glass/Kapton layer with the glass portion laid-up against the conductor surface (Figure 94). A glass-only half-lap layer was observed to be wound over the co-wound glass/Kapton layer (Figure 95). Each layer-to-layer region evidenced an additional flat-laid glass layer (Figure 96).

Figure 85 – Coil pack section plane C dry glass

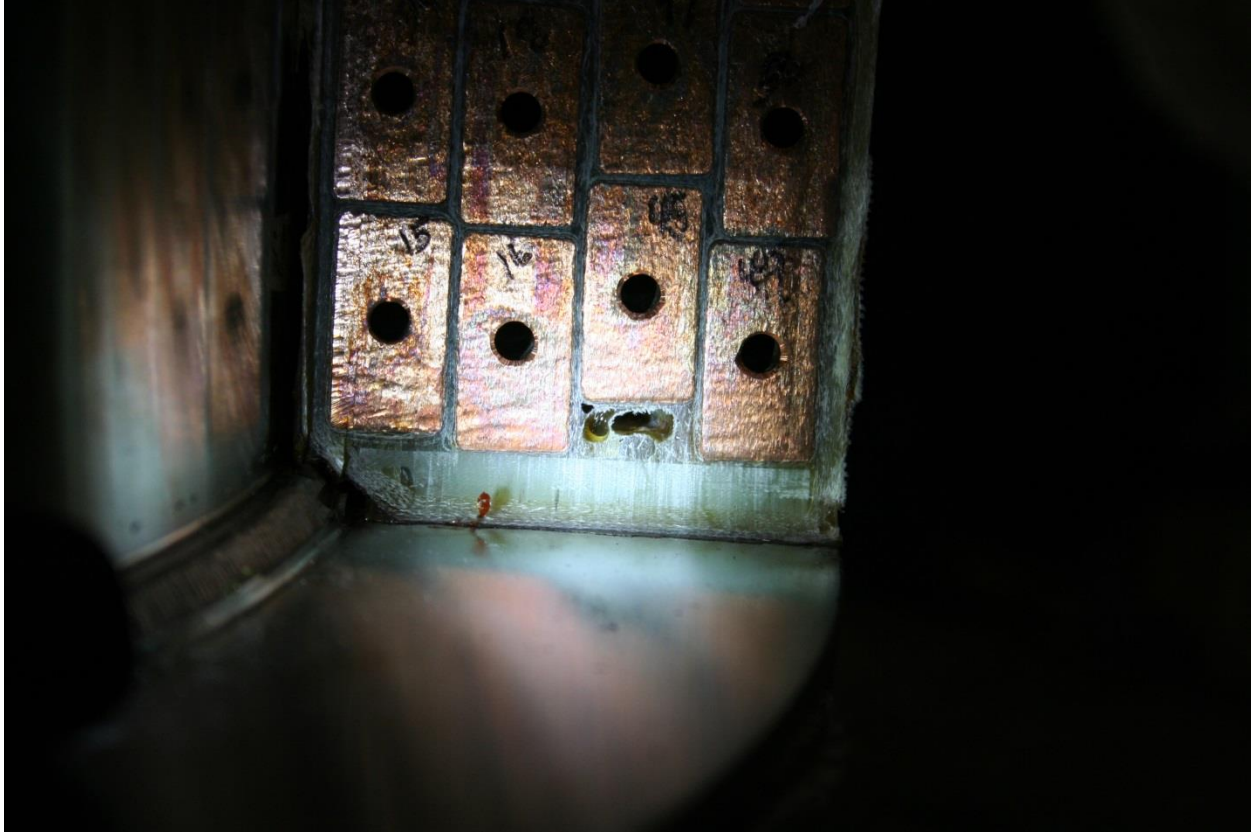
Figure 87 – Coil pack section plane A void
