Forensic Analysis of the NSTX-U PF1A-Upper Coil Failure

Rev. 0

November 18, 2016

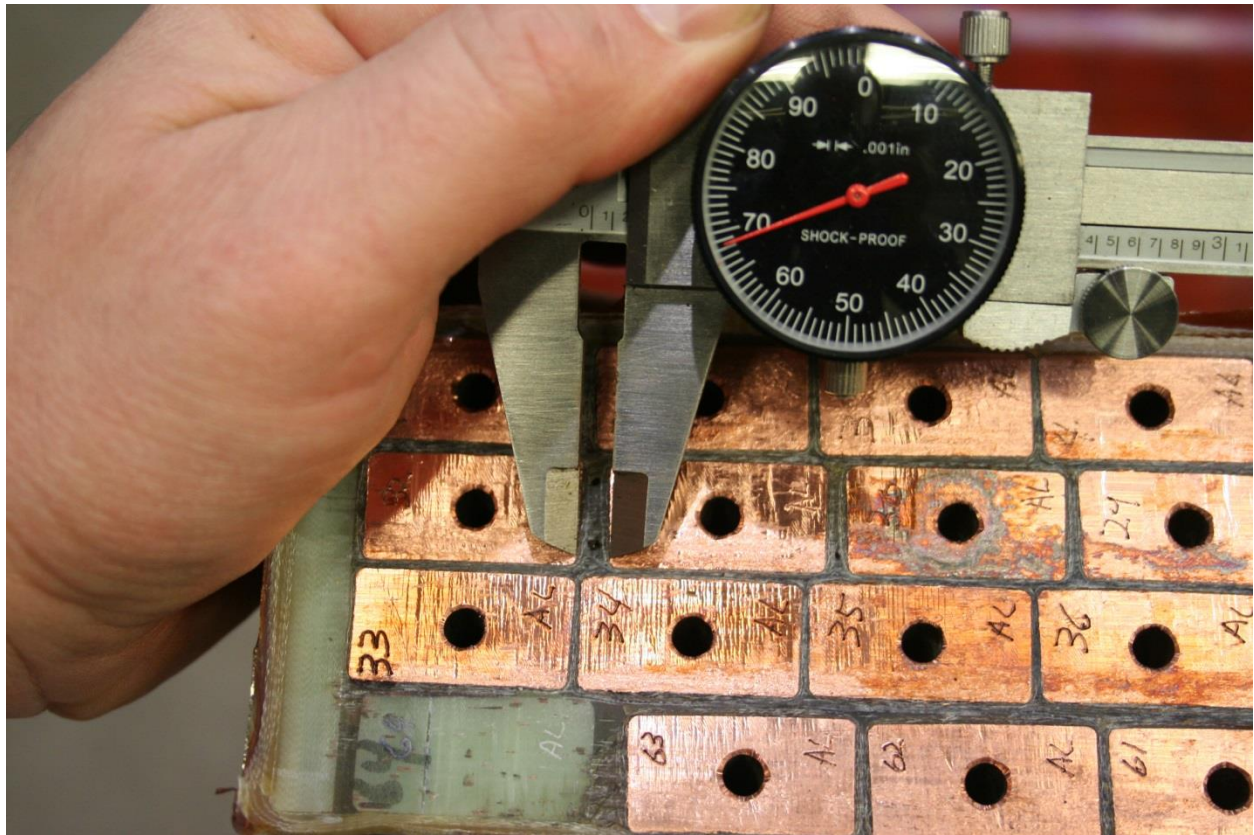
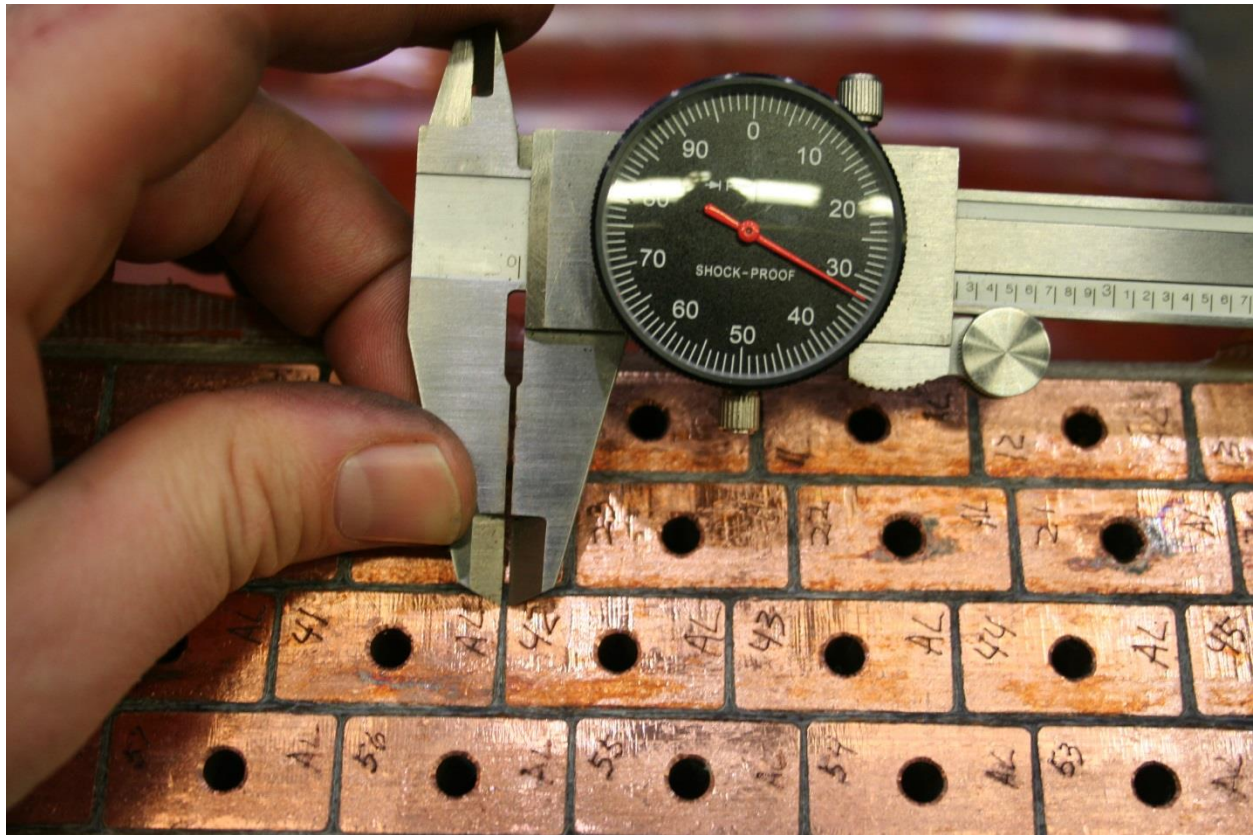
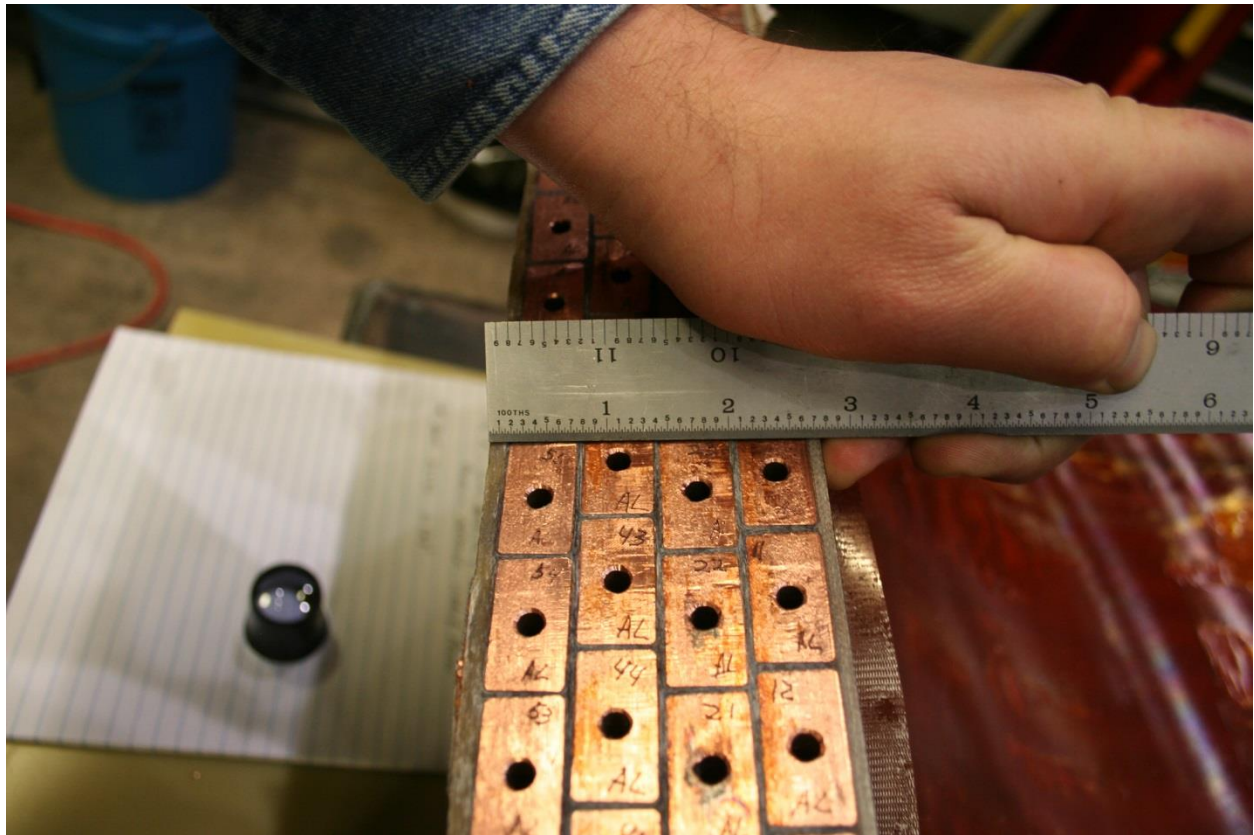
Figure 91 – Coil pack section plane A insulation spacing

Figure 92 – Coil pack section plane A insulation spacing

Figure 93 – Coil pack section plane A insulation spacing

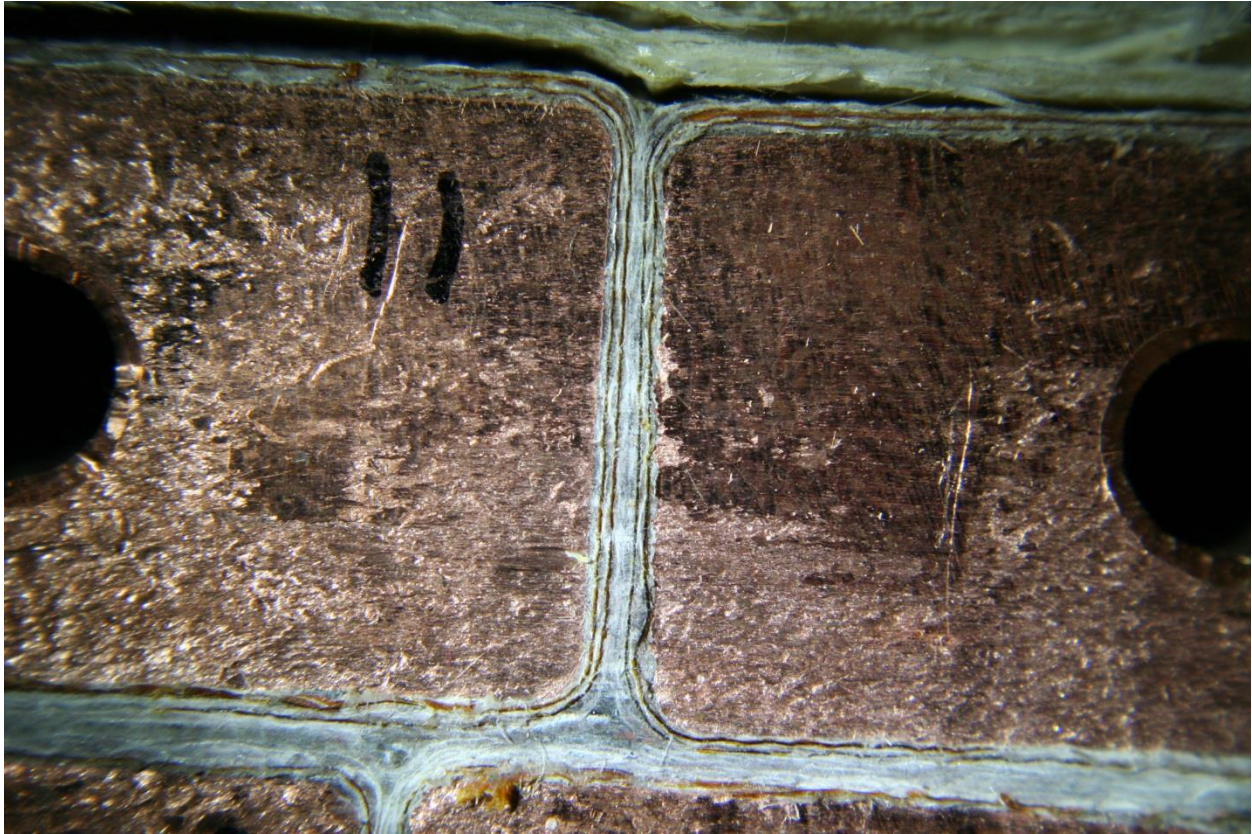
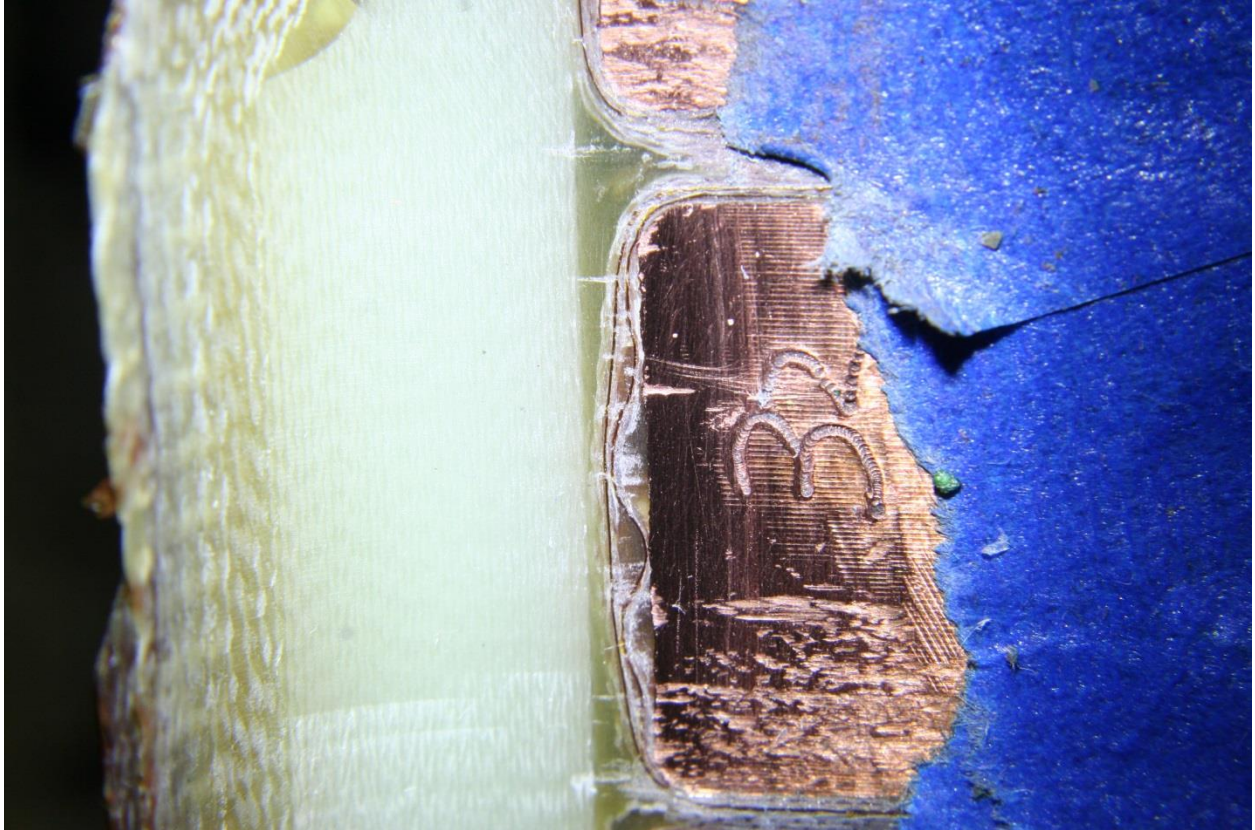
Exterior visual examination of cutting planes A and C, left and right, evidenced similar insulation anomalies observed during the milling process (Figures 84 thru 87). Cutting plane B, left and right, evidenced a separation between conductor layers two (2) and three (3) from approximately conductor row three (3) to conductor row sixteen (16) (Figures 88 and 89). Observed conductor spacing, insulation characteristics, and conductor keystoneing were noted and photographed (Figures 90 thru 93). Examination of the insulation wrap sequence evidenced that each conductor was wrapped with a half-lap co-wound glass/Kapton layer with the glass portion laid-up against the conductor surface (Figure 94). A glass-only half-lap layer was observed to be wound over the co-wound glass/Kapton layer (Figure 95). Each layer-to-layer region evidenced an additional flat-laid glass layer (Figure 96).

Figure 94 – Coil pack section plane C insulation lay-up

Figure 95 – Coil pack section plane A insulation lay-up

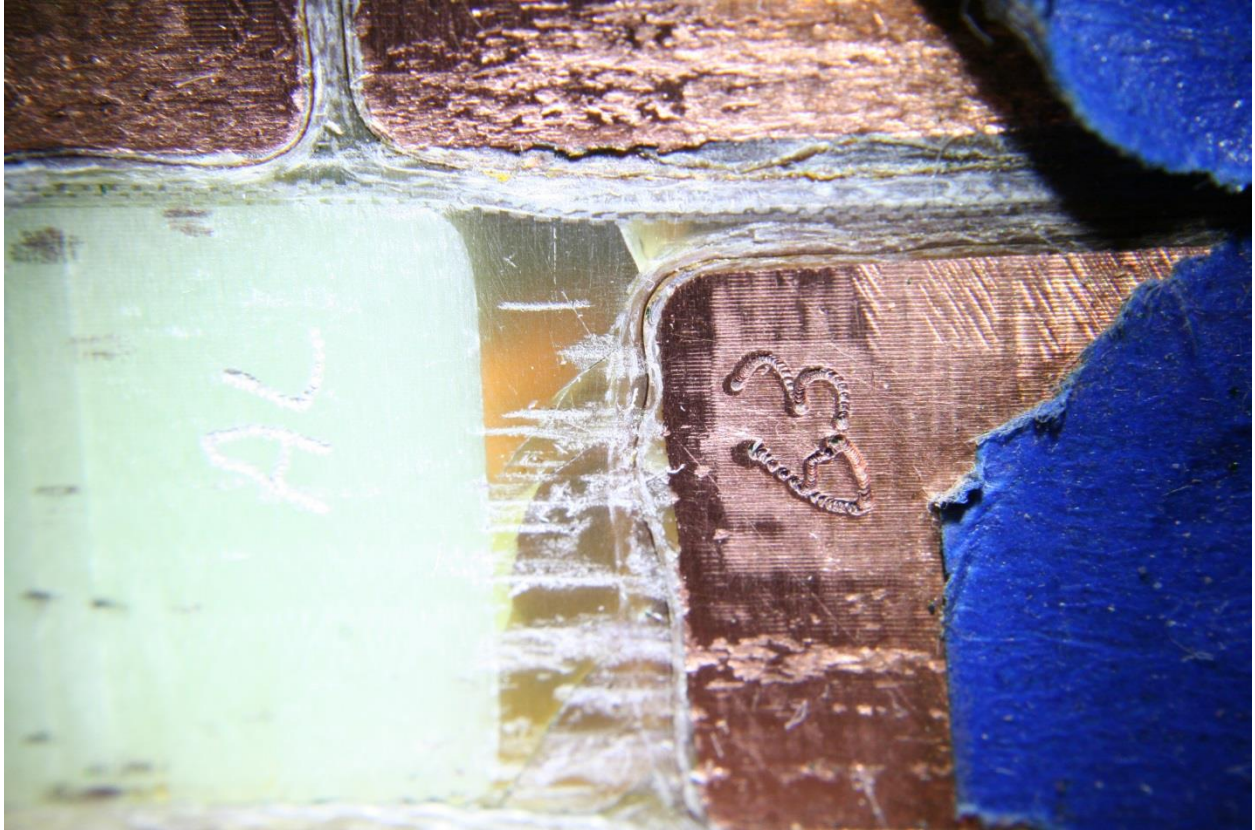
Figure 96 – Coil pack section plane A insulation layer-to-layer

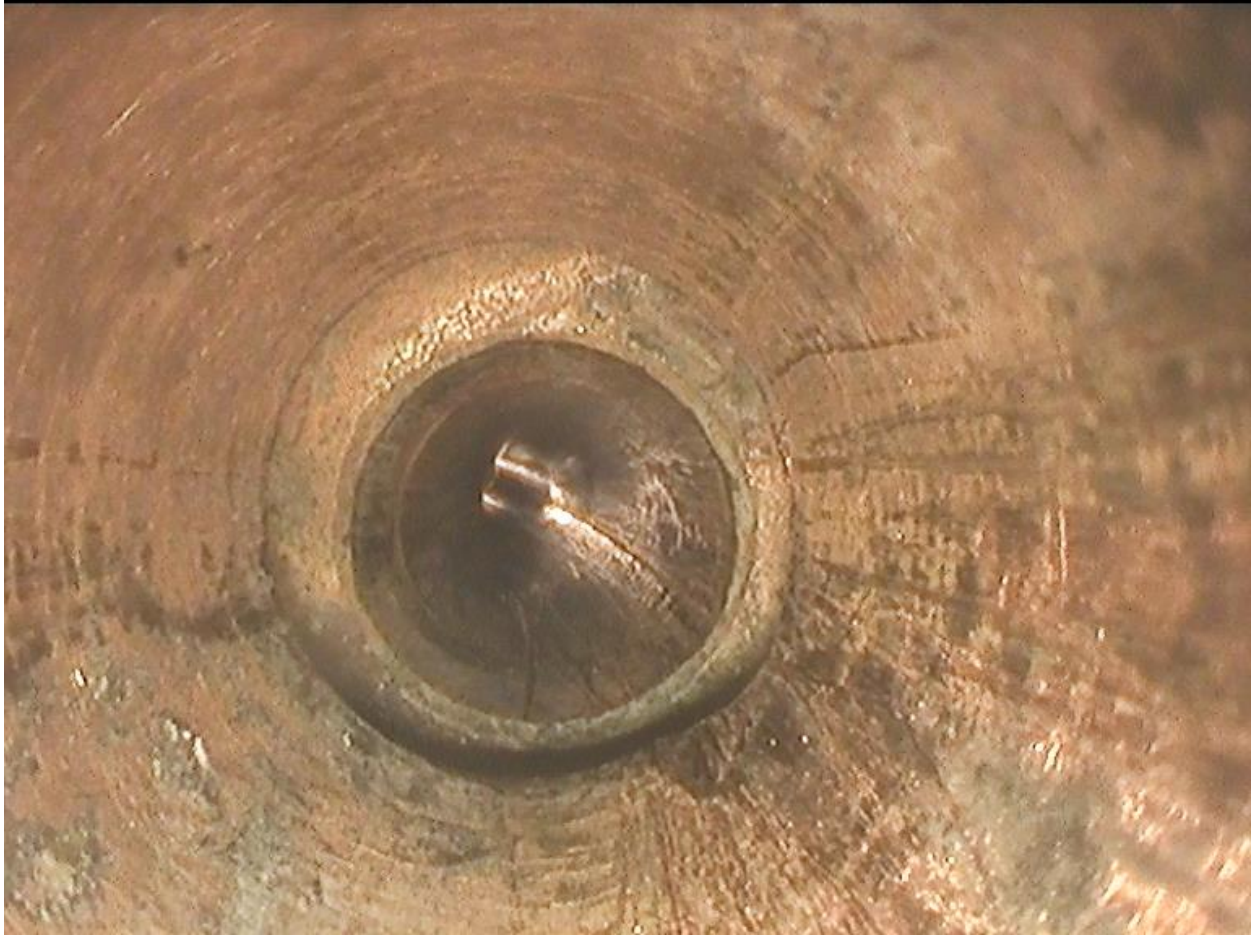
<u>Item</u>	<u>Location</u>	<u>Observations</u>	<u>Photographs</u>
Braze Joint #1	C-A, conductor layer 1, row 15	Blockage Observed	Figures 97-99
Braze Joint #2	A-B, conductor layer 2, row 3	Void Observed	Figures 100-102
Braze Joint #3	A-B, conductor layer 3, row 13	Blockage Observed	Figures 103-105
Braze Joint #4	C-A, conductor layer 4, row 6	Misalignment Observed	Figures 106-107
Anomaly "Delta"	A-B, conductor layer 3, row 9	Void in sidewall of cooling path	Figures 108-112
Conductor 24	A-B, conductor layer 2, row 9	Discoloration along surface of cooling path	Figure 113

Figure 99 – Braze Joint #1 without blockage – view from plane C

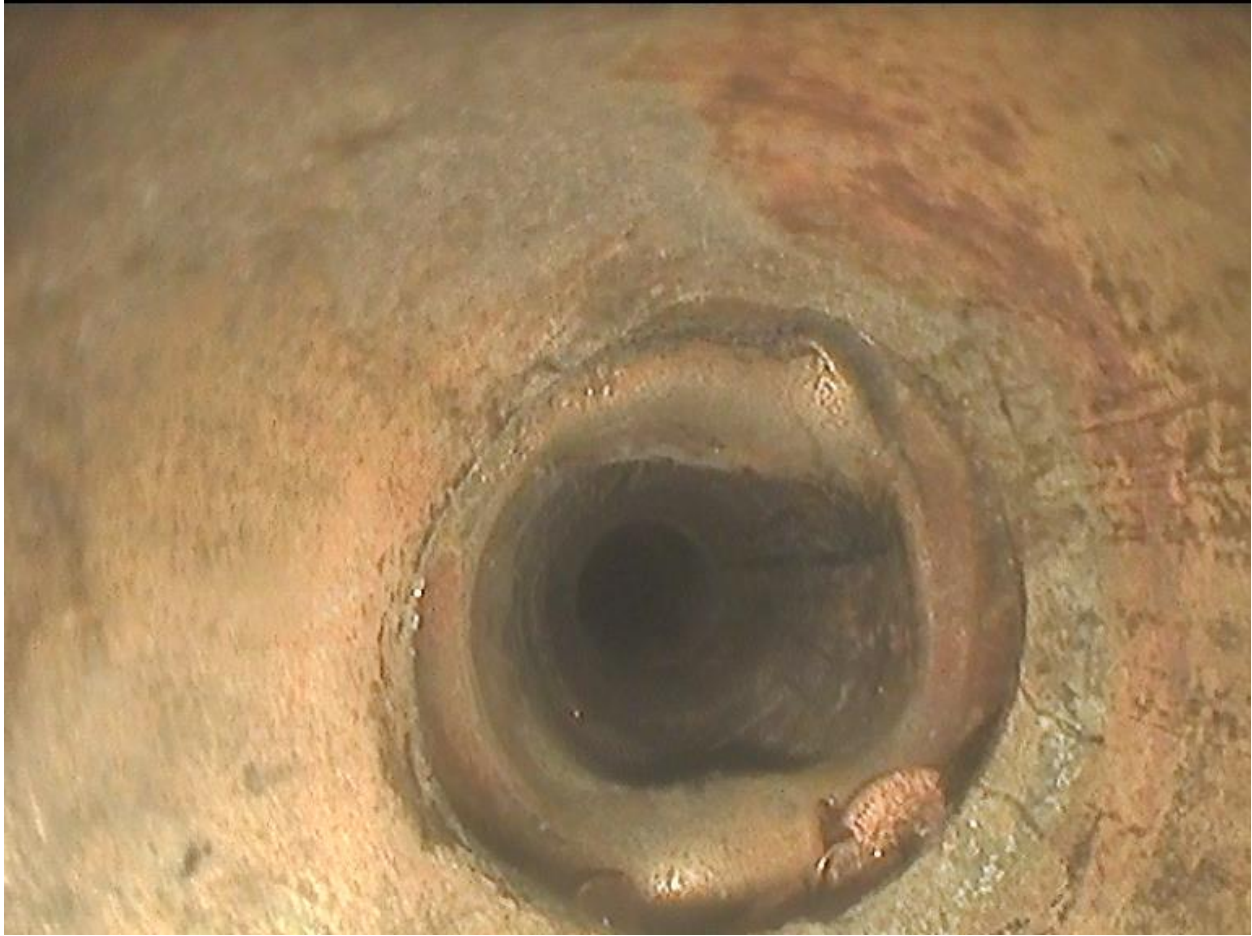
Figure 105 – Braze Joint #3 without blockage – view from plane A

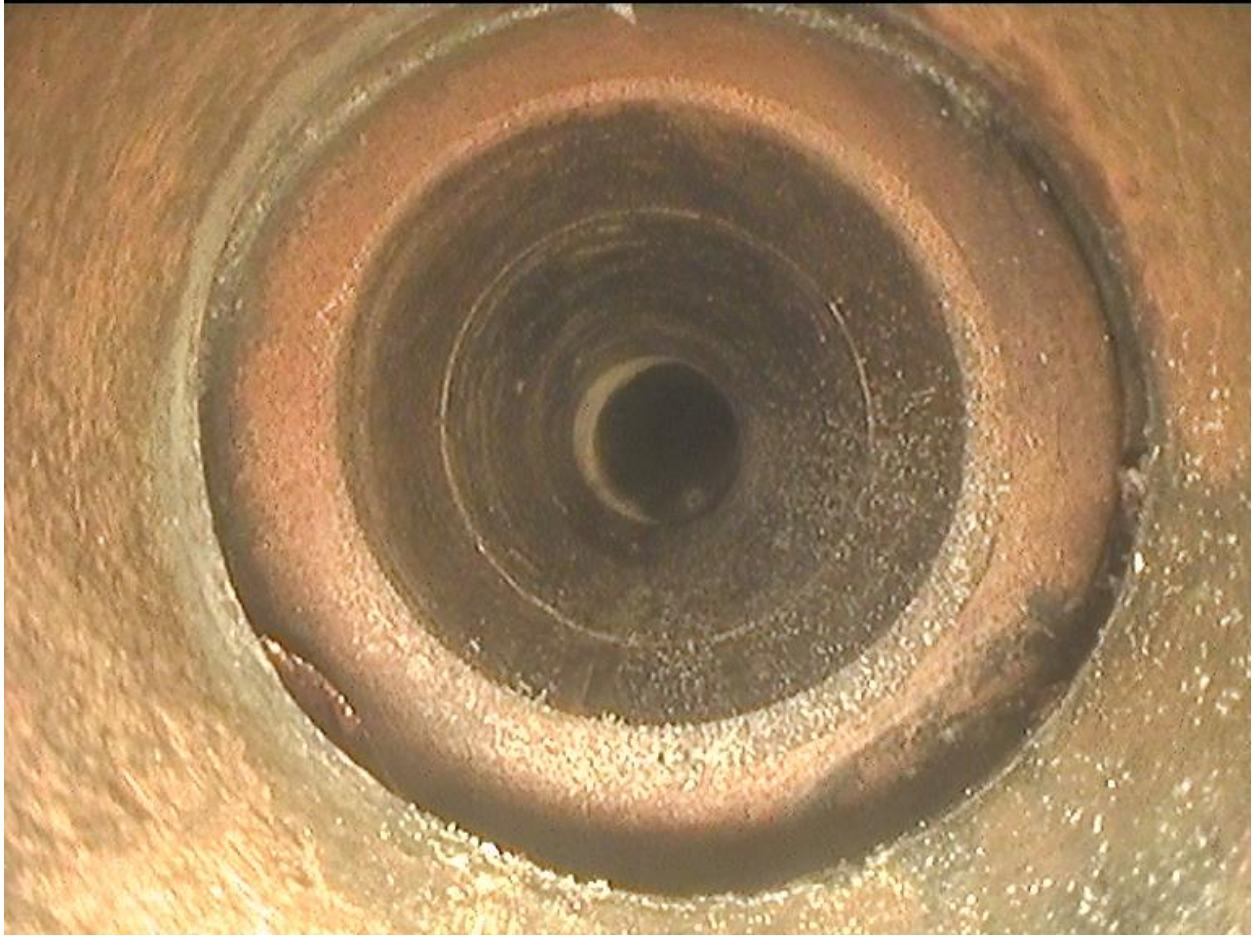
Figure 106 – Braze Joint #4 – view from plane B

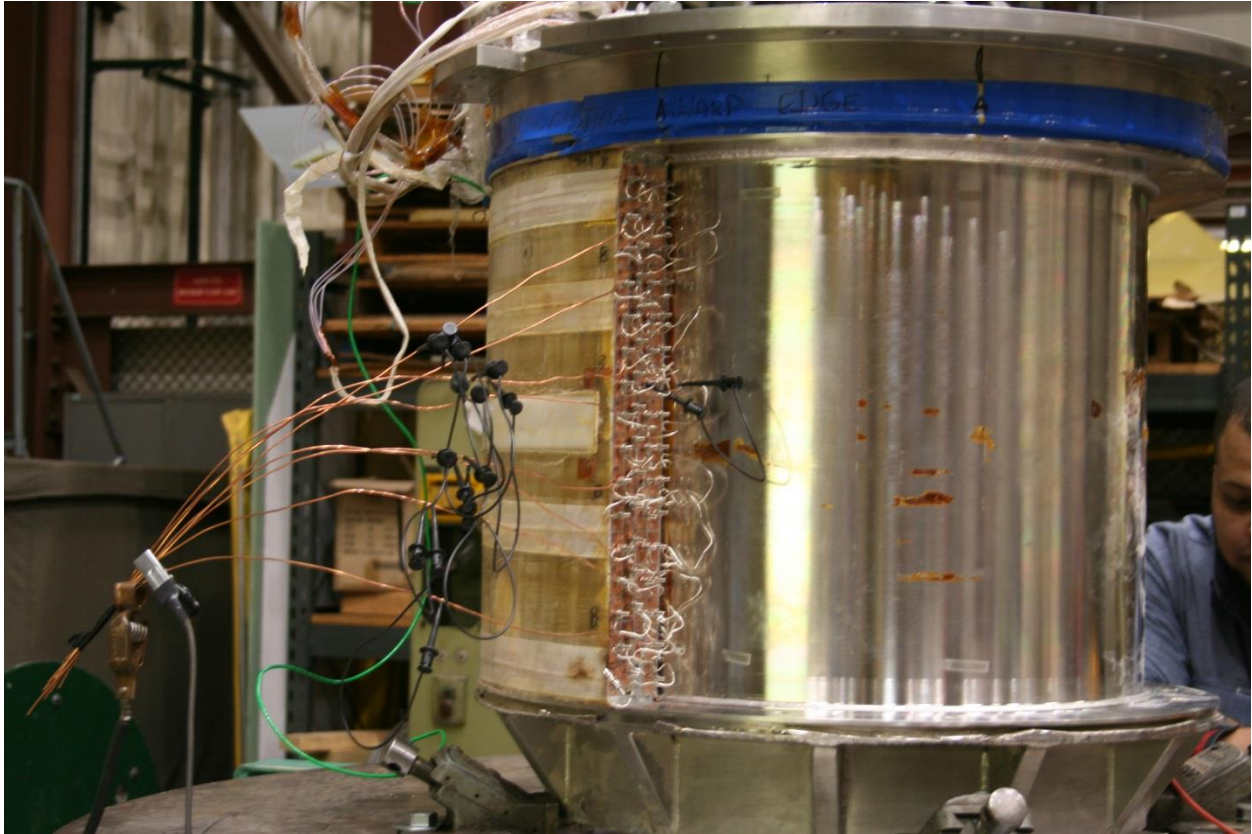
A grounding harness consisting of copper wire and banana plugs was inserted into the cooling path of each conductor along one side of each coil pack section for megger testing (Figure 114). The conductor under test was electrically disconnected from the grounding harness during the test. Each conductor segment was megger tested at 250VDC per the Generic Megger and Hipot Procedure - PTP-GEN-01. The observed conductor insulation resistance varied from 1.81 Mohm to greater than 750Gohm in un-shortened conductor segments. Results were tabulated for future analysis and are listed in Table 7.

Figure 114 – Electrical testing set-up example

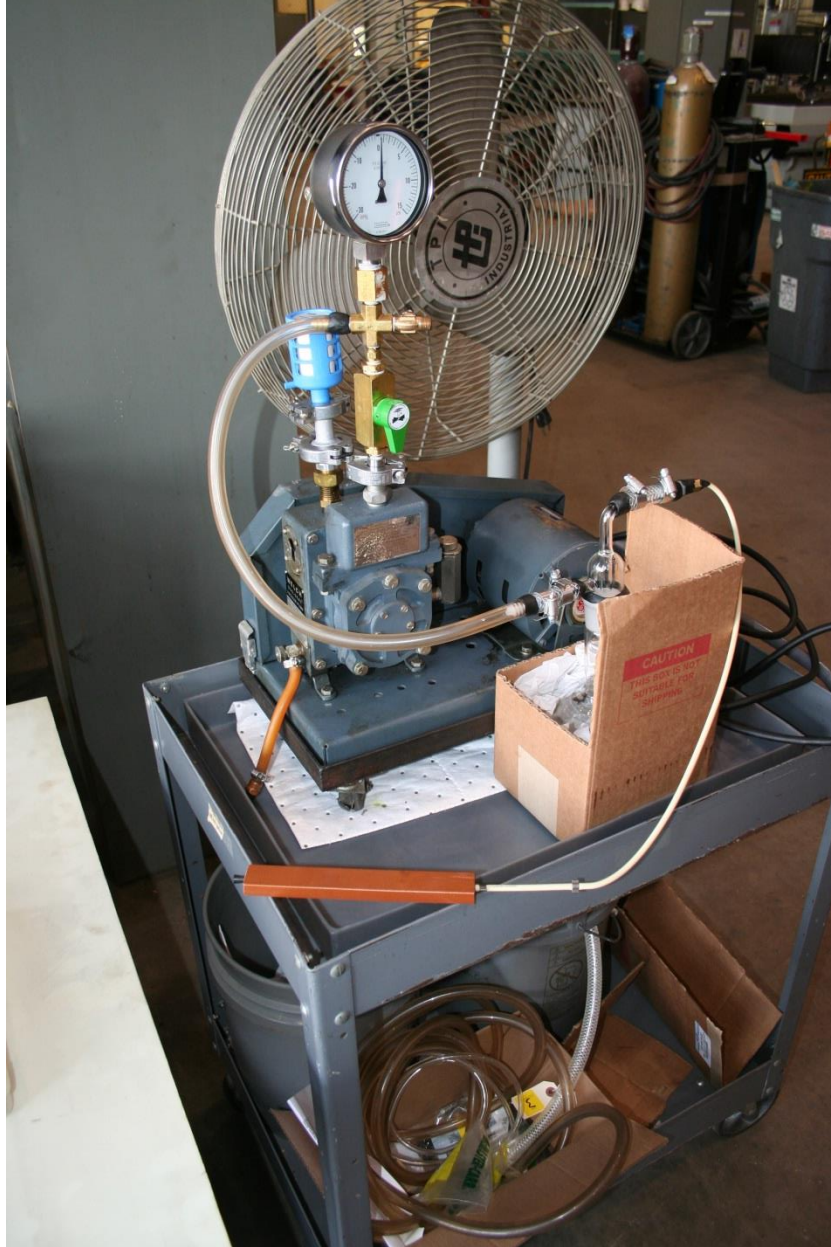
A low-vacuum pump was configured with a moisture/debris trap in order to selectively apply vacuum to conductor segment cooling paths (Figure 115). Each cooling path segment was vacuum tested at approximately 29 inches of mercury for 2 minutes (Table 9). One conductor segment cooling path failed to hold vacuum. The leaking conductor section was determined to be the cooling path with the internally observed void (Section A-B, Layer 3, Row 9, conductor #41).

Figure 115 – Vacuum testing apparatus

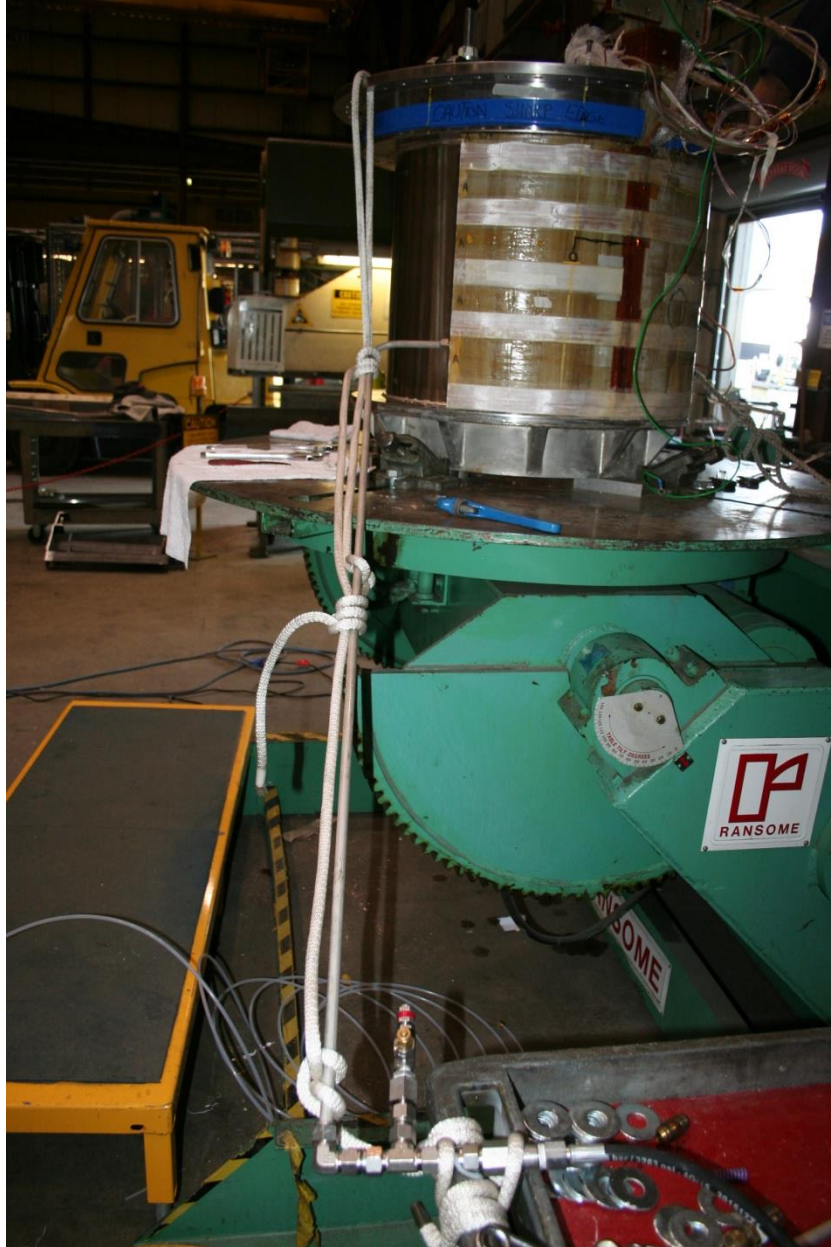
The cooling paths of conductor segments containing braze joints and leads were tapped with a 1/8" NPT tapered thread for the attachment of pressure testing components . A 15 psi nitrogen pressure test was followed by a 400 psi hydrostatic pressure tests per ENG-014 for each tested conductor segment (Figure 116). Hydrostatic tests were repeated to vet out set-up variances, including subjecting one test set-up to an overnight leak-down. All four tested braze joints and leads passed hydrostatic testing at 400 psi. Low-pressure helium leak tests were additionally performed on the conductor segments featuring the leads, braze joint number two (2) and braze joint number three (3) in Section A-B and were unremarkable. Excerpts from the braze joint and lead(s) conductor segment hydrostatic test results are illustrated in Table 10.

Figure 116 – Pressure testing set-up example
